# PIER 70 BUILDING SURVEY

HISTORIC BUILDINGS  
CONDITIONS AND ASSESSMENT  
CAREY & CO. AND OLMMA, INC  
MAY 2008

Pier 70  
San Francisco, California

Historic Building  
Conditions Survey and Assessment  
May 22, 2008

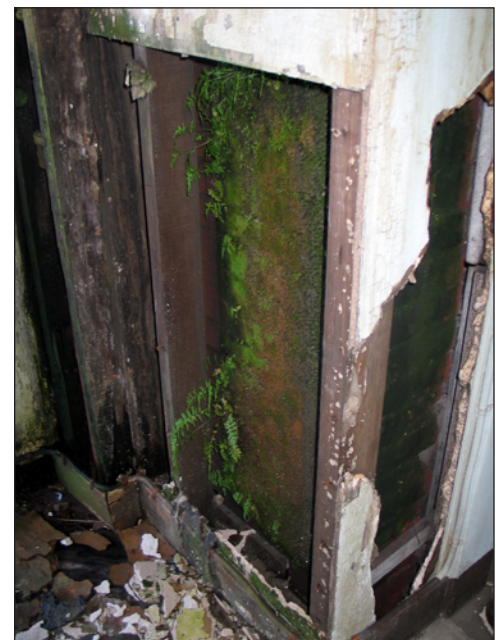
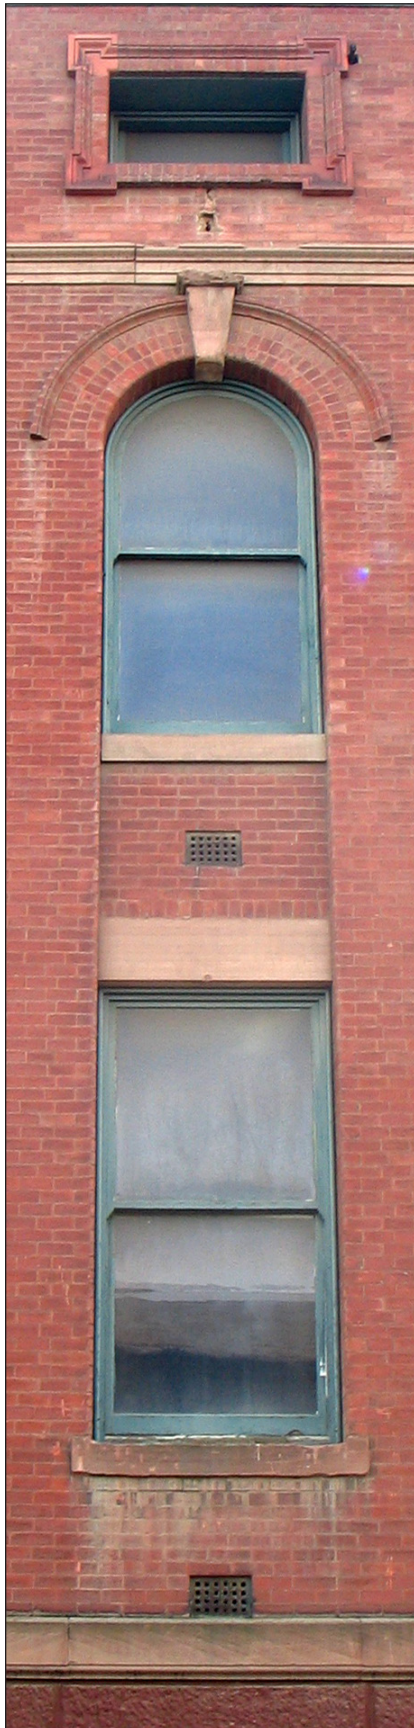
- Hospital addition roof slopes towards building
- Hospital addition roof drains non-functional
- At northwest hospital addition where hospital addition finish walls removed, significant vegetation growth on brick wall. Water damage present from 2<sup>nd</sup> floor to basement at NW interior wall.

- Possible extensive water damage to brick exterior wall

- Remove additional finish wall surfaces to investigate brick wall condition
