Heron's Head

SUBAREA DESCRIPTION

The Heron's Head subarea primarily consists of the 21-acre Heron's Head Park, originally constructed as part of never-completed construction of a new cargo terminal, "Pier 98," and officially zoned as an industrial area. It is now home to native plants and more than 100 bird species and one of the few wetlands on San Francisco's shoreline. The EcoCenter at Heron's Head Park is the first LEED Platinum - Zero Net Energy Building in San Francisco, using sustainable on-site power, and wastewater systems. The educational community center at the EcoCenter as well as the park walking paths, bird watching, and ecosystem restoration activities are part of a commitment to create a sustainable waterfront for generations to come.

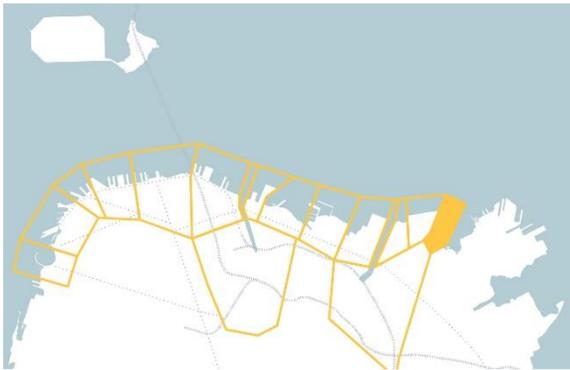
This shoreline within this subarea is primarily an embankment that is fronted by marsh or varying degrees of rock protection.

The primary pathways of flooding are from overtopping over broad stretches of mostly natural shoreline along the northern edge of Heron's Head Park and along the India Basin Shoreline to the south of this subarea. The wetland area at Heron's Head Park and the India Basin Shoreline already experience regular inundation during high tides today.
