MEMORANDUM

SUBJECT: Informational presentation on the Results of the Earthquake Vulnerability Study of the Northern Waterfront Seawall

Exhibit A: Typical Seawall Section

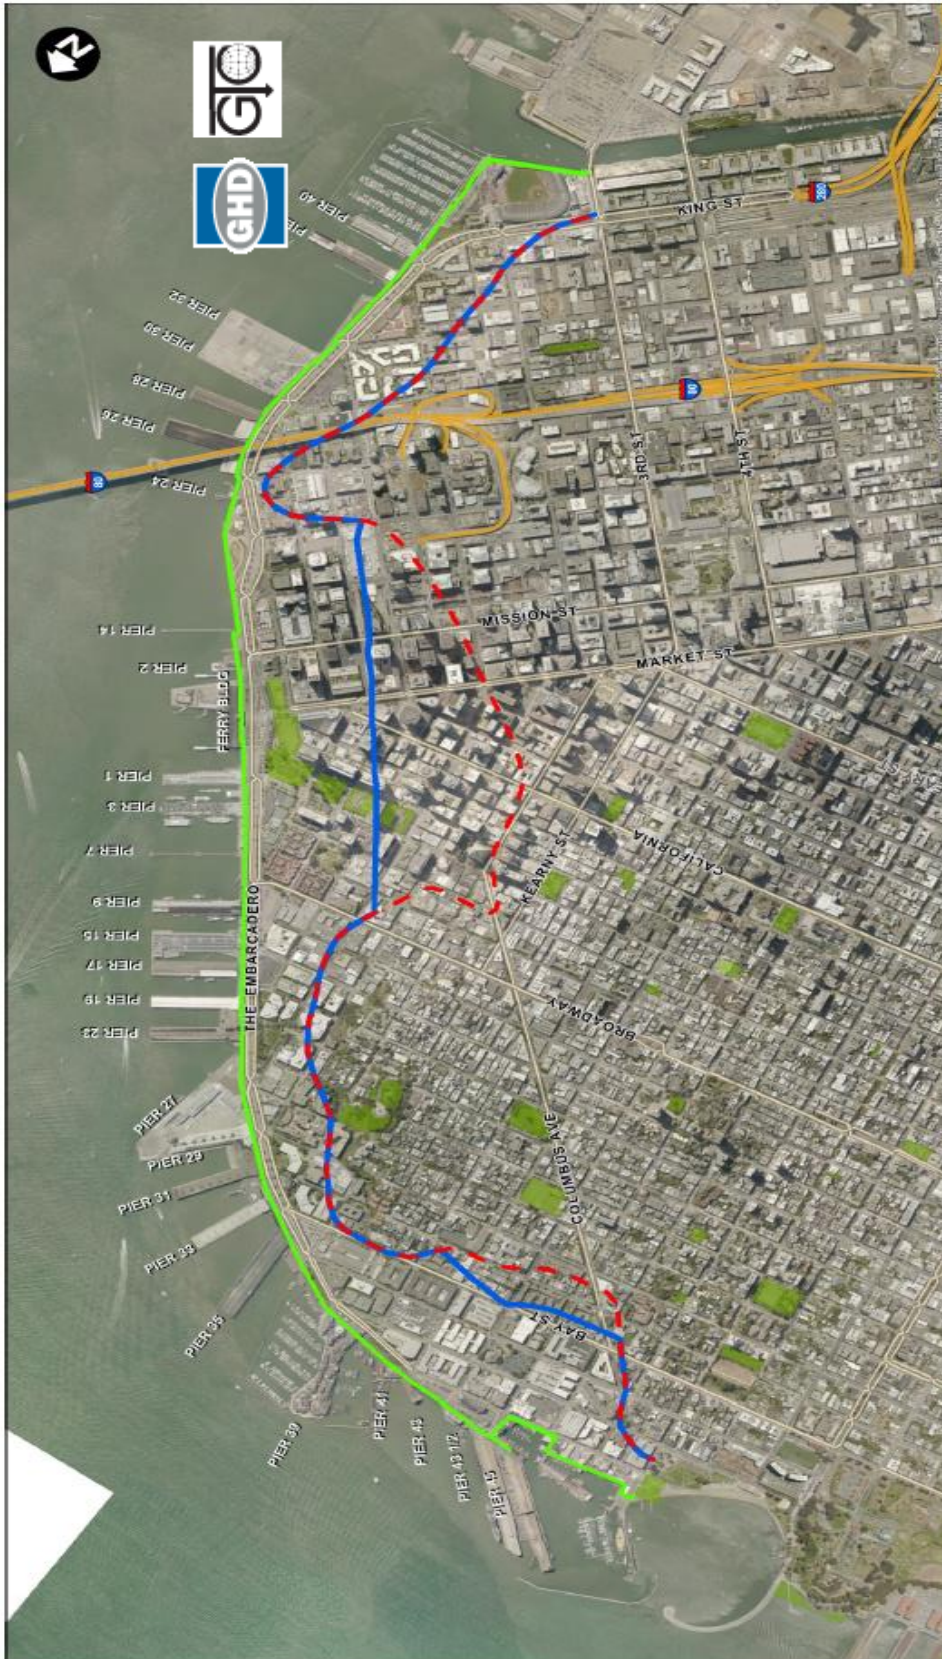
Exhibit B: Seawall Zone of Influence

Project Study Area, within 1200 feet of the Seawall Bulkhead and within the Lateral Spread Hazard Zone

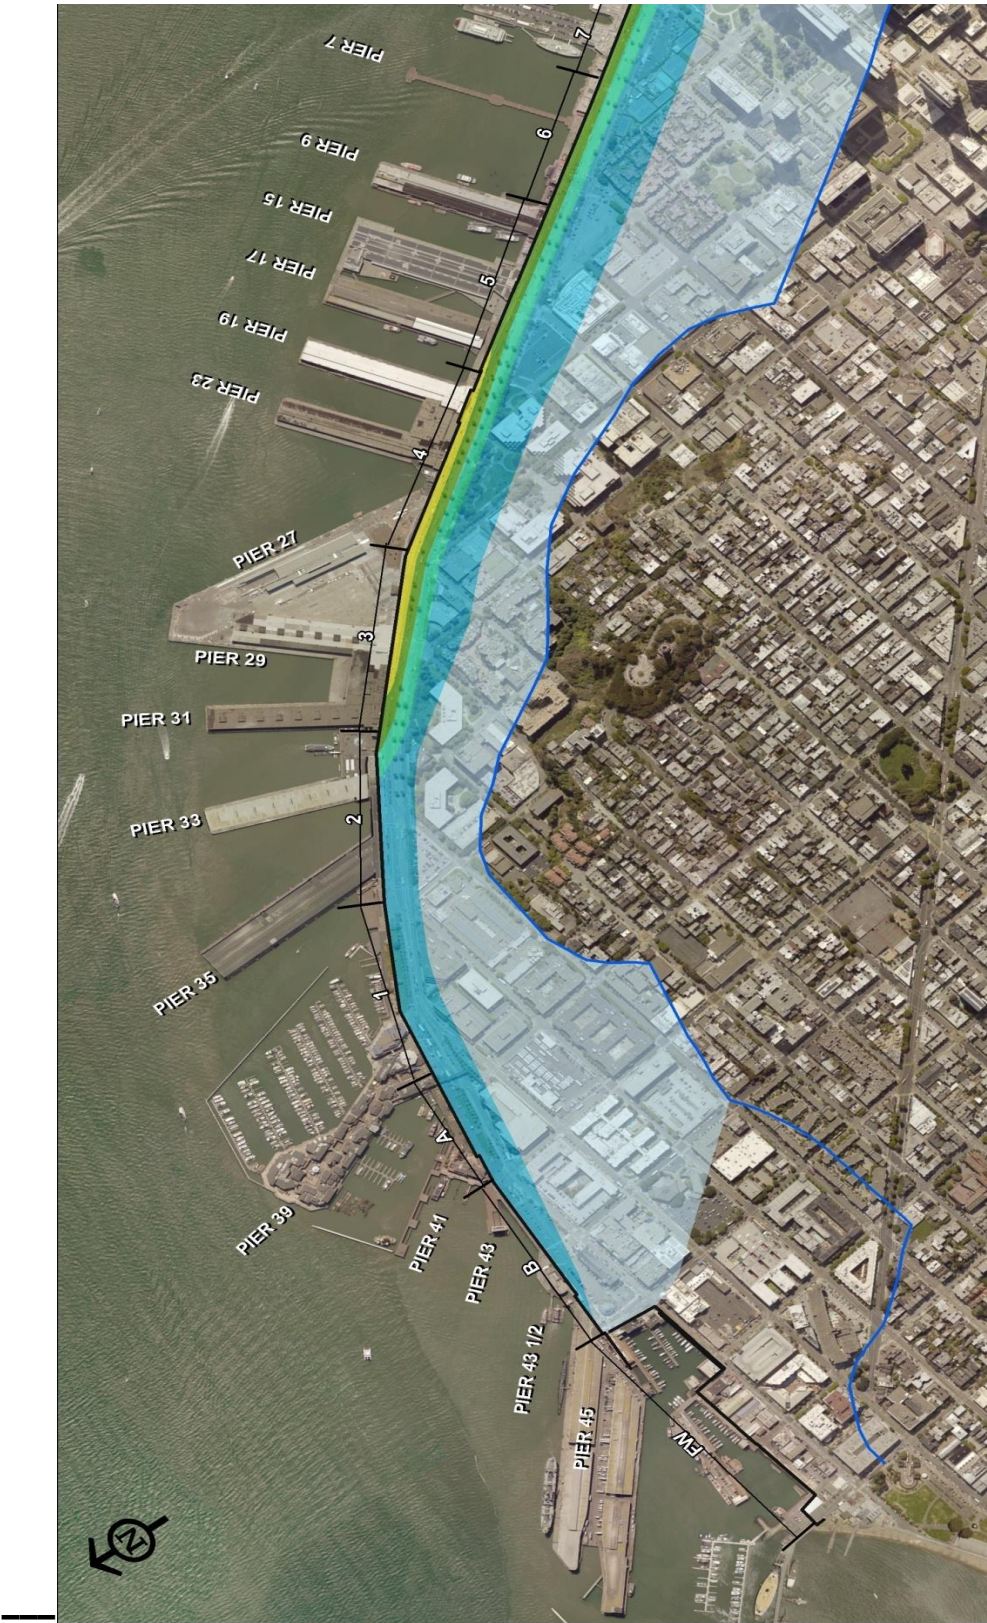
Exhibit D-1: Lateral Spreading Map, 1 of 2

-   Seawall Bulkhead
-   Seawall Sections
-   Zone of influence, within 1200 feet of the Seawall Bulkhead and within the HLA 1992 Lateral Spread Hazard Zone
