Fisherman's Wharf

Subarea 1-2

Subarea Description

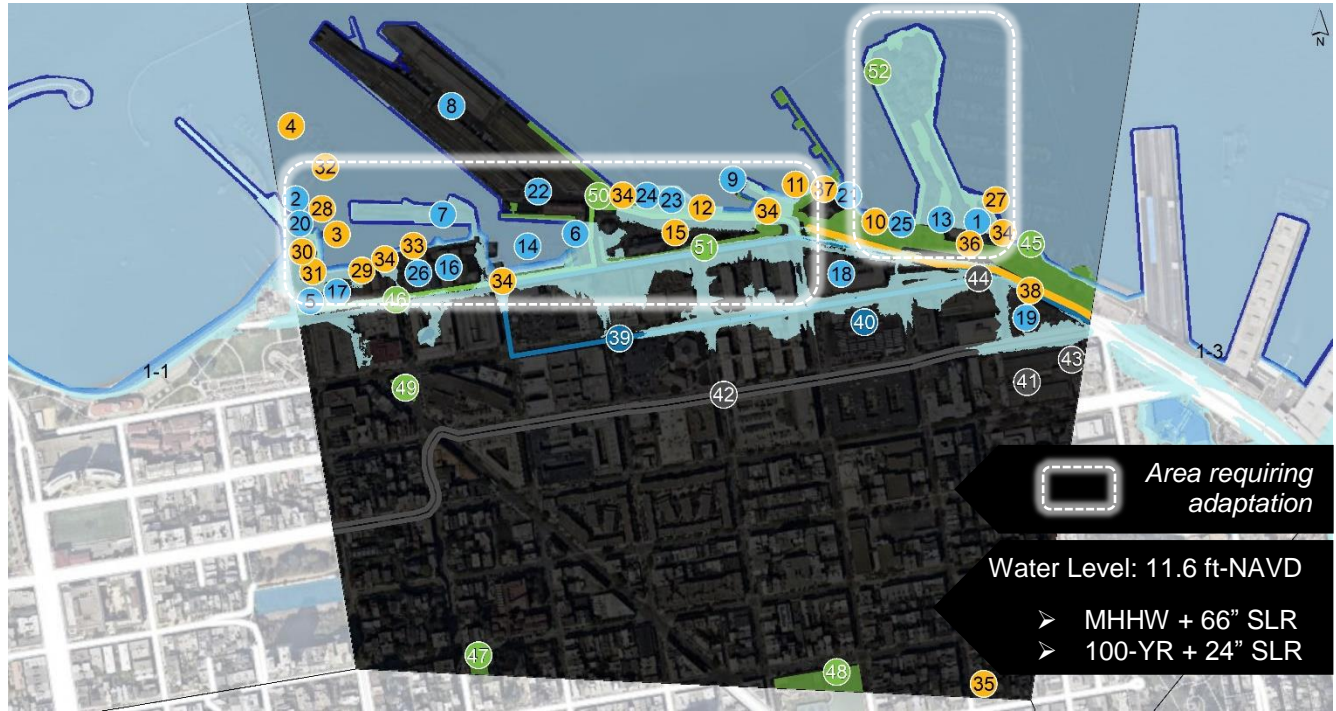
Adaptation Focus: Tipping Point

Shoreline Characteristics	Shoreline Overtopping					Timing of Impact (100-YR)				
	Classification	Avg. Elev.	Avg. Depth (ft)	Max Depth (ft)	Length (ft)	%	USACE Low	USACE Inter.	OPC Most Likely	USACE High
Engineered	10.8 ft. NAVD	0.8	1.1	8,975	51.3%	>2150	2113	2071	2060	2052

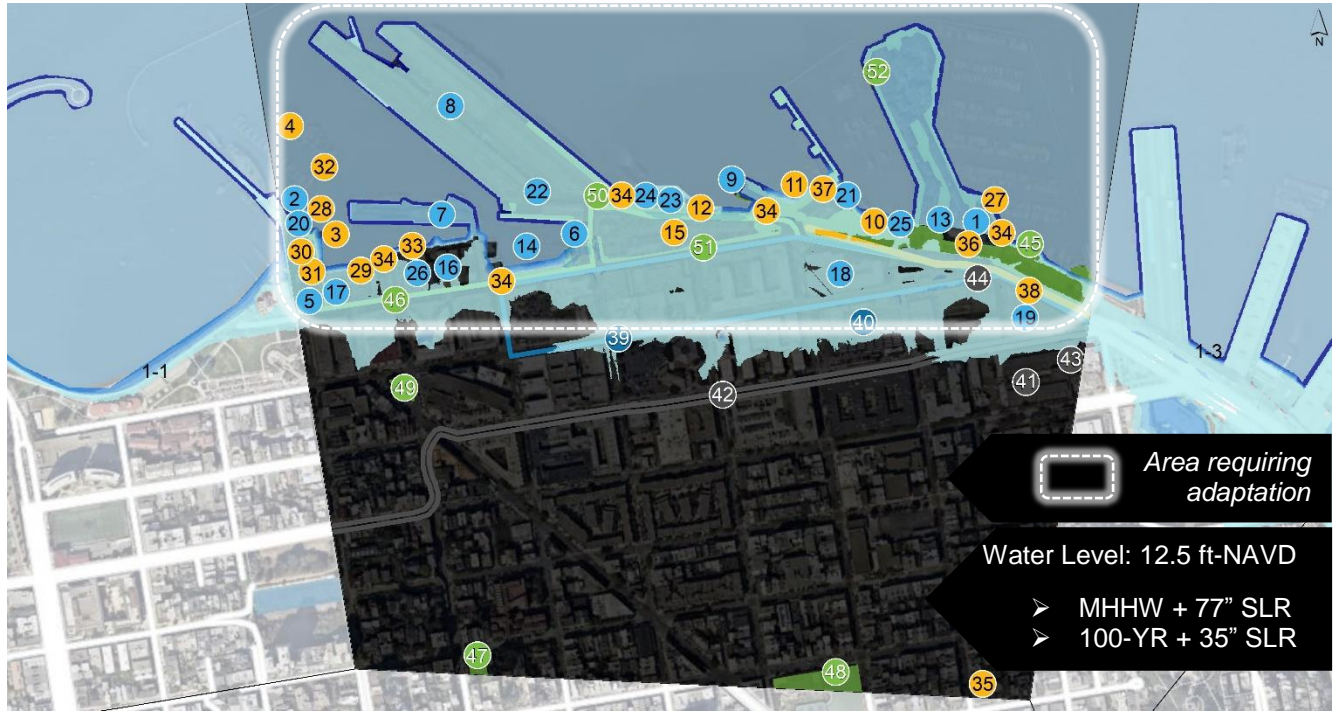
Adaptation Focus: Long-Term >2050

Shoreline Characteristics	Shoreline Overtopping					Timing of Impact (100-YR)				
	Classification	Avg. Elev.	Avg. Depth (ft)	Max Depth (ft)	Length (ft)	%	USACE Low	USACE Inter.	OPC Most Likely	USACE High
Engineered	11.5 ft. NAVD	1.0	2.1	17,385	99.3%	>2150	2143	2090	2074	2063
