Subarea Description

Pier 70

Subarea 3-5

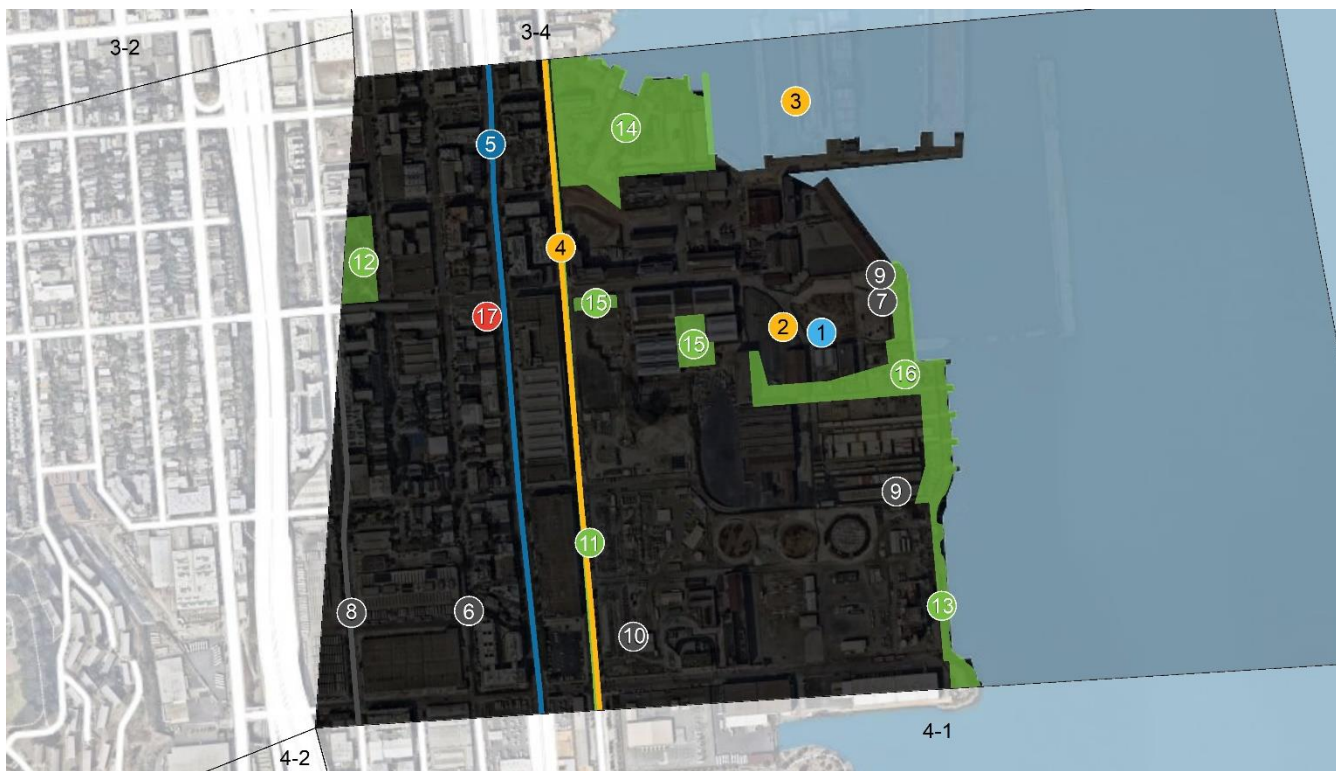
The entire shoreline within this subarea is hardened, either through piers or engineered shoreline protection (rock armoring). The primary flooding pathway is overtopping along the shoreline. Flooding initially occurs from overtopping of the shoreline at Pier 68 where the new Crane Cove Park is planned. With higher Bay water levels, overtopping will occur along the entire subarea shoreline, first along Port’s Seawall Lot 349, followed by Pier 70, then the shoreline adjacent to the old power plant. Once overtopping along Pier 68 and Seawall Lot 349 occurs, the adjacent inland areas will be impacted but inundation will mostly be contained east of Illinois Street. Flooding within this subarea will comingle with flooding in the adjacent Subareas 3-4 and 4-1.

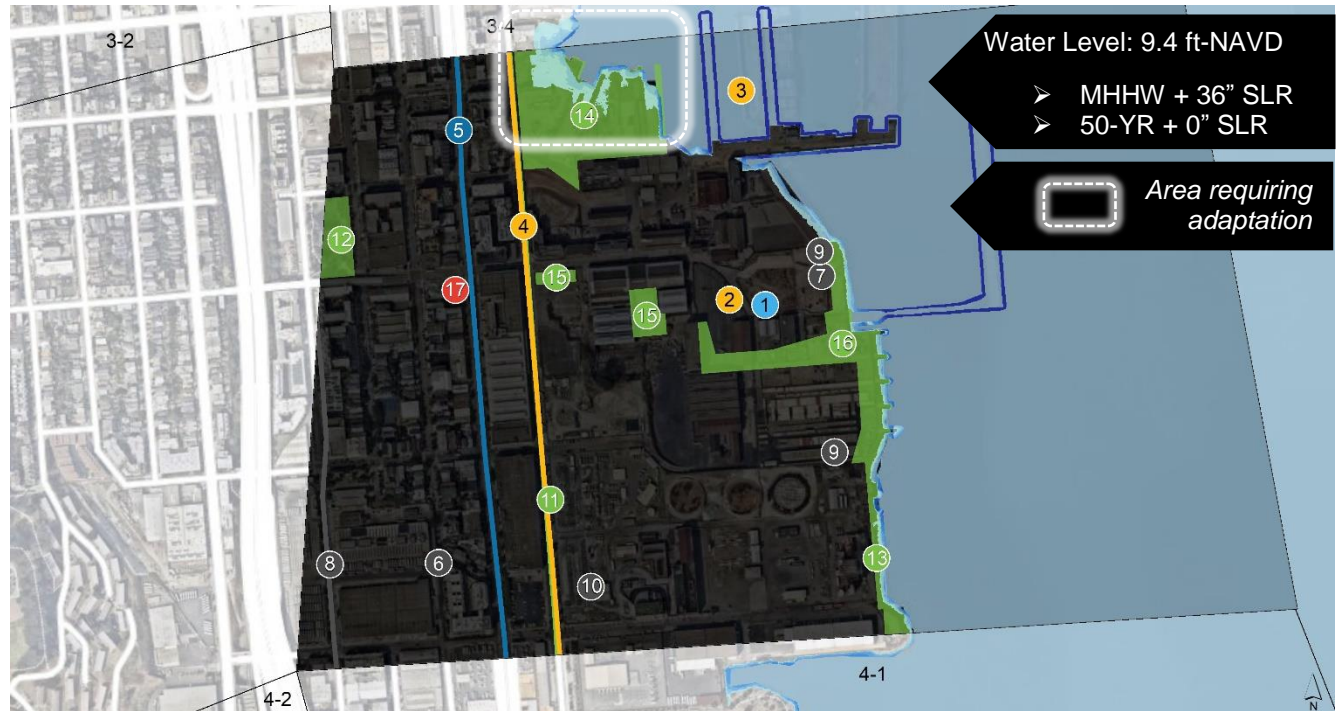
Adaptation Focus: Immediate

Shoreline Characteristics	Shoreline Overtopping					Timing of Impact (100-YR)				
	Avg. Elev.	Avg. Depth (ft)	Max Depth (ft)	Length (ft)	%	USACE Low	USACE Inter.	OPC Most Likely	USACE High	OPC 1-in-200
Engineered	7.9 ft. NAVD	1.8	3.0	1,100	7.4%	Today	Today	Today	Today	Today
