# Pier 31 to 35

## Subarea 1-3

### Subarea Description

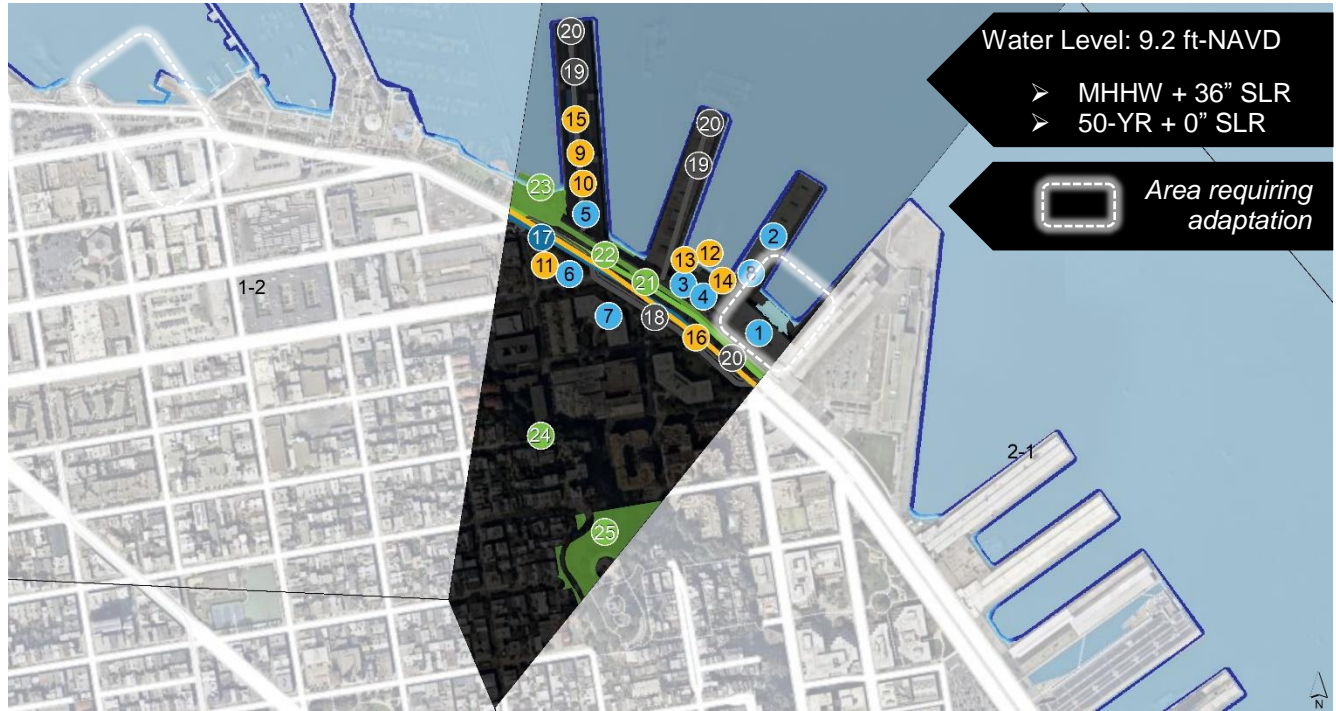
## Adaptation Focus: Immediate

Shoreline Characteristics	Shoreline Overtopping					Timing of Impact (100-YR)				
	Avg. Elev.	Avg. Depth (ft)	Max Depth (ft)	Length (ft)	%	USACE Low	USACE Inter.	OPC Most Likely	USACE High	OPC 1-in-200
Engineered	9.0 ft. NAVD	0.3	0.6	200	2.5%	Today	Today	Today	Today	Today
