Subarea Description

Cargo Way

Subarea 4-3

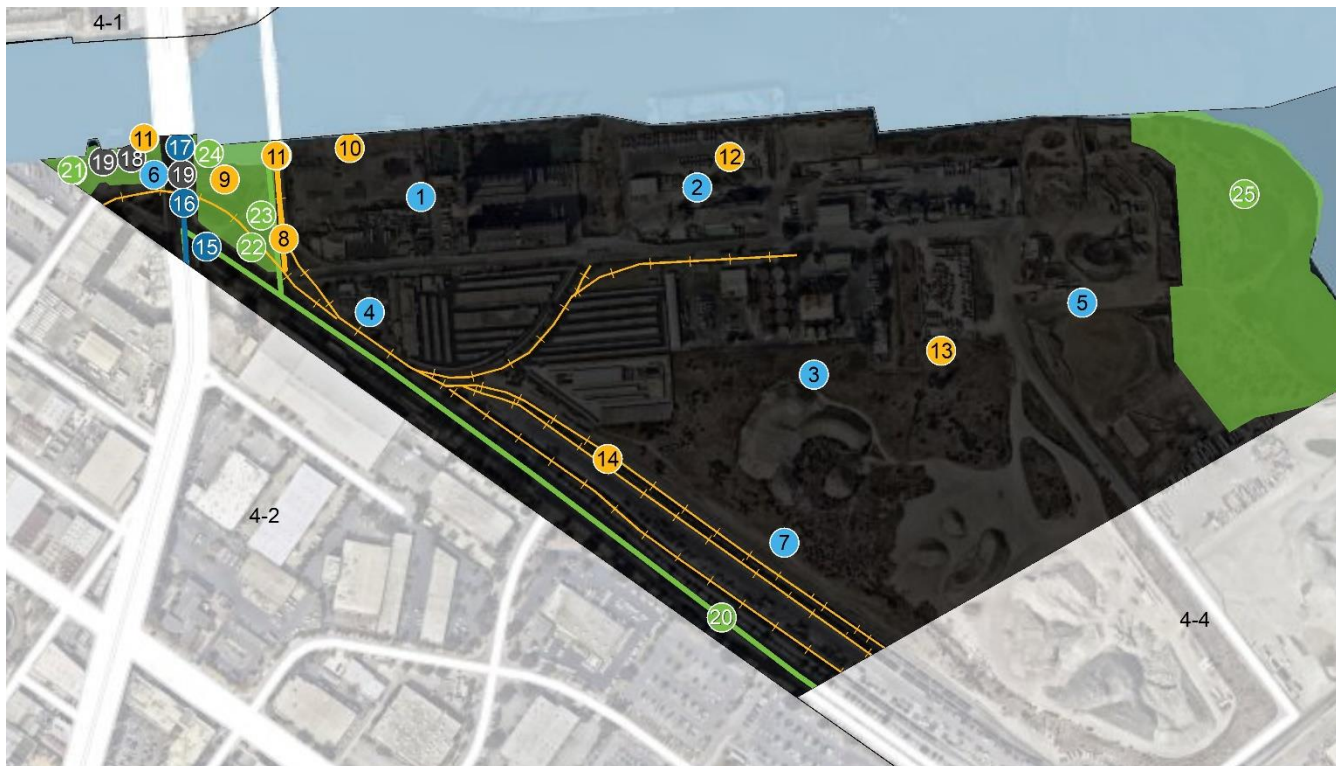
The southern shoreline of Islais Creek within this subarea has several shoreline types, including embankments with varying degrees of rock protection, engineered bulkheads and structures on piles, and bayfront marsh (Pier 94 wetlands).

The primary pathways of flooding are from overtopping of the engineered southern Islais Creek shoreline near the 3rd Street Bridge and the Illinois Street Bridge, and further east along Seawall Lot 352. Shoreline overtopping initially results in inundation contained within the subarea boundary; however, increasing water levels allow flooding to connect with Subarea 4-2 and subsequently Subarea 4-4. Flood risk reduction strategies in this subarea will eventually require coordination with the adjacent subareas.
