# The Northern Waterfront Seawall History and Earthquake Performance

**Waterfront Plan Working Group Meeting  
April 13, 2016**

**Steven Reel, PE - Project Manager, Engineering Division, Port**

**The Seawall is a complex and Historic Resource that  
is the foundation of the Northern Waterfront  
22 Original Seawall Sections  
55+ Combinations of Bulkheads and Wharves  
Modifications & Repairs throughout 100 years**

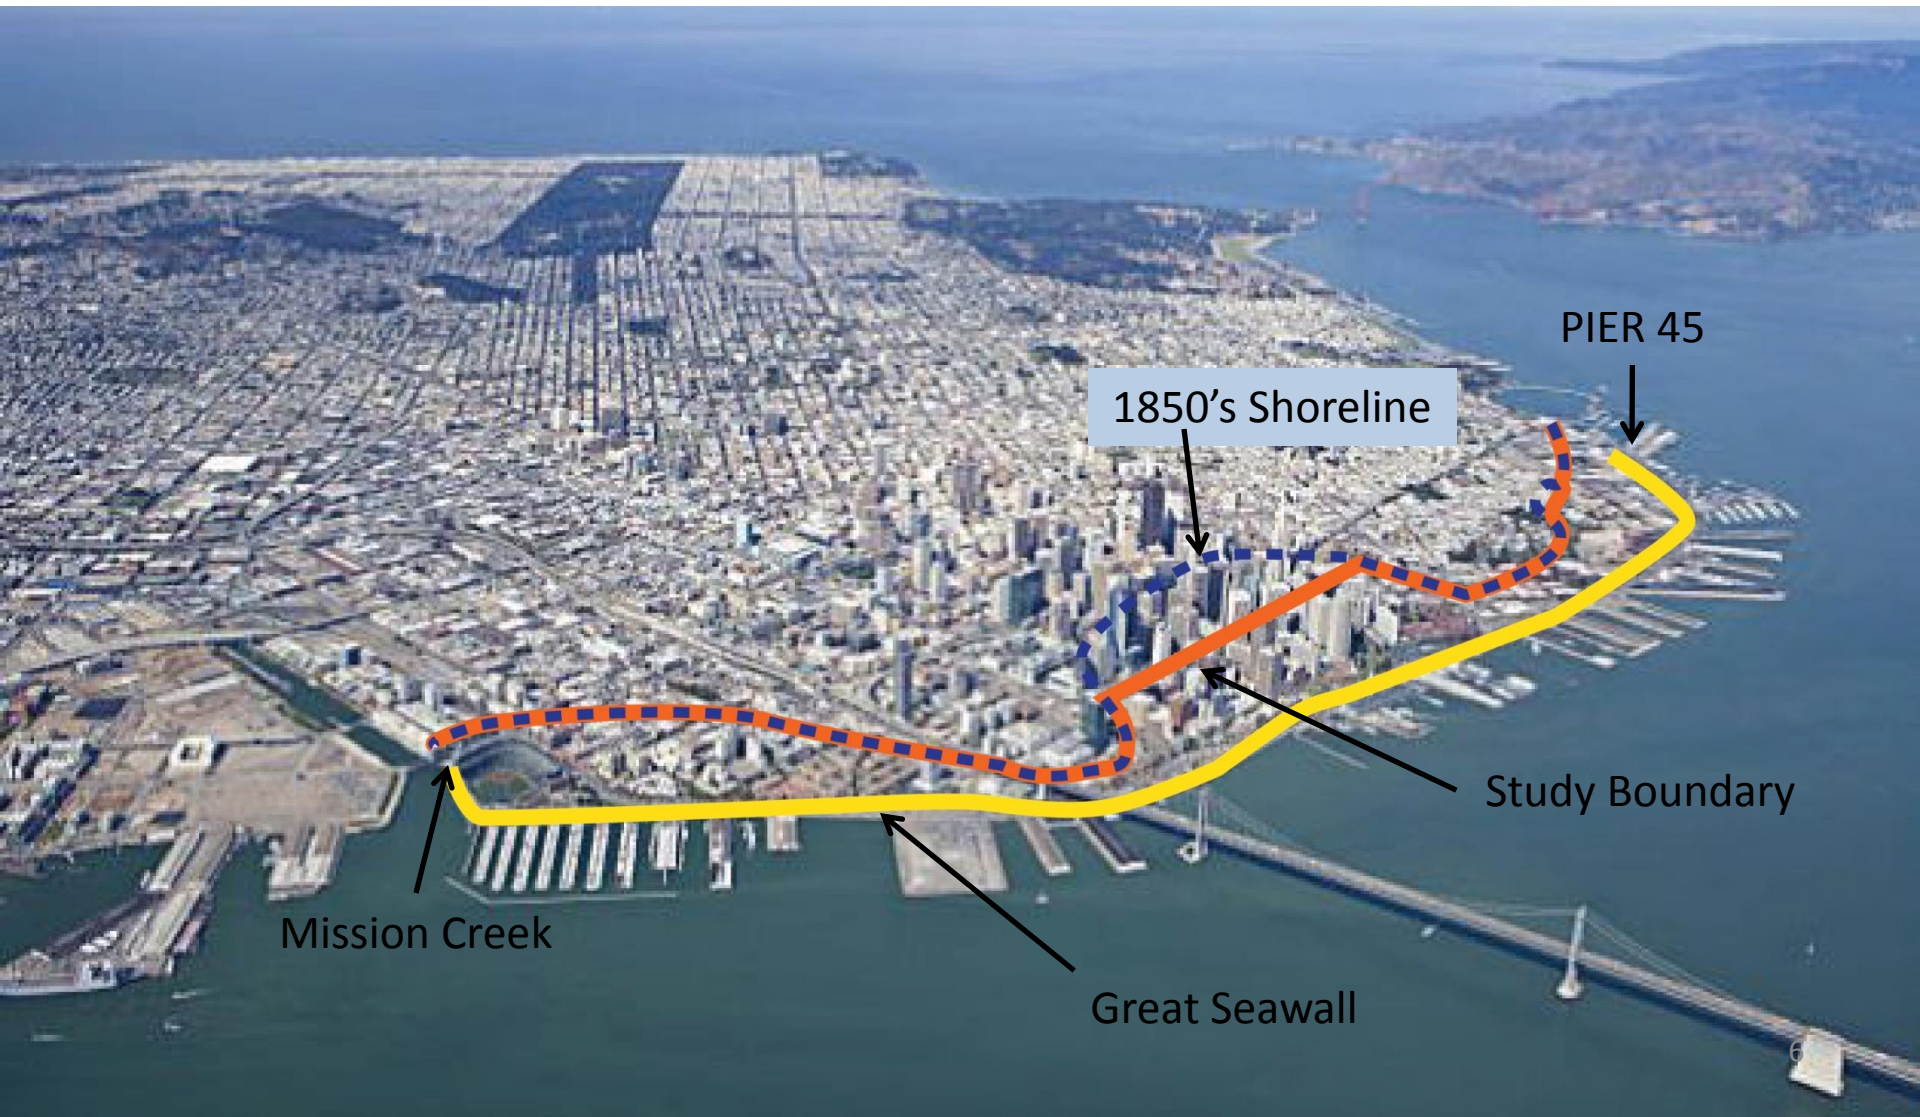
# The Great Seawall stretches from Fisherman's Wharf to Mission Creek

## Study Boundary is similar to the original shoreline

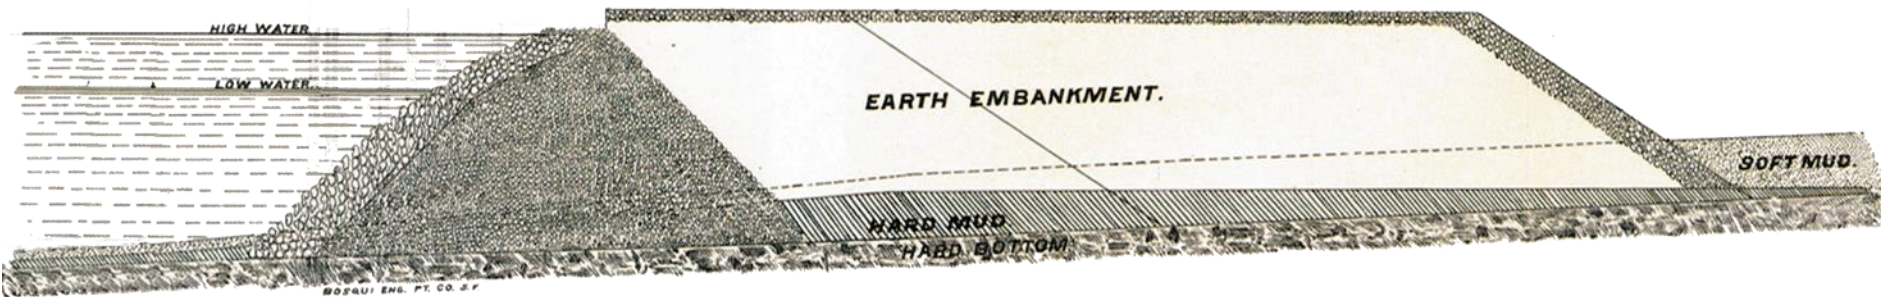
**TRANSVERSE SECTION of SEA WALL and THOROUGHFARE.**

# Great Seawall – Typical Early Construction

SCALE 20 ft. = 1 INCH.

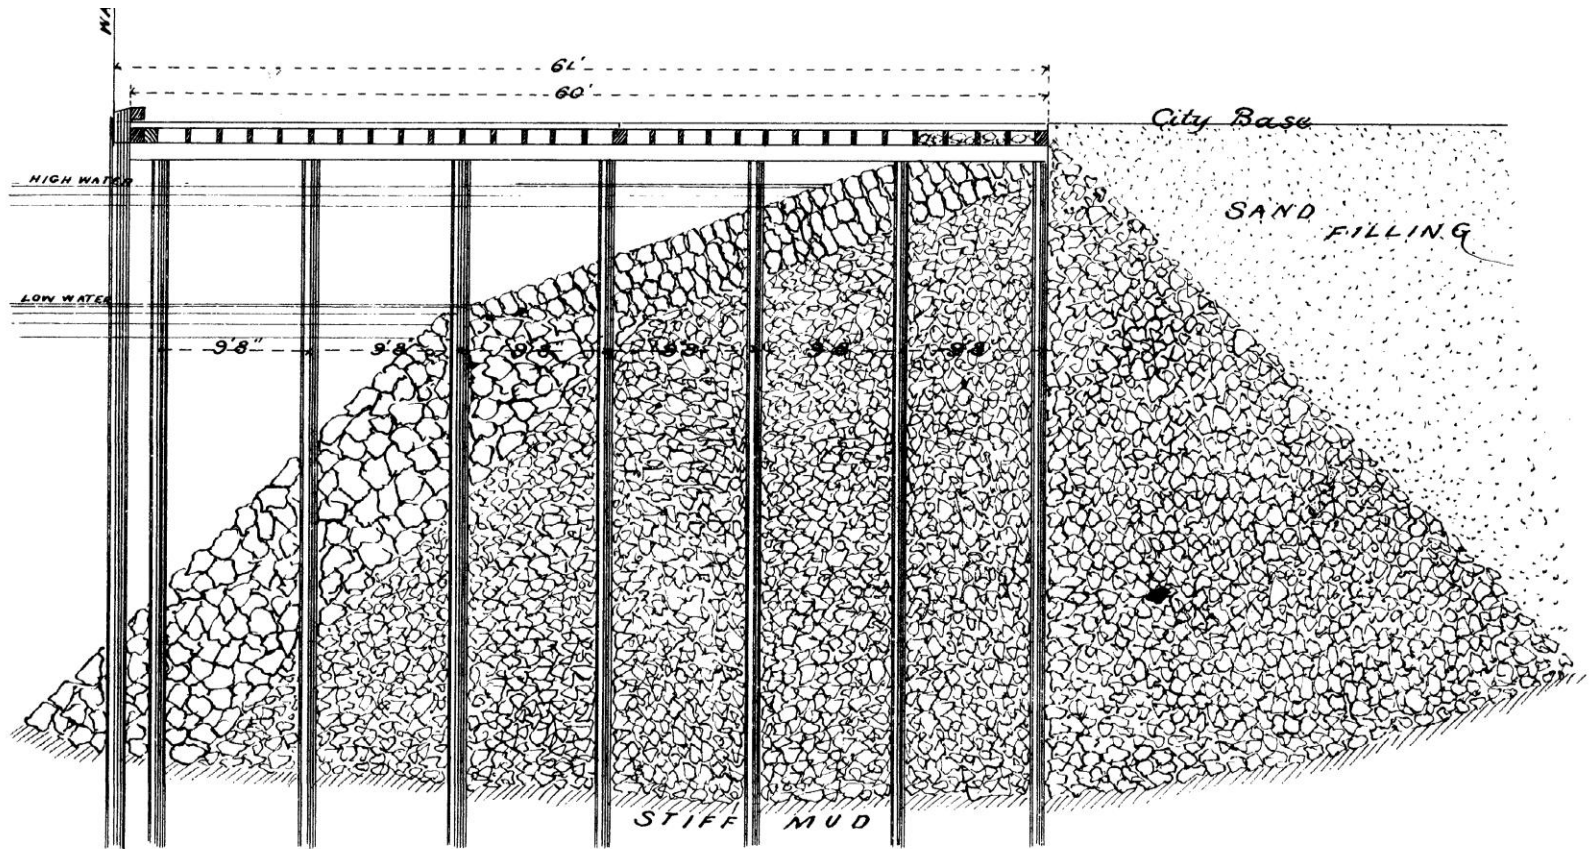
*Cross-Section through Sec. 7*  
*Scale 10ft = 1 inch*

# Great Seawall – Early Construction (1879-1893)

A, 1, 2, 3, 4, 5, 6, 7, B 1-1/2 Miles

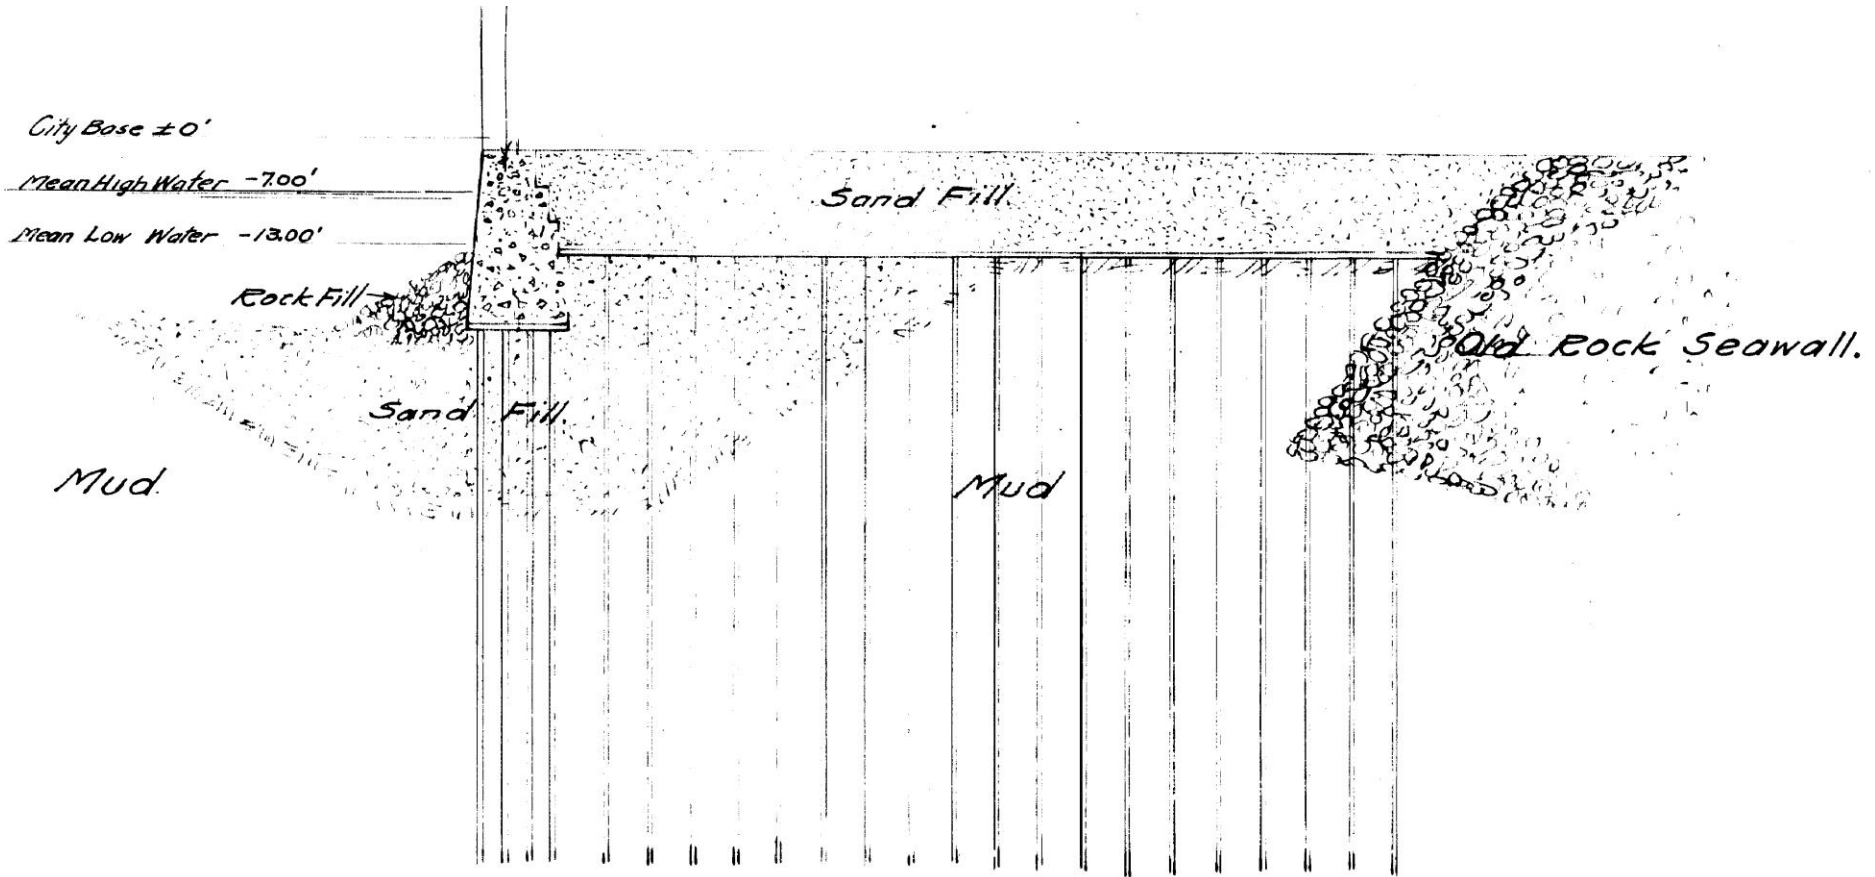
Cross Section at Present Seawall Section #8<sup>b</sup>.

# Great Seawall – Ferry Building

## Section 8a (1891-1893) & 8b (1888 – 1890)

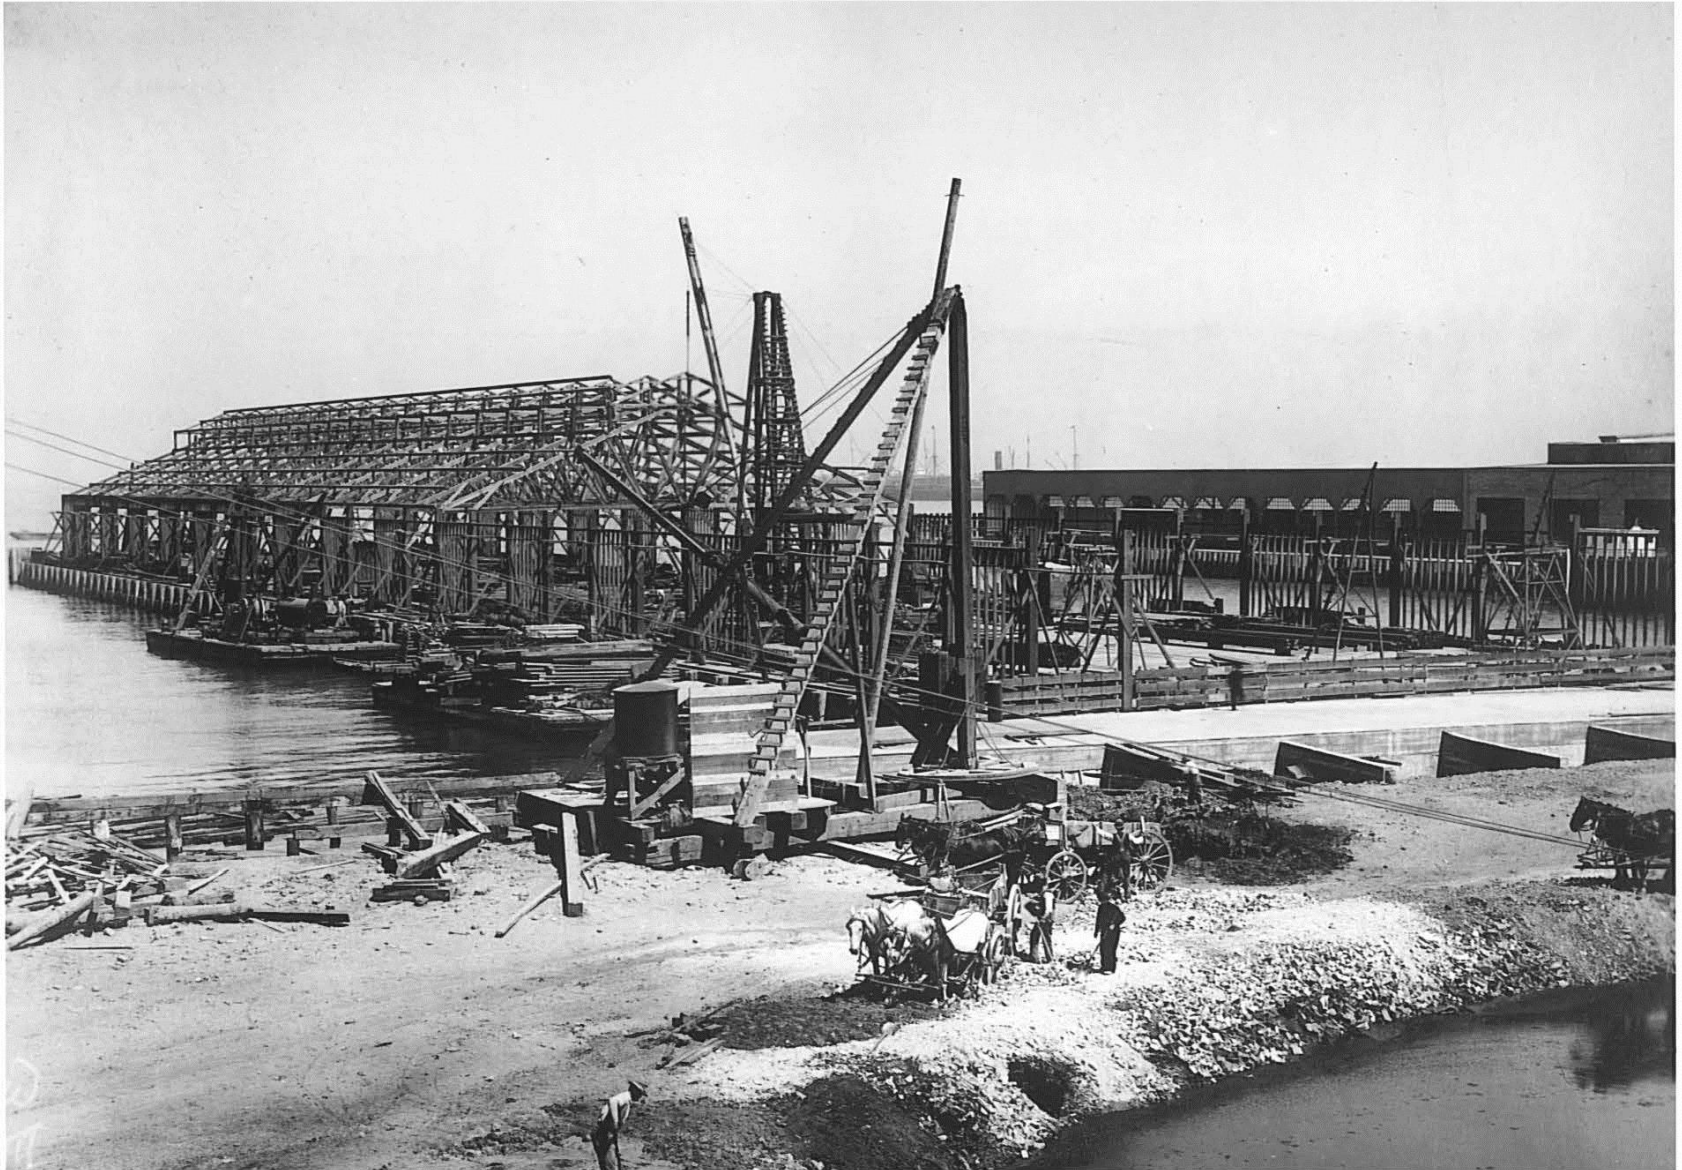
# Great Seawall - Section 11 (1909)

## Pier 34 & Pier 36

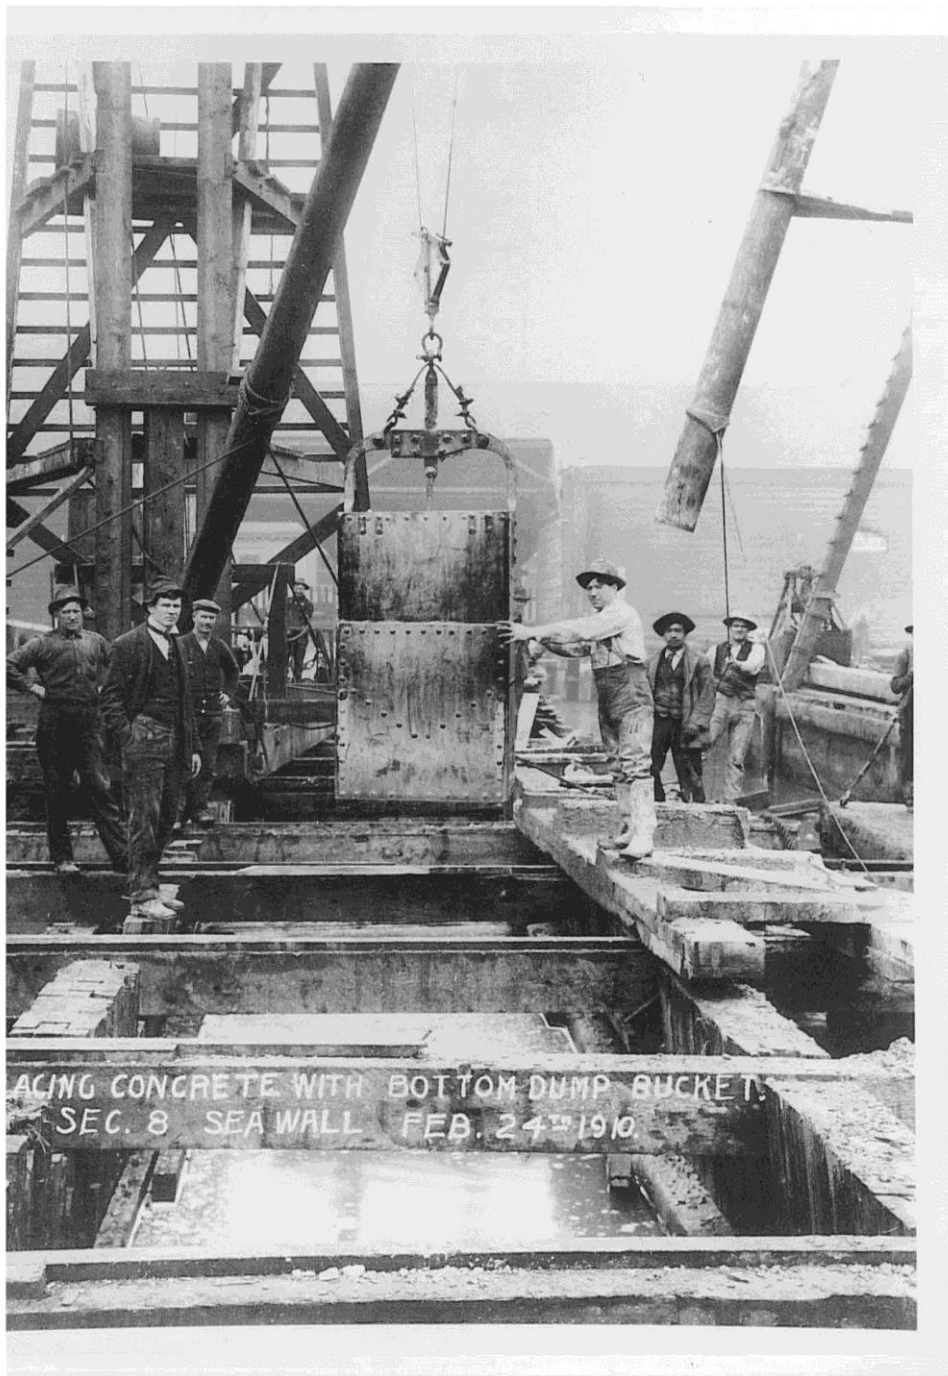
## Great Seawall - Section 8 (1910)

Construction was  
a major effort  
using technology  
of the day and  
employing  
thousands

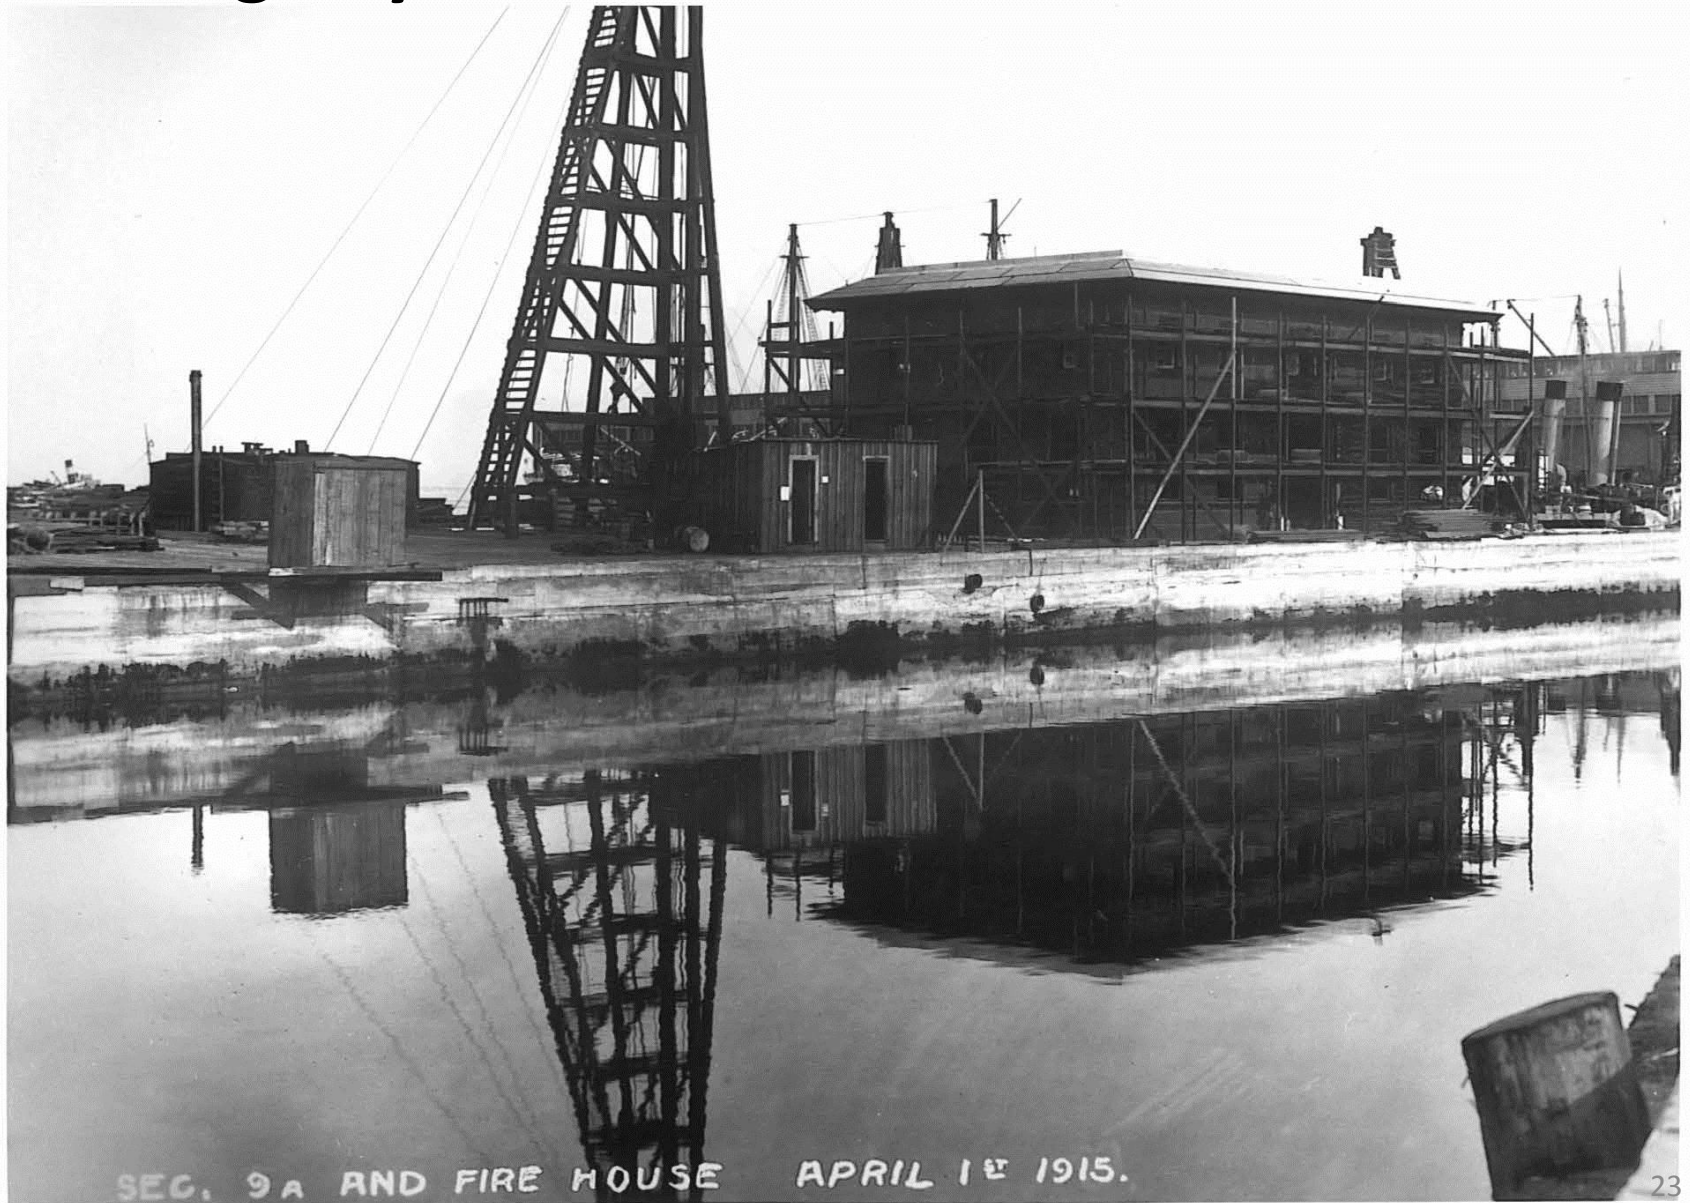
SEC. 9A AND FIRE HOUSE APRIL 1<sup>ST</sup> 1915.

# Great Seawall: Sect. 9A (1915)

## Looking Bayward over the Embarcadero "Canal"

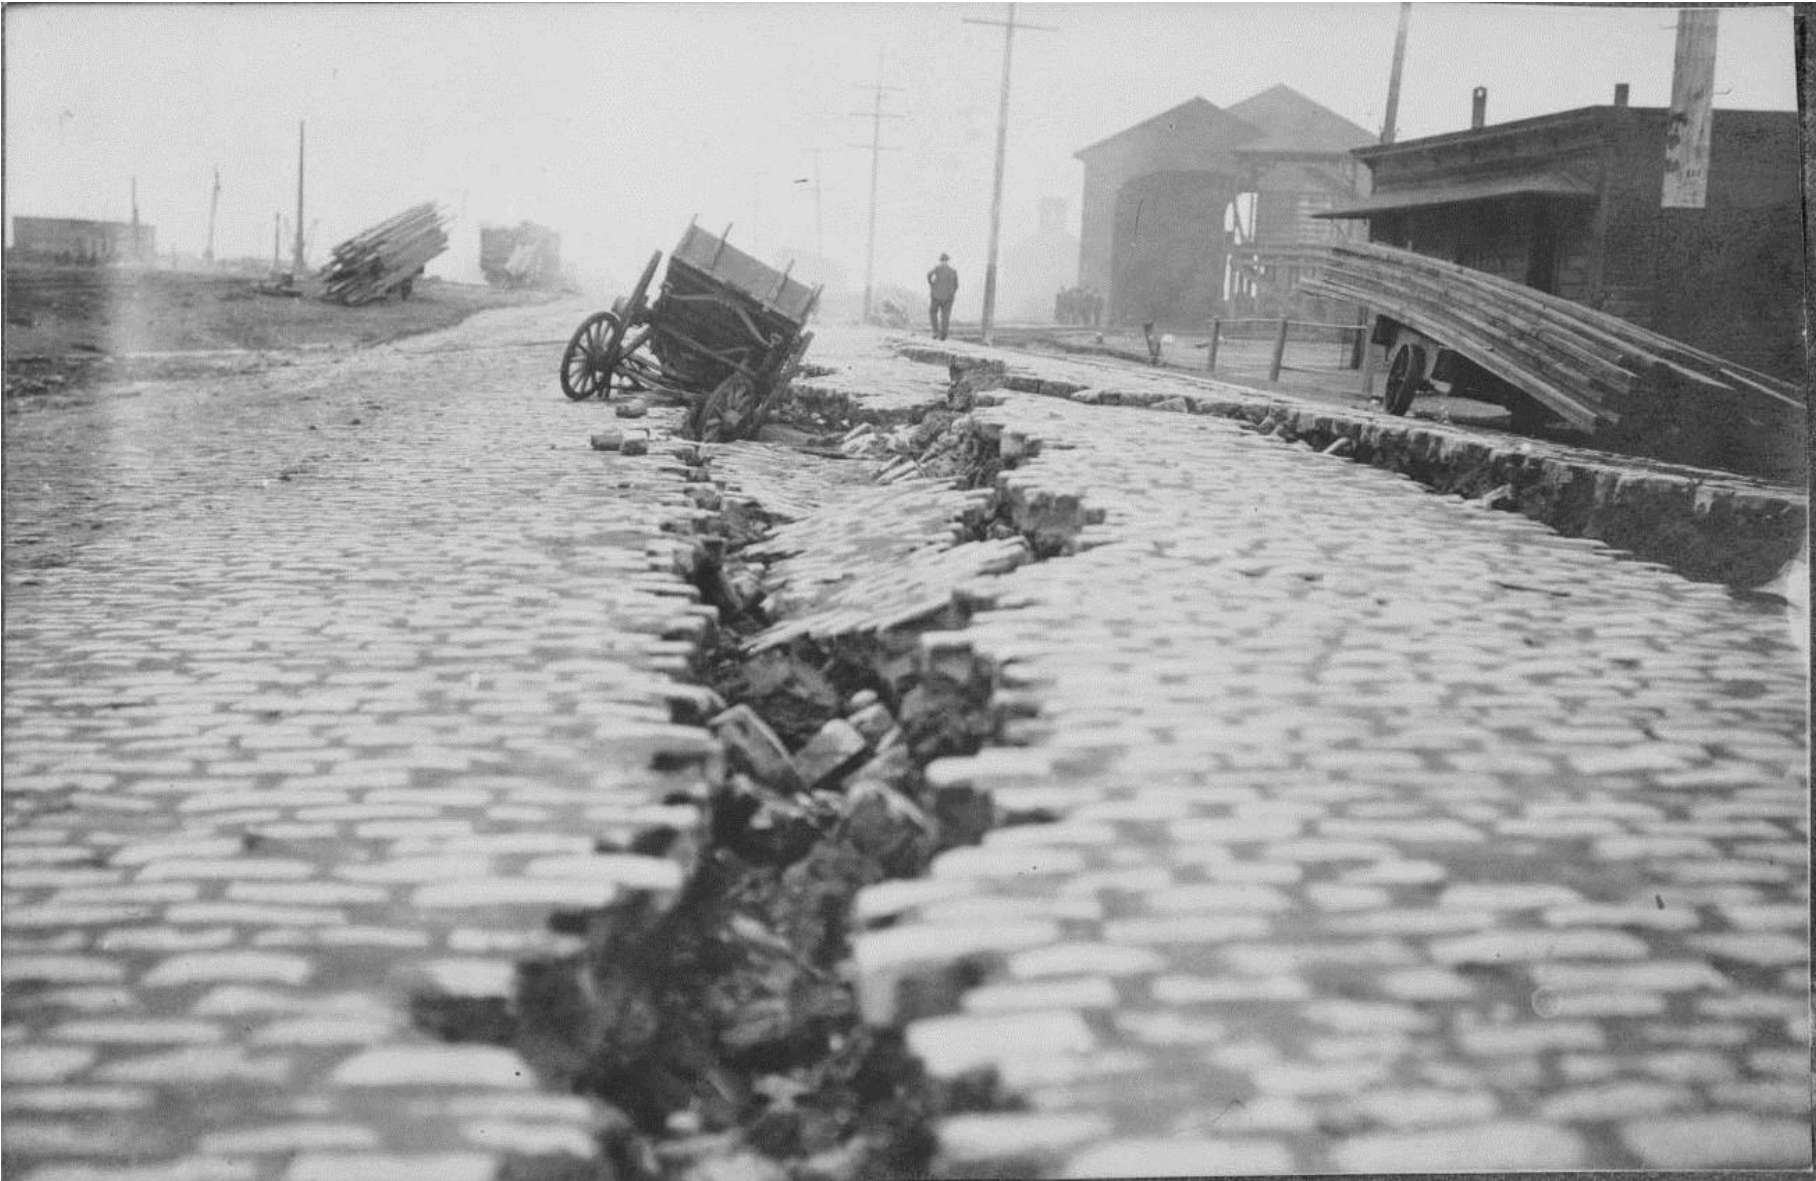
**1906 EQ – Embarcadero (East St)**

*Result of Earth-quake on East St. near the Ferry.*

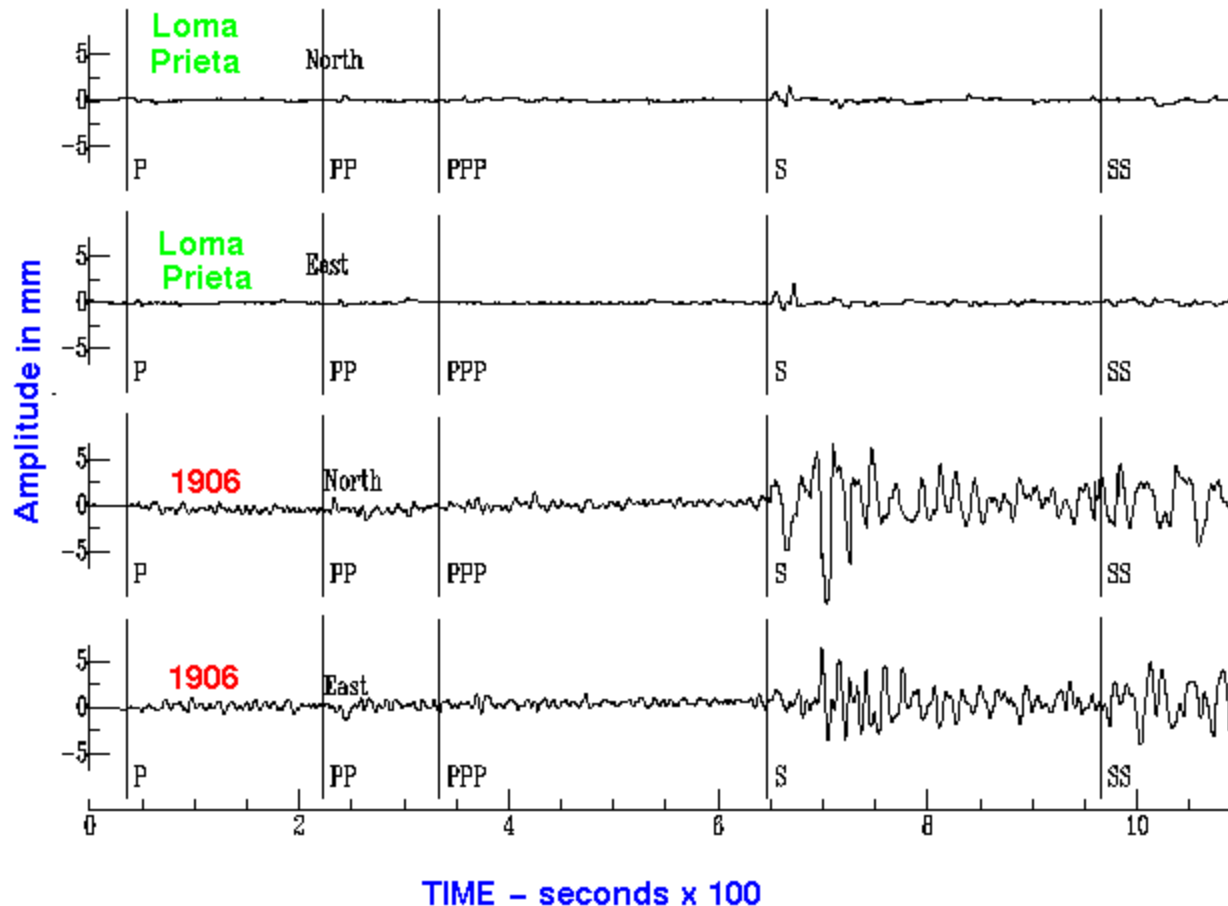
# 1906 vs 1989 Loma Prieta Earthquake

## Ground shaking recorded in Germany

Comparison of 1906 and Loma Prieta records at Gottingen, Germany

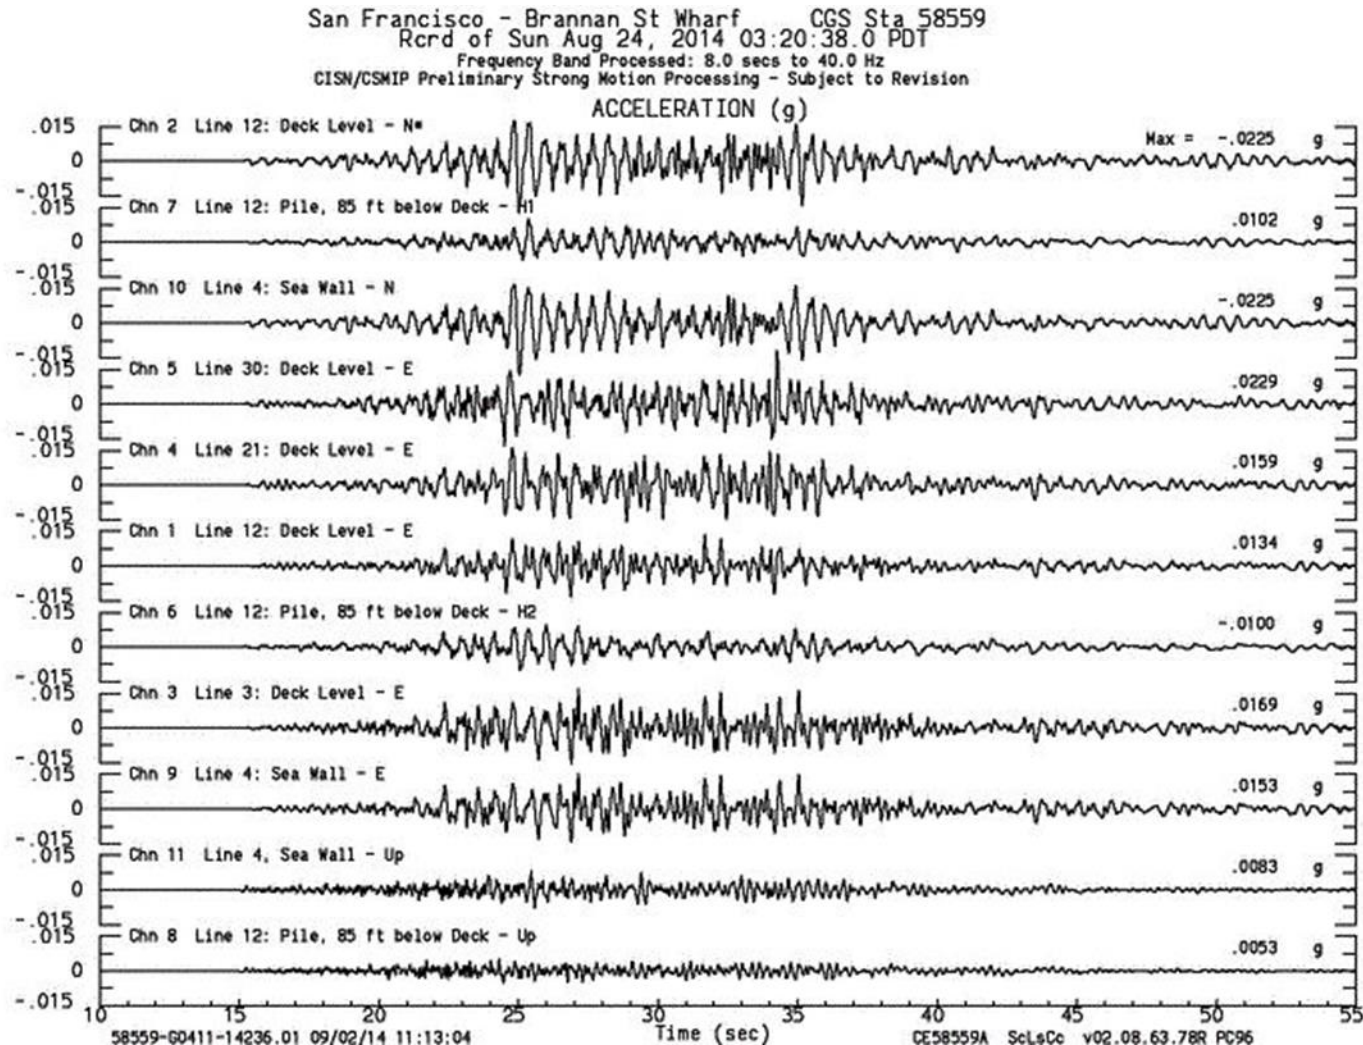
# 2014 South Napa Earthquake (M6.0, 29 mi)

## Strong Motion Recording from Brannan St Wharf

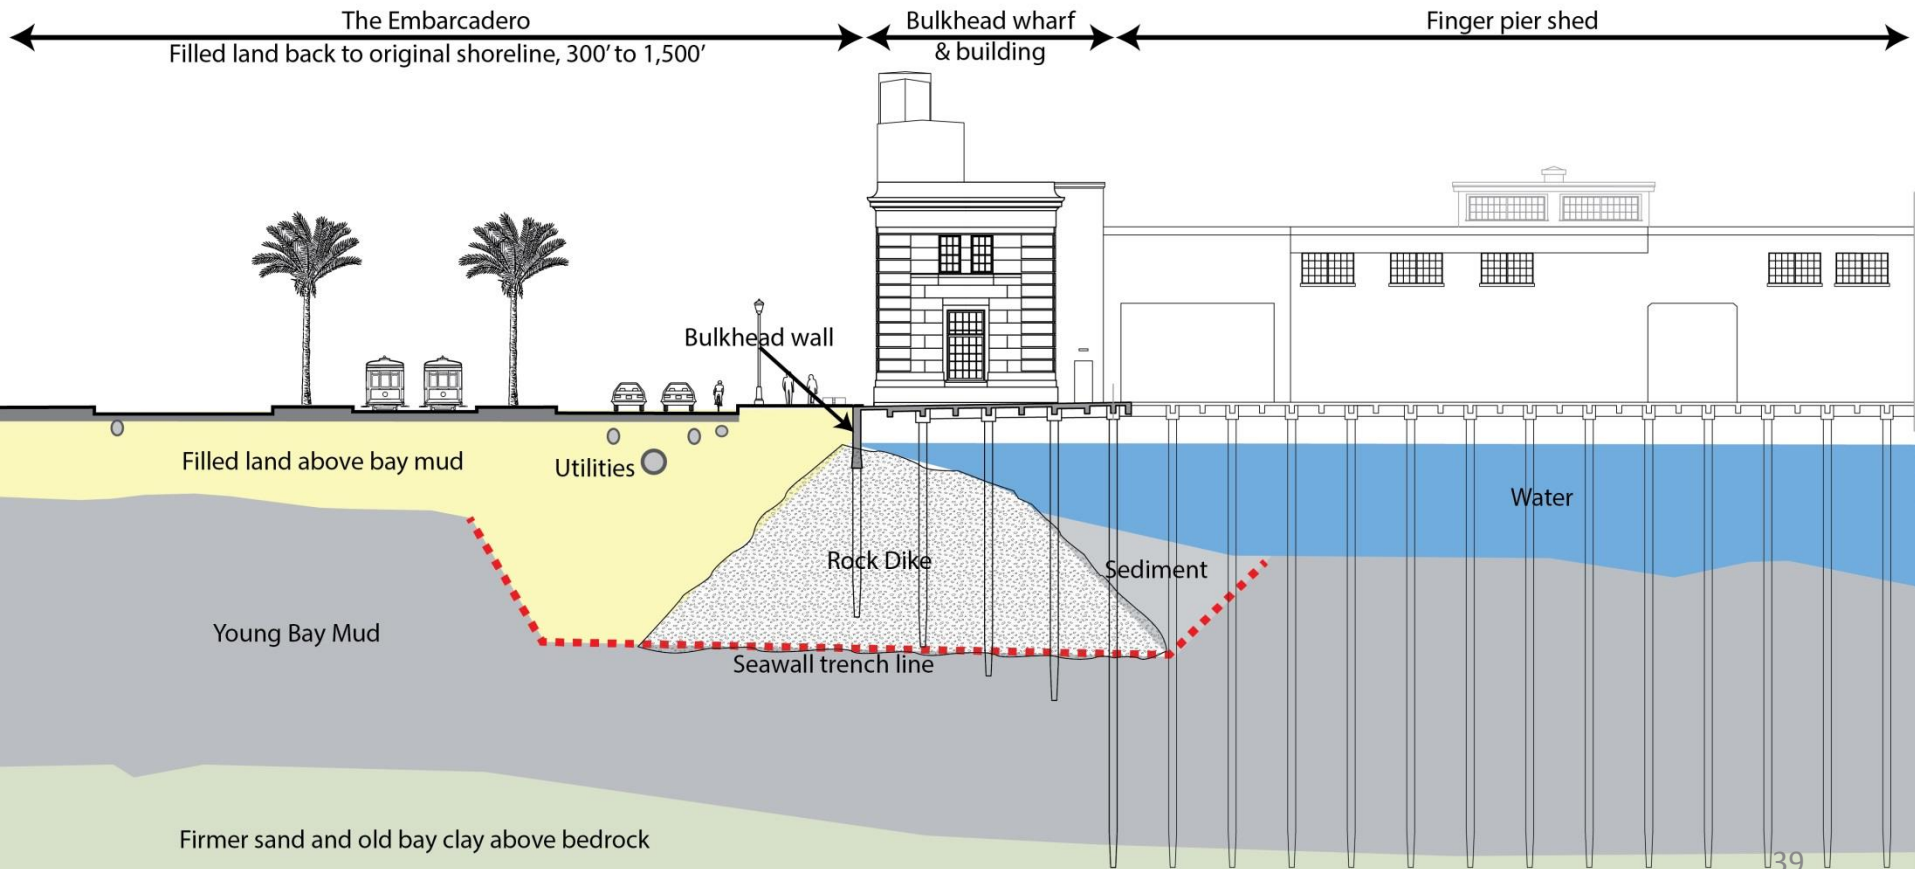
# Seawall – Existing Conditions, Typical

Seawall = Rock Dike, Bulkhead Wall, Bulkhead Wharf

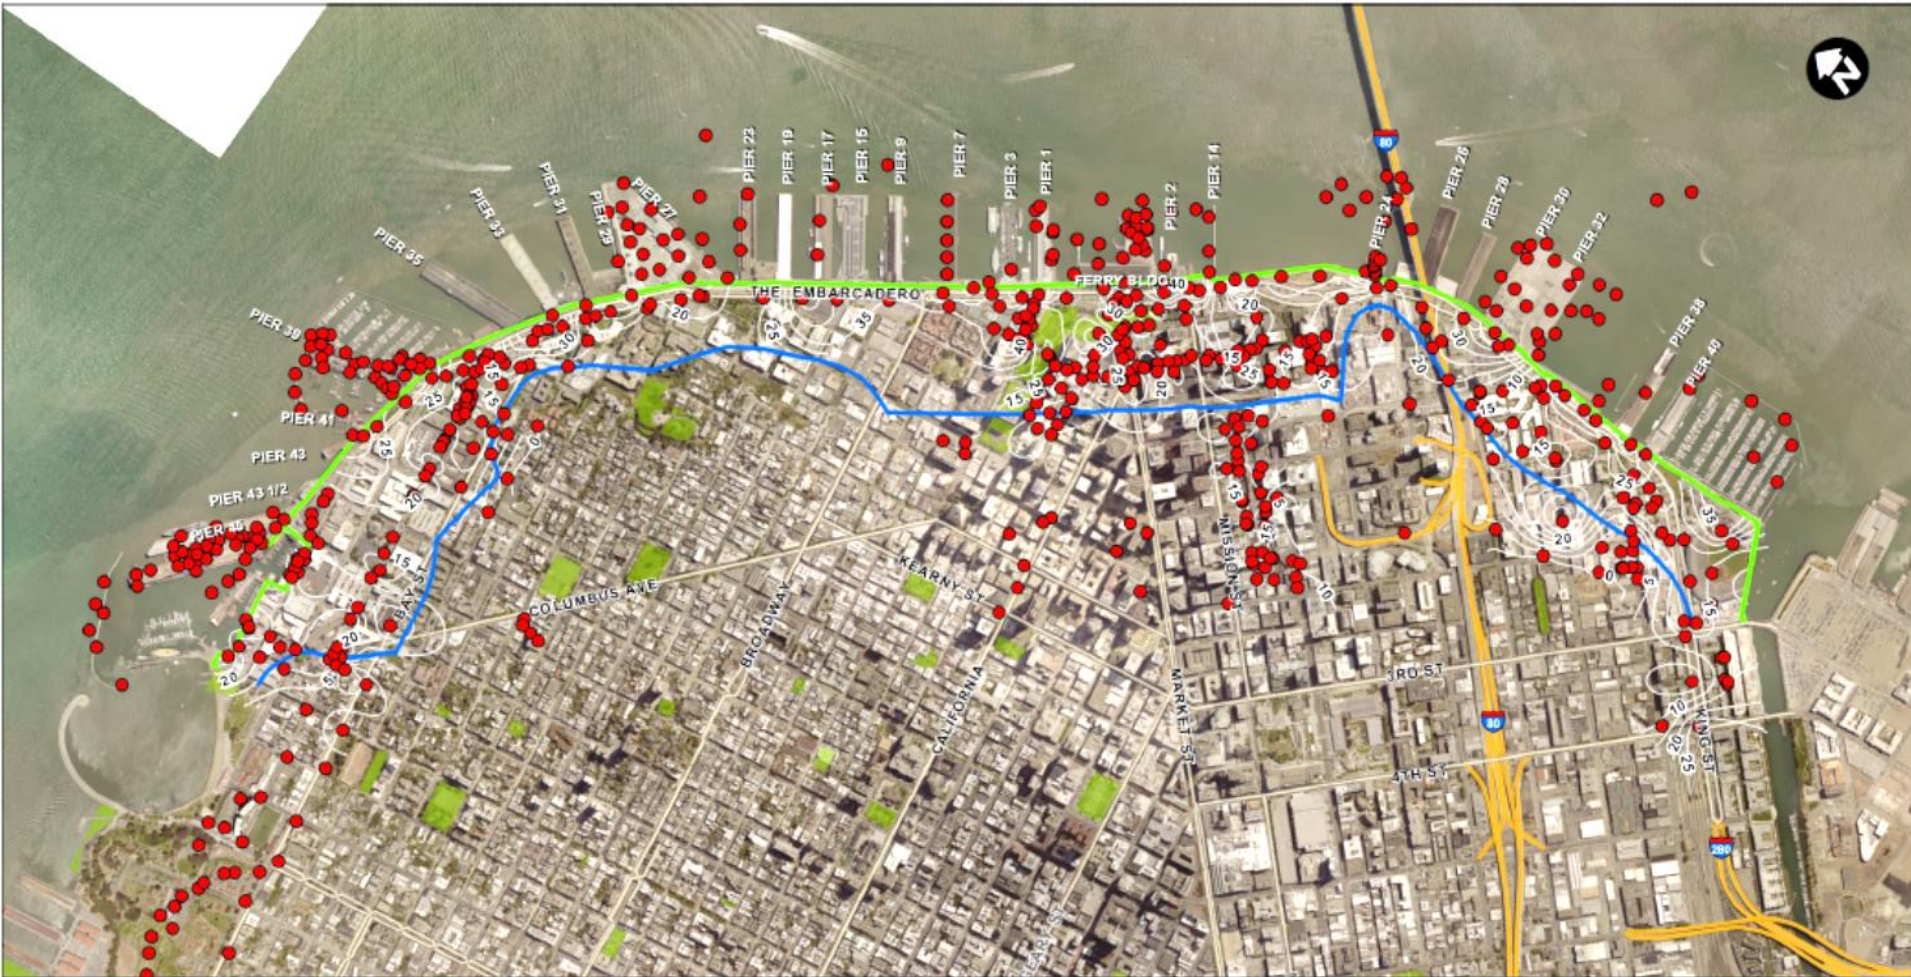
## Subsurface Mapping – Artificial Fill Thickness

The Study Team collected existing geotechnical borings and cataloged in GIS to create subsurface maps of the soils within the Zone of Influence

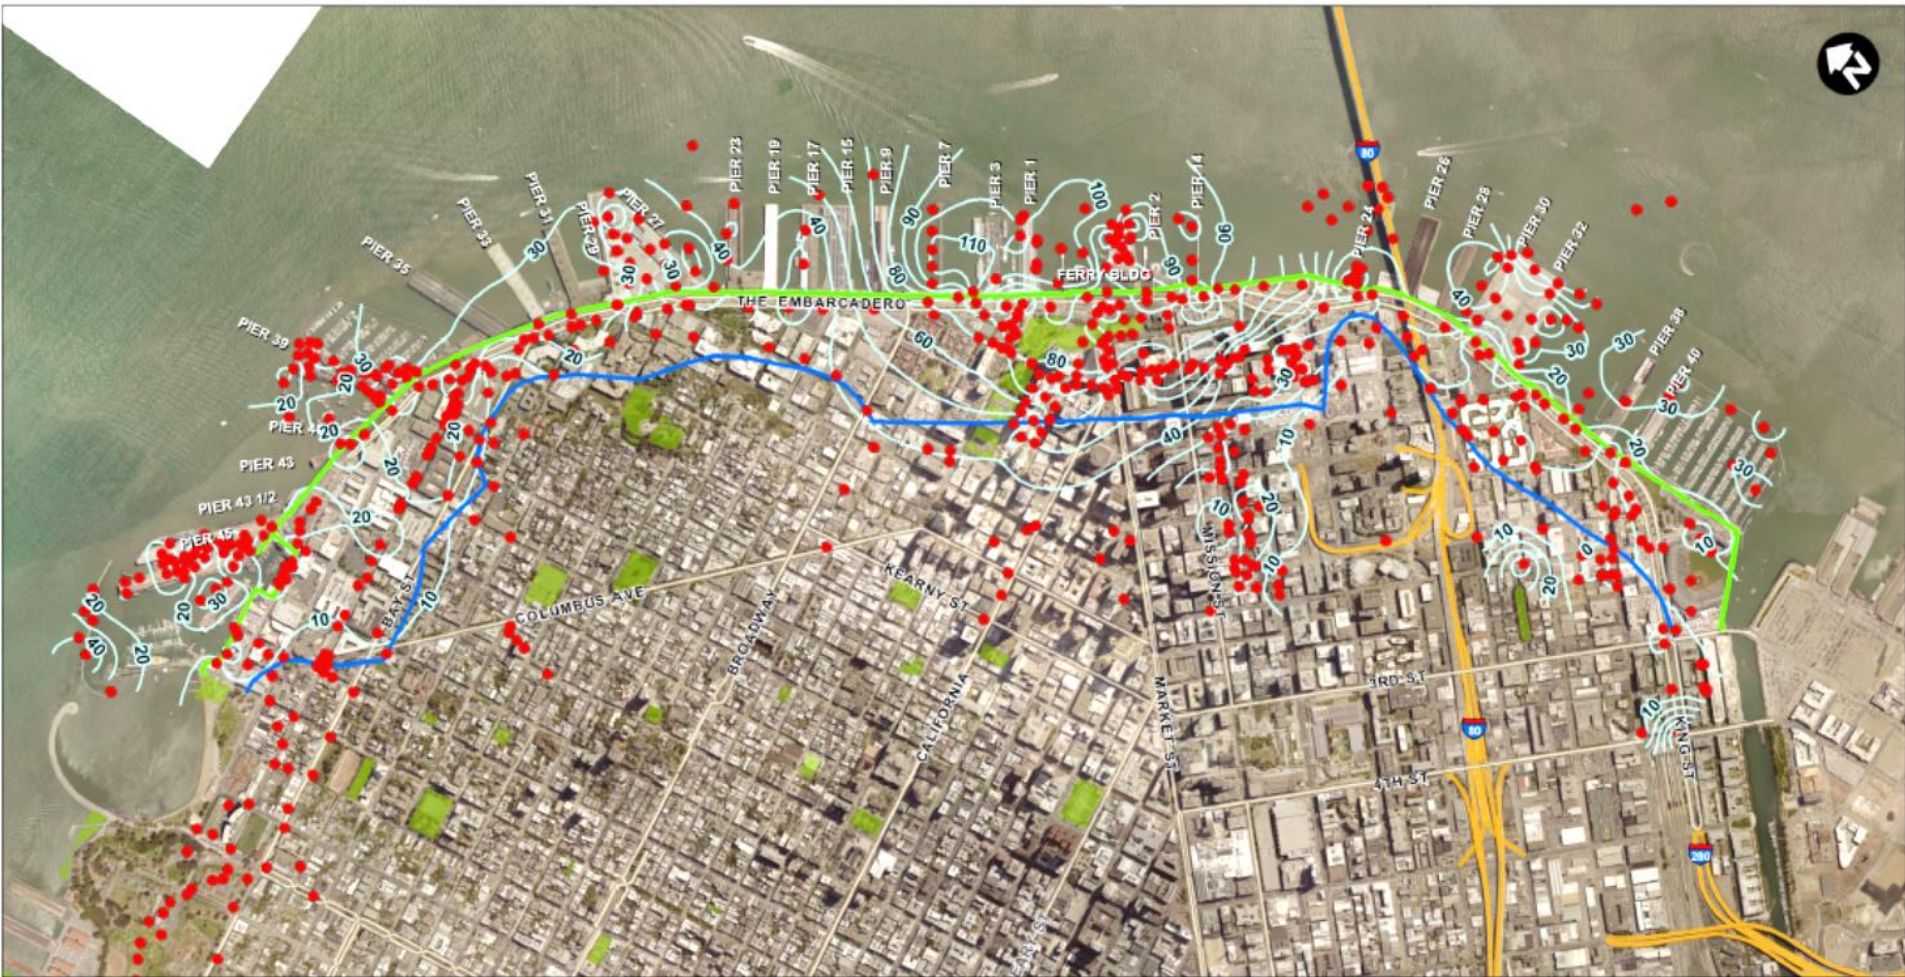
## Subsurface Mapping – Young Bay Mud Thickness
