# The Northern Waterfront Seawall History and Earthquake Performance

**Waterfront Plan Working Group Meeting  
April 13, 2016**

**Steven Reel, PE - Project Manager, Engineering Division, Port**

**The Seawall is a complex and Historic Resource that  
is the foundation of the Northern Waterfront  
22 Original Seawall Sections  
55+ Combinations of Bulkheads and Wharves  
Modifications & Repairs throughout 100 years**

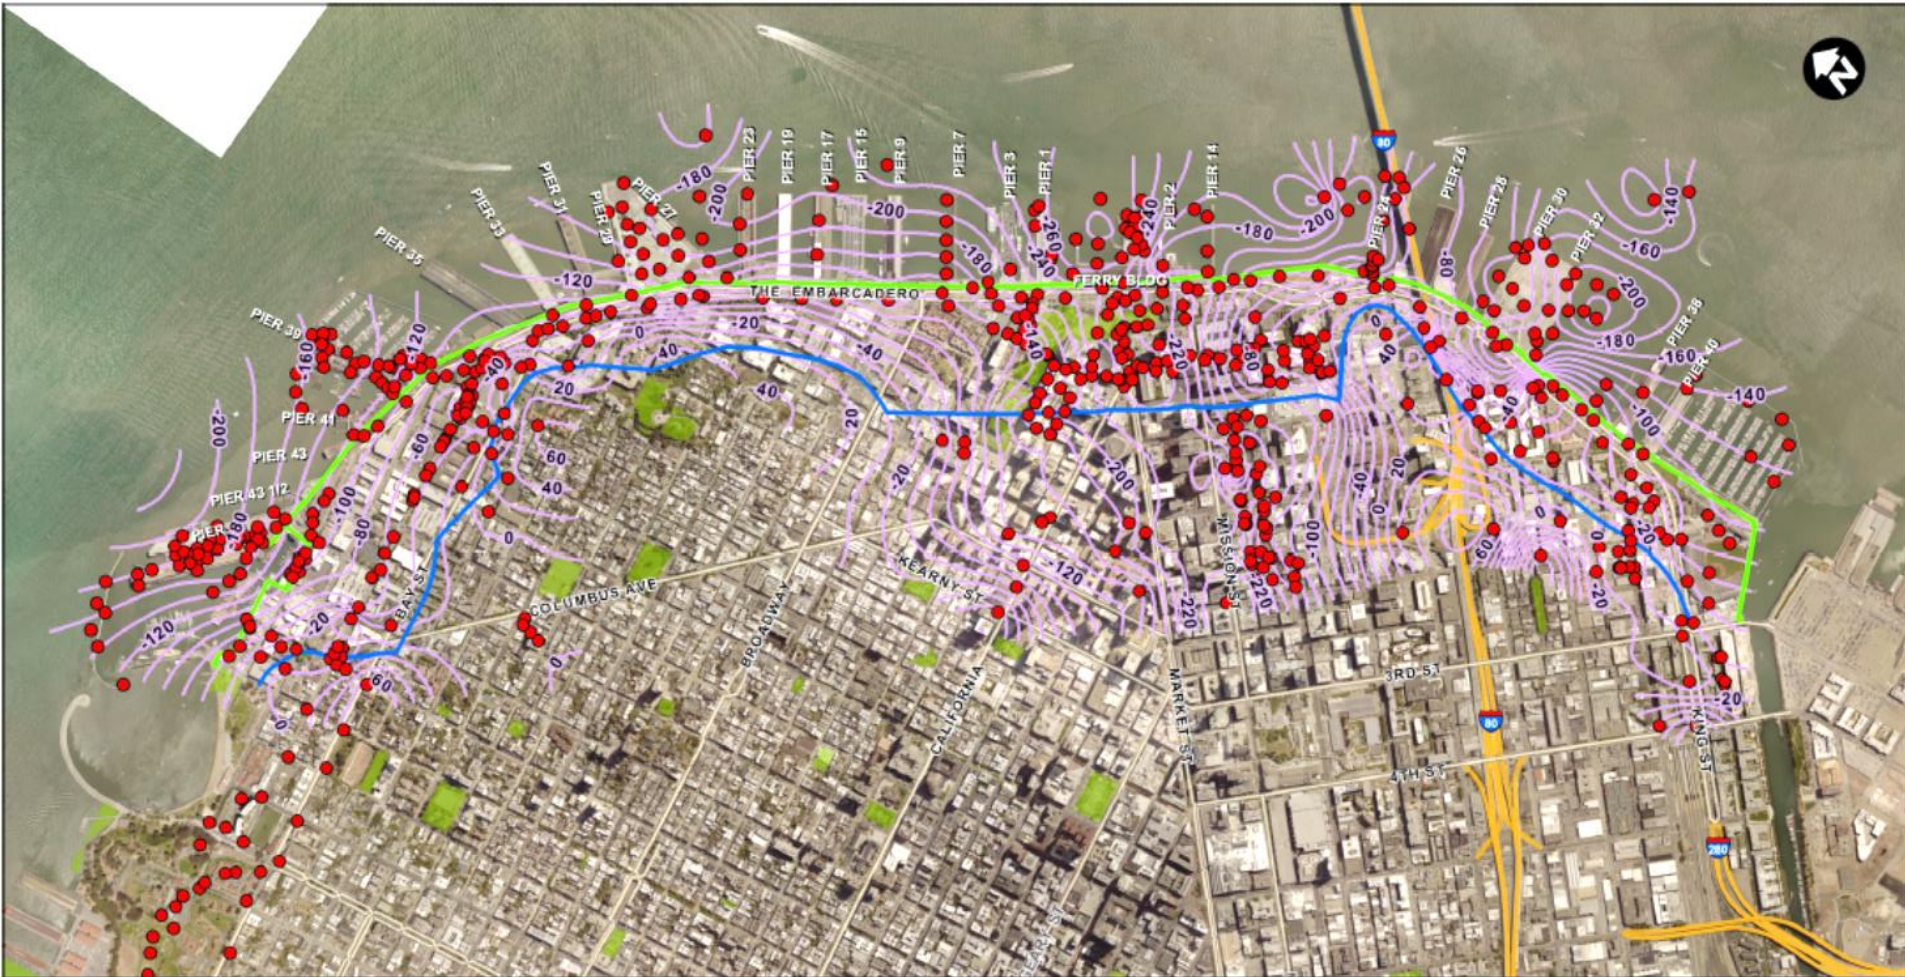
# Subsurface Mapping – Bedrock Elevation

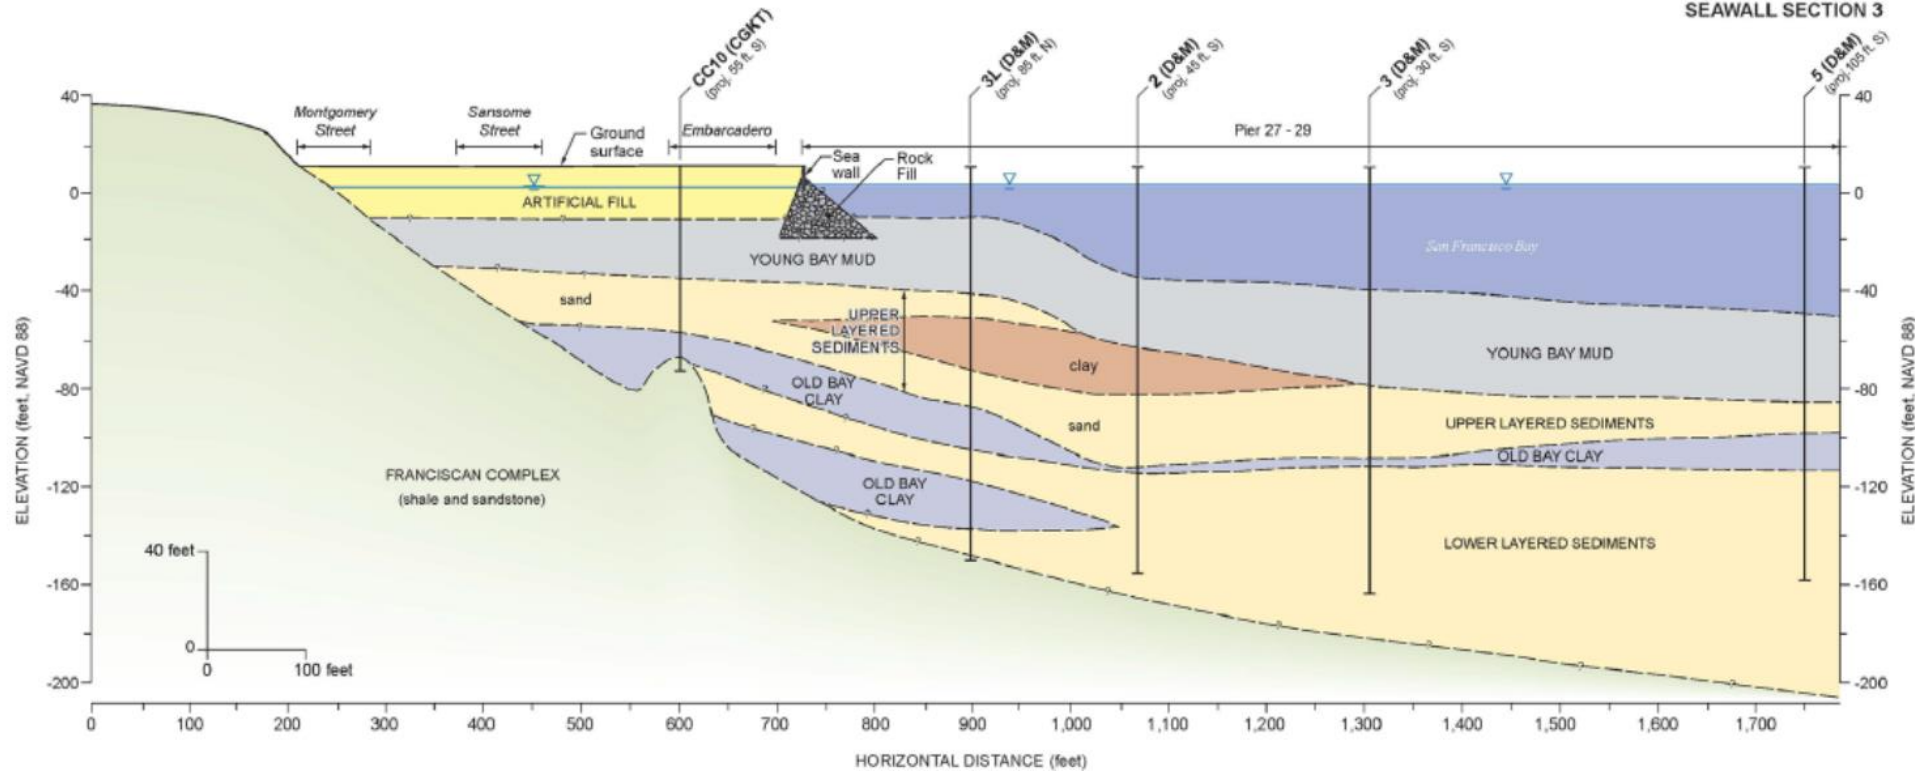
GEOLOGIC PROFILE  
THROUGH  
SEAWALL SECTION 3

The Study Team chose 8 representative sections for detailed analysis

## Geotechnical Section Section 3 - Vicinity of Pier 29

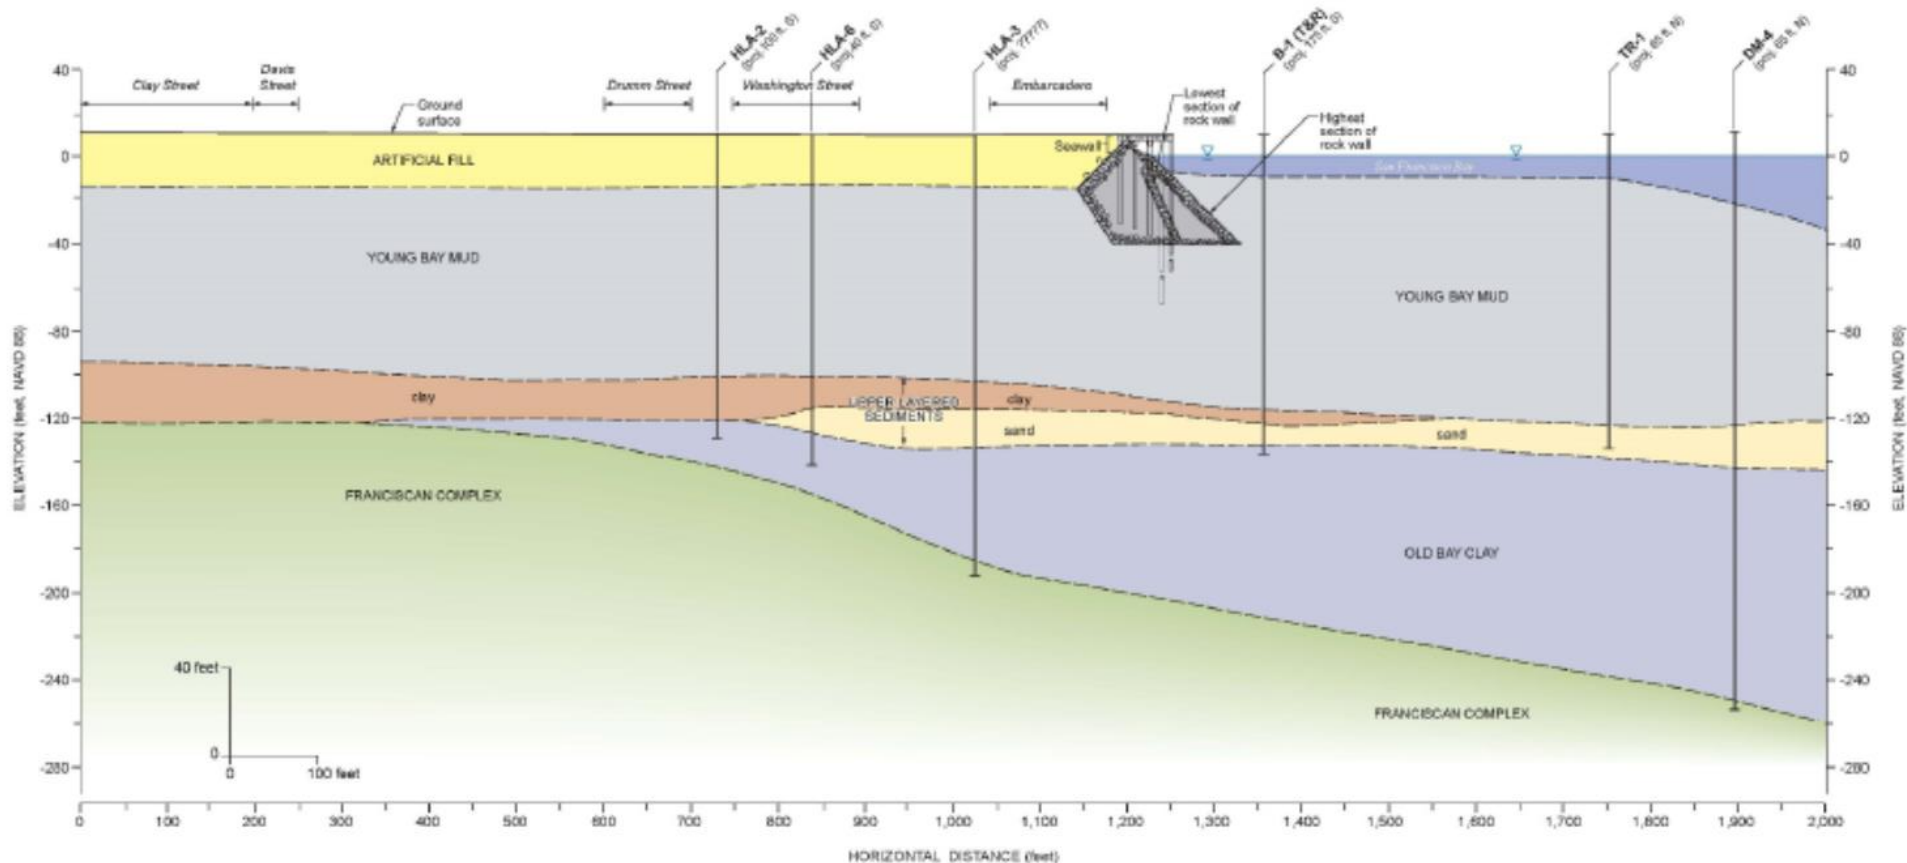
GEOLOGIC PROFILE  
THROUGH  
SEAWALL SECTION 7

# Geotechnical Section Section 7 - Vicinity of Pier 3

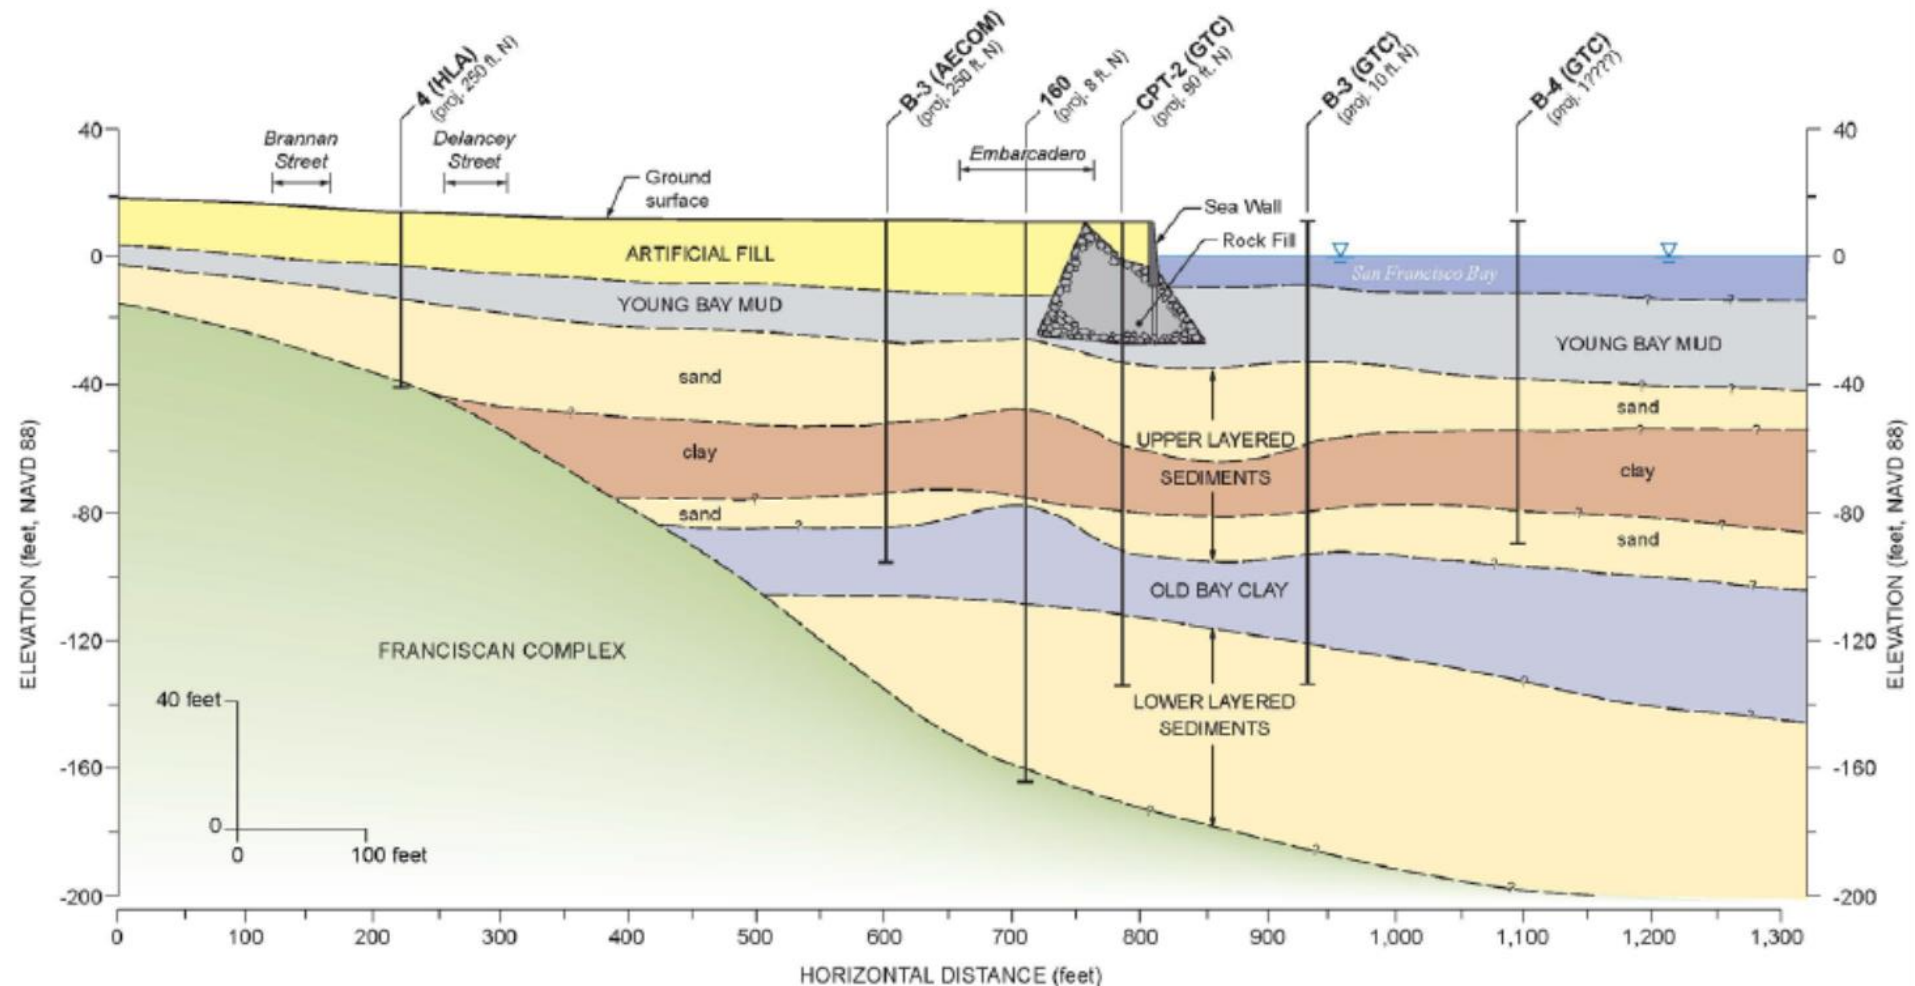
GEOLOGIC PROFILE  
THROUGH  
SEAWALL SECTION 12

# Geotechnical Section Section 12 – Vicinity of Pier 38

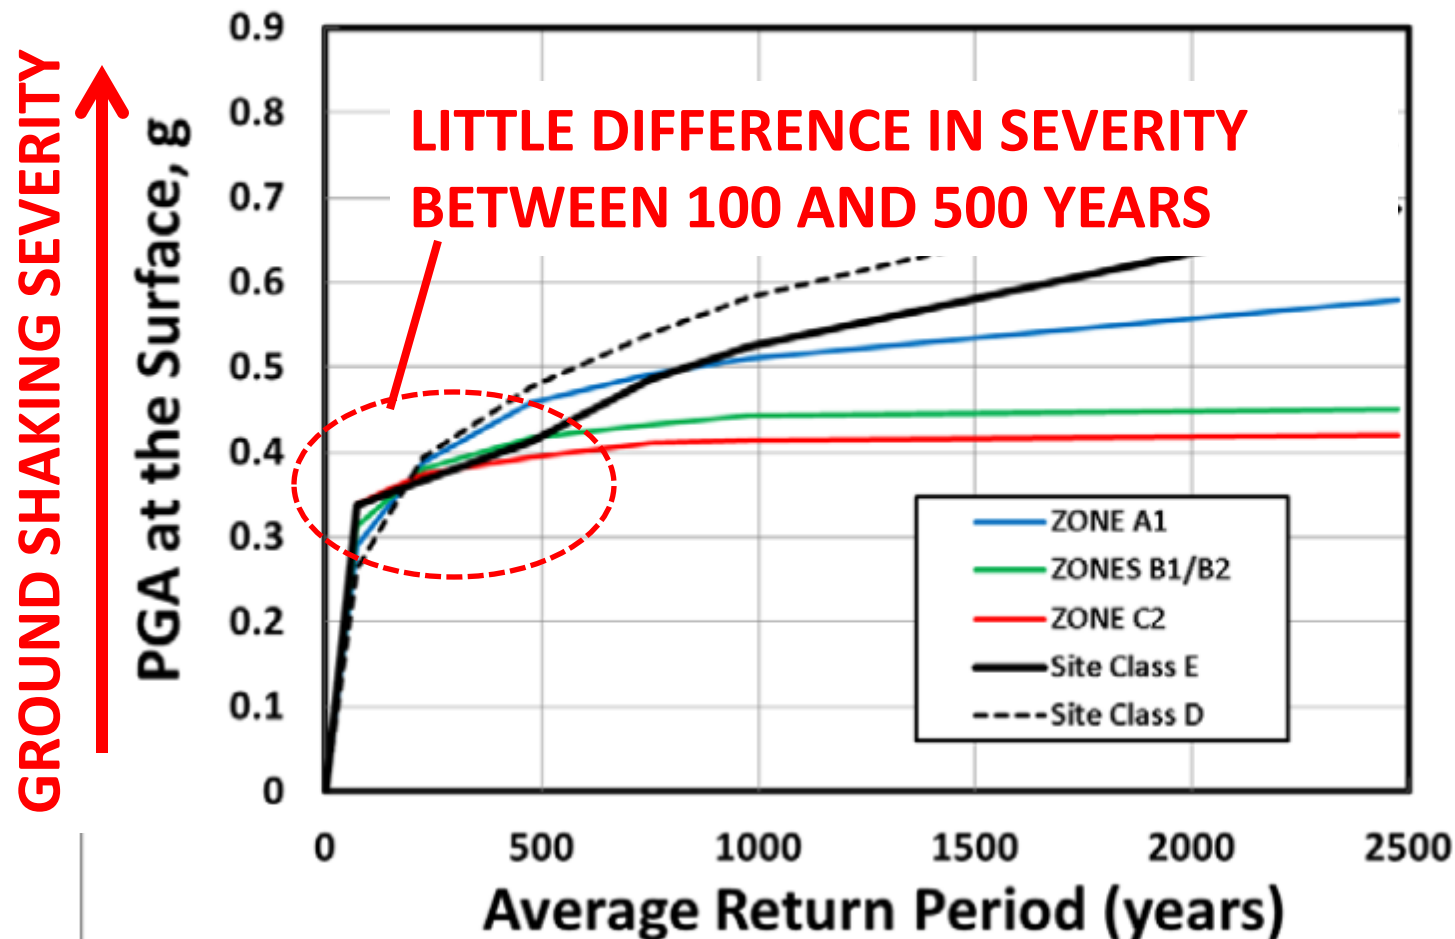
## Waterfront Trends in PGA versus ARP (Ground Surface)

**Probabilistic Site Hazard Analysis**  
**Peak Ground Acceleration vs Return Period**

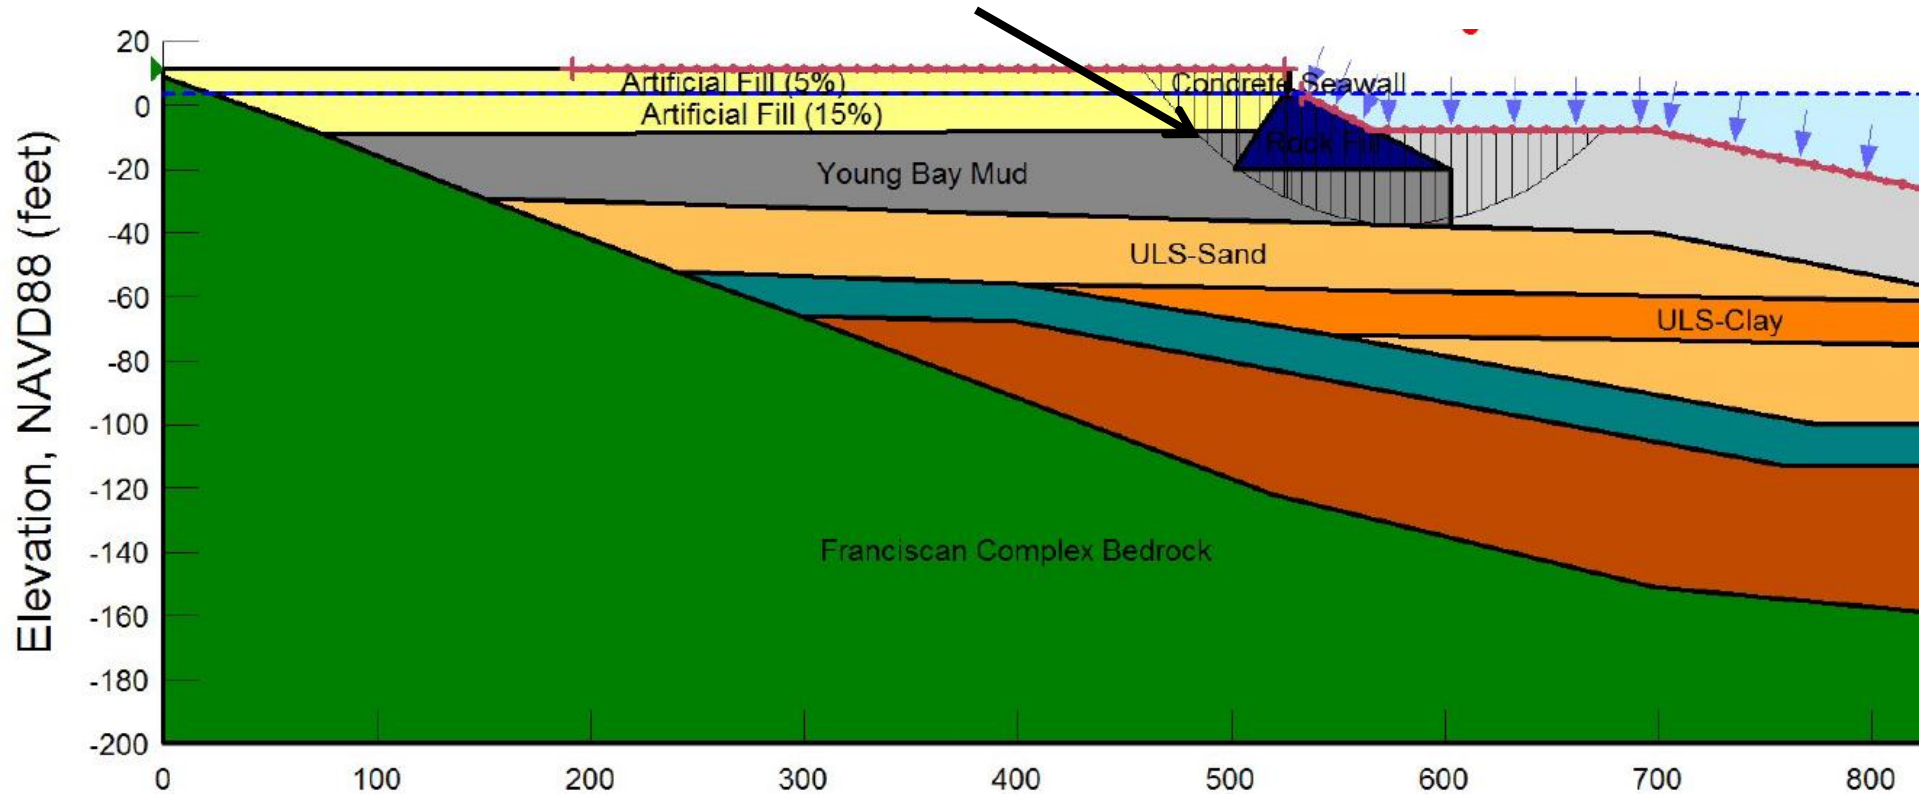
## PREDICTED SLIP SURFACE

## Slope Stability Analysis of Seawall

Various methods used, Calibrated to observations,  
Non-linear Bay Mud Properties and data from recent earthquakes

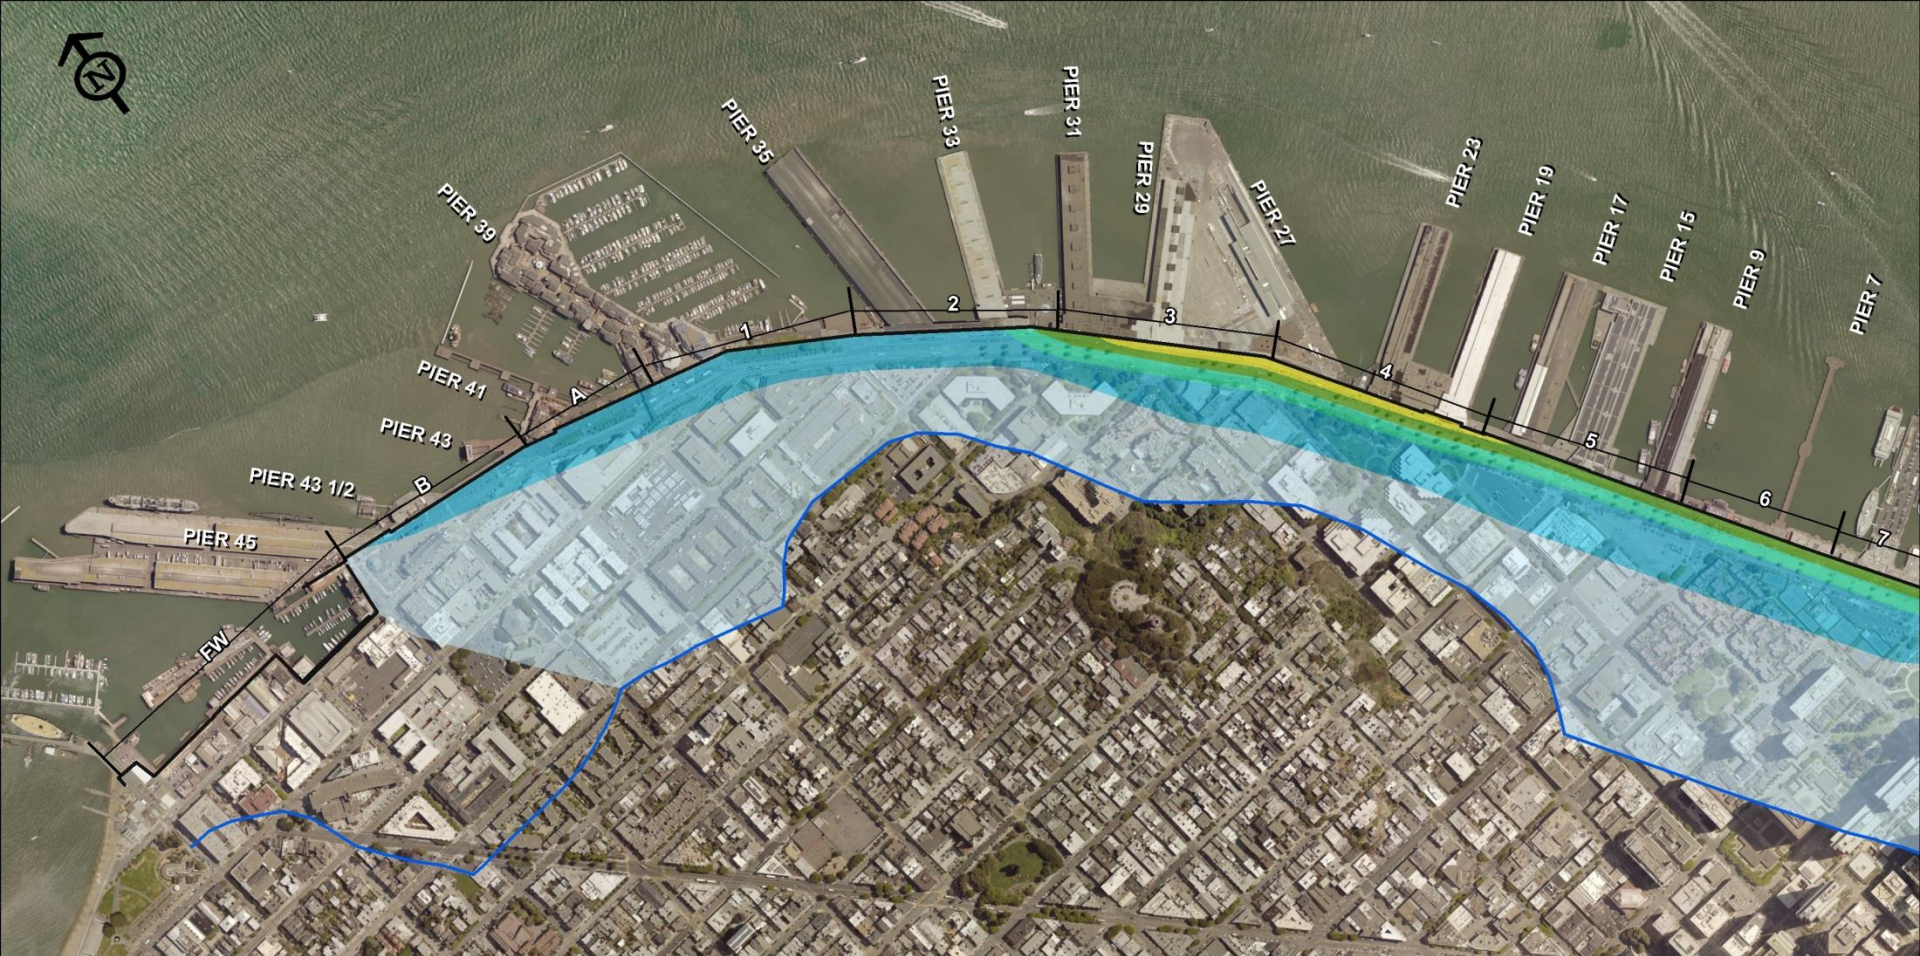
Lateral Spread Displacement - M8.0 San Andreas (median)  
Contour Interval (inches)

**Lateral Spreading Results:**  
**M8.0 San Andreas (median) (approx. 20%/50yrs)**

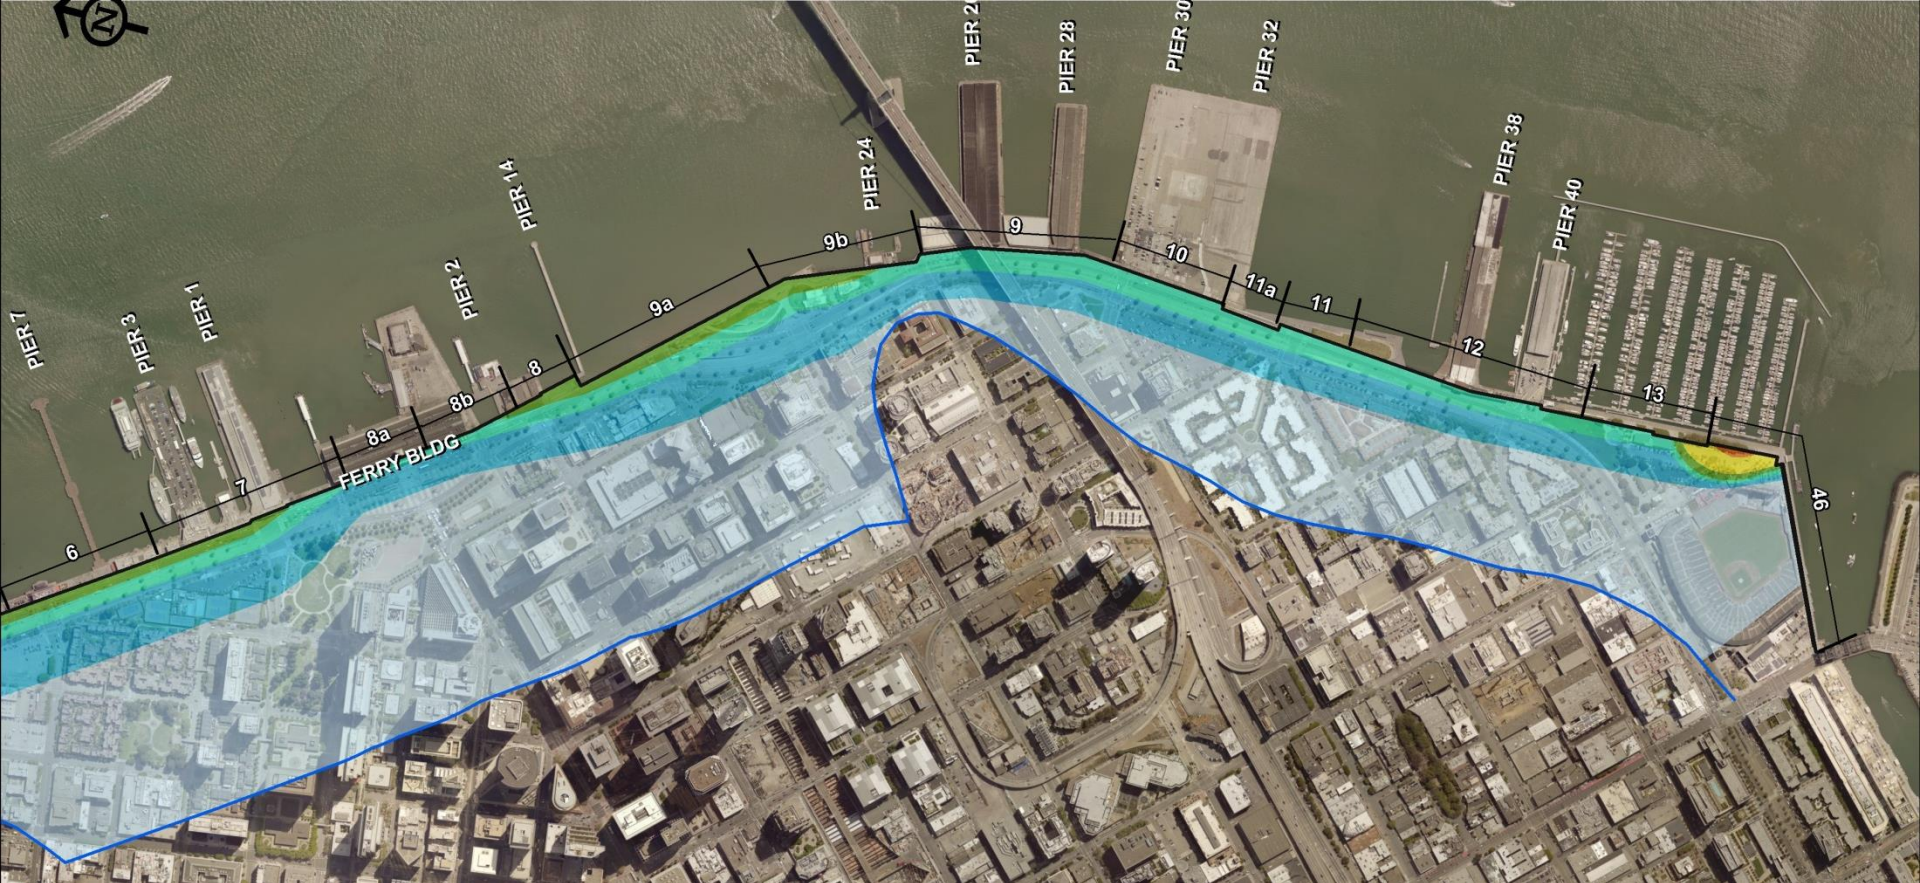
**Lateral Spreading Results:**  
**M8.0 San Andreas (median) (approx. 20%/50yrs)**

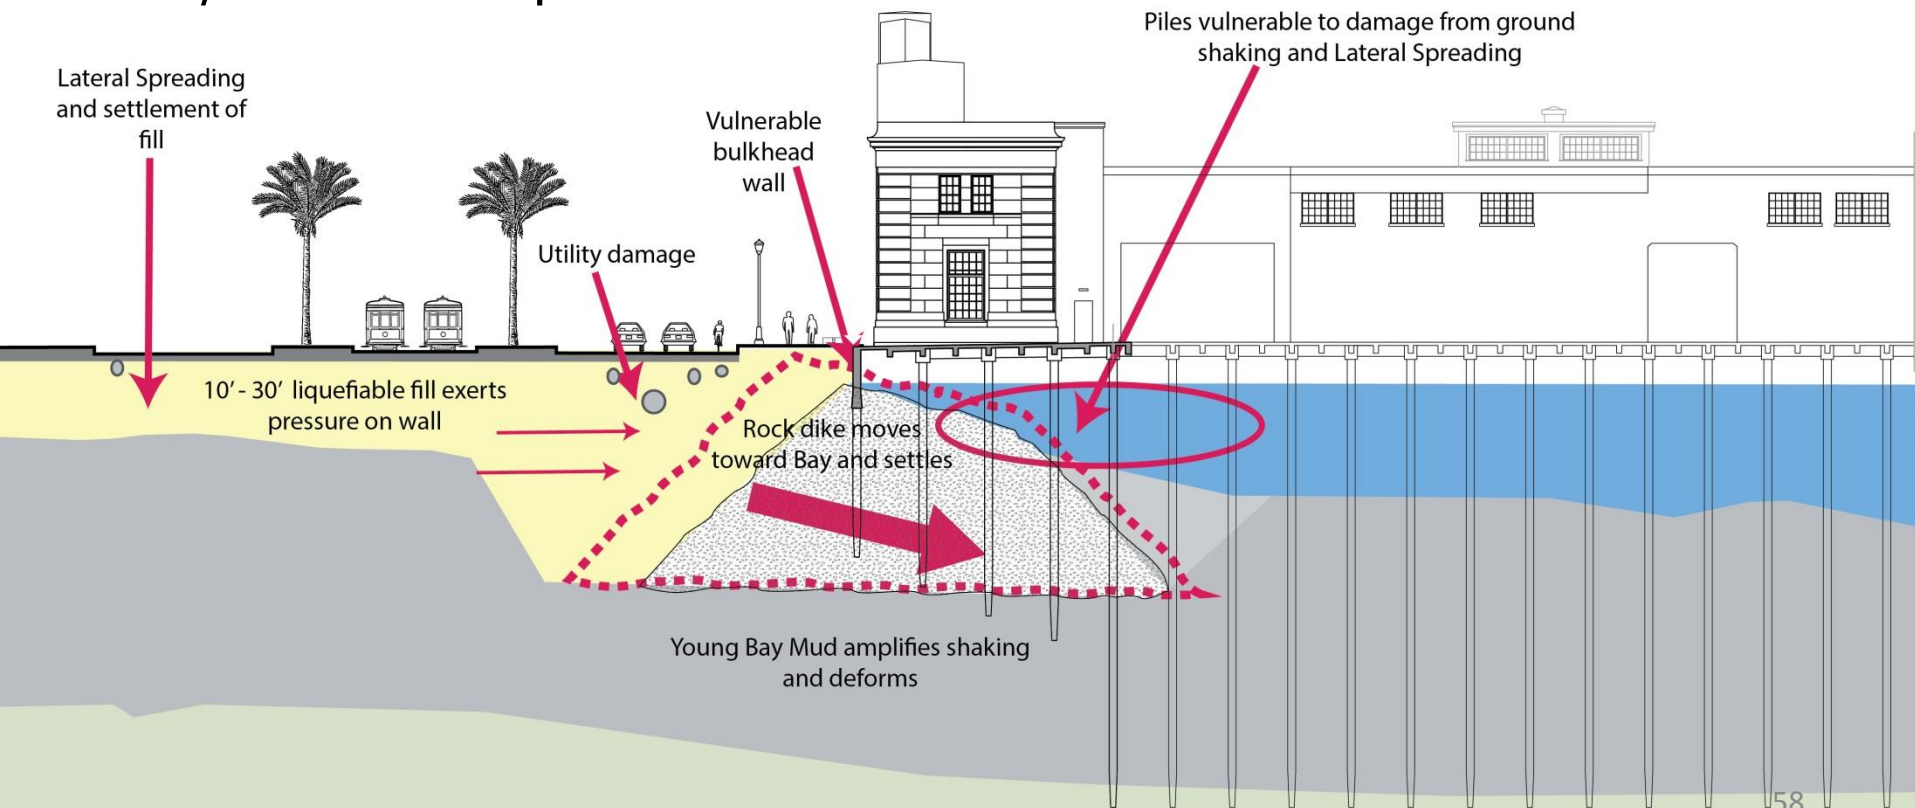
# Option 1: Liquefaction Remediation of Upland Fill

- Techniques: Stone Columns, Grouting, Soil Mixing, Compaction
- Reduces earthquake pressure on Seawall and lowers permanent ground displacements
- Reduces utility, roadway & Muni earthquake damage
- Does not provide stable base for SLR adaptation
- Disruption of Embarcadero

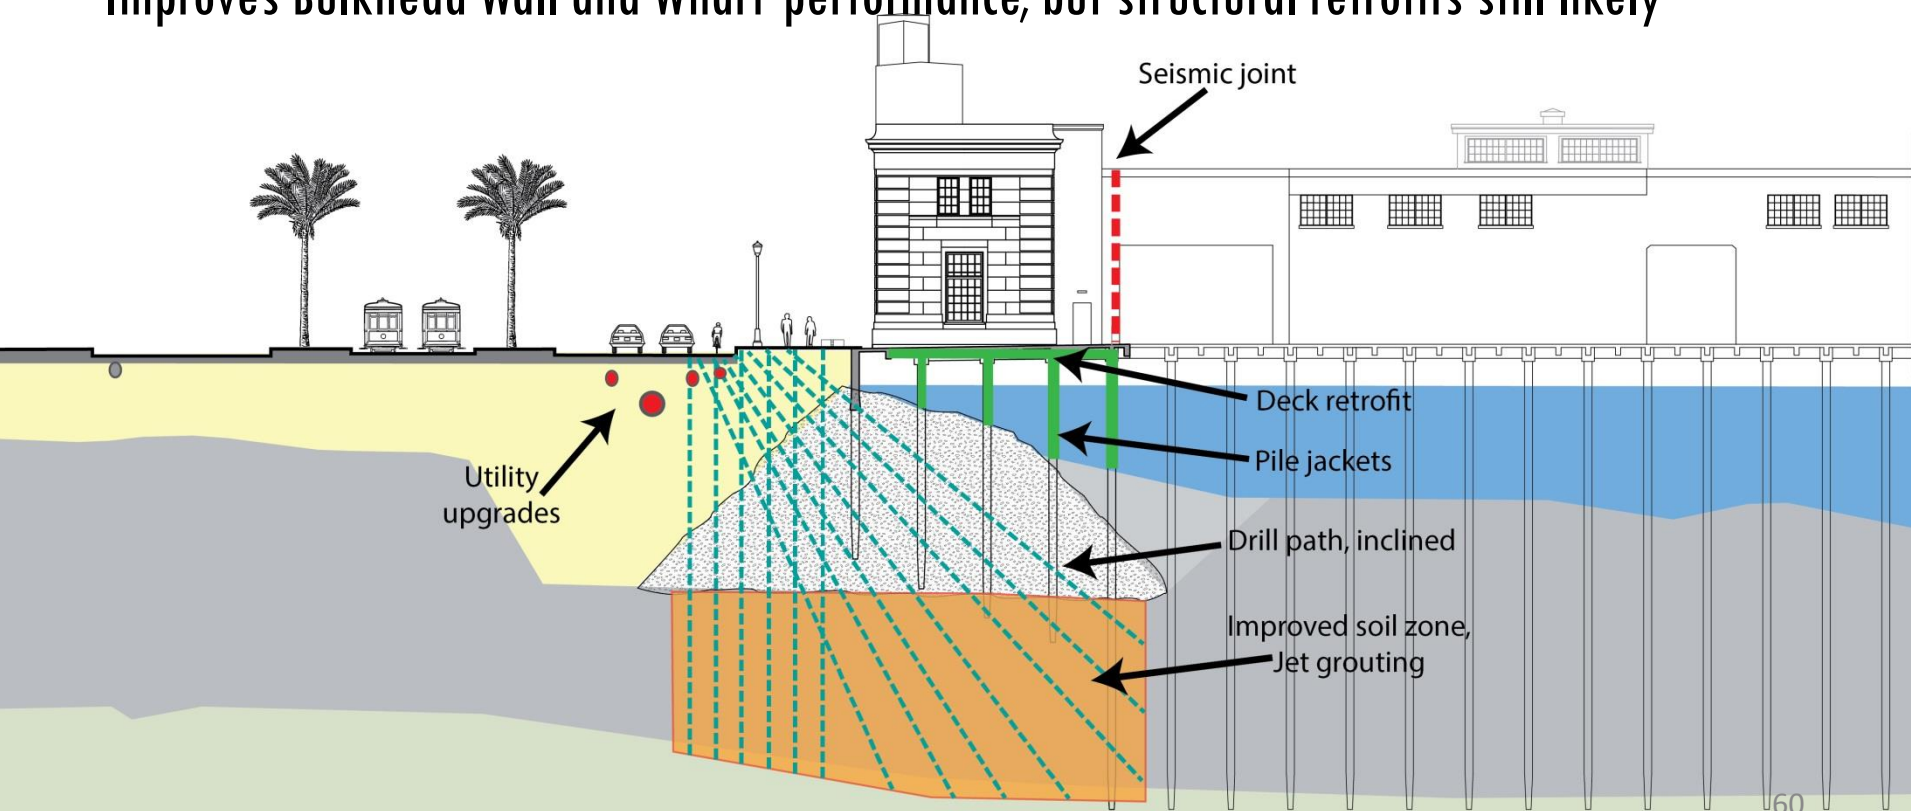
# Option 3: Ground Improvement Landside of Seawall

- Jet Grouting and Deep Soil Mixing to improve landside fill
- Stabilizes Embarcadero and reduces lateral spreading and settlement
- Combine with Bulkhead Wharf Pile and Deck Retrofits
- Replace brittle utility mains and laterals
- Provides stable base for SLR adaptation

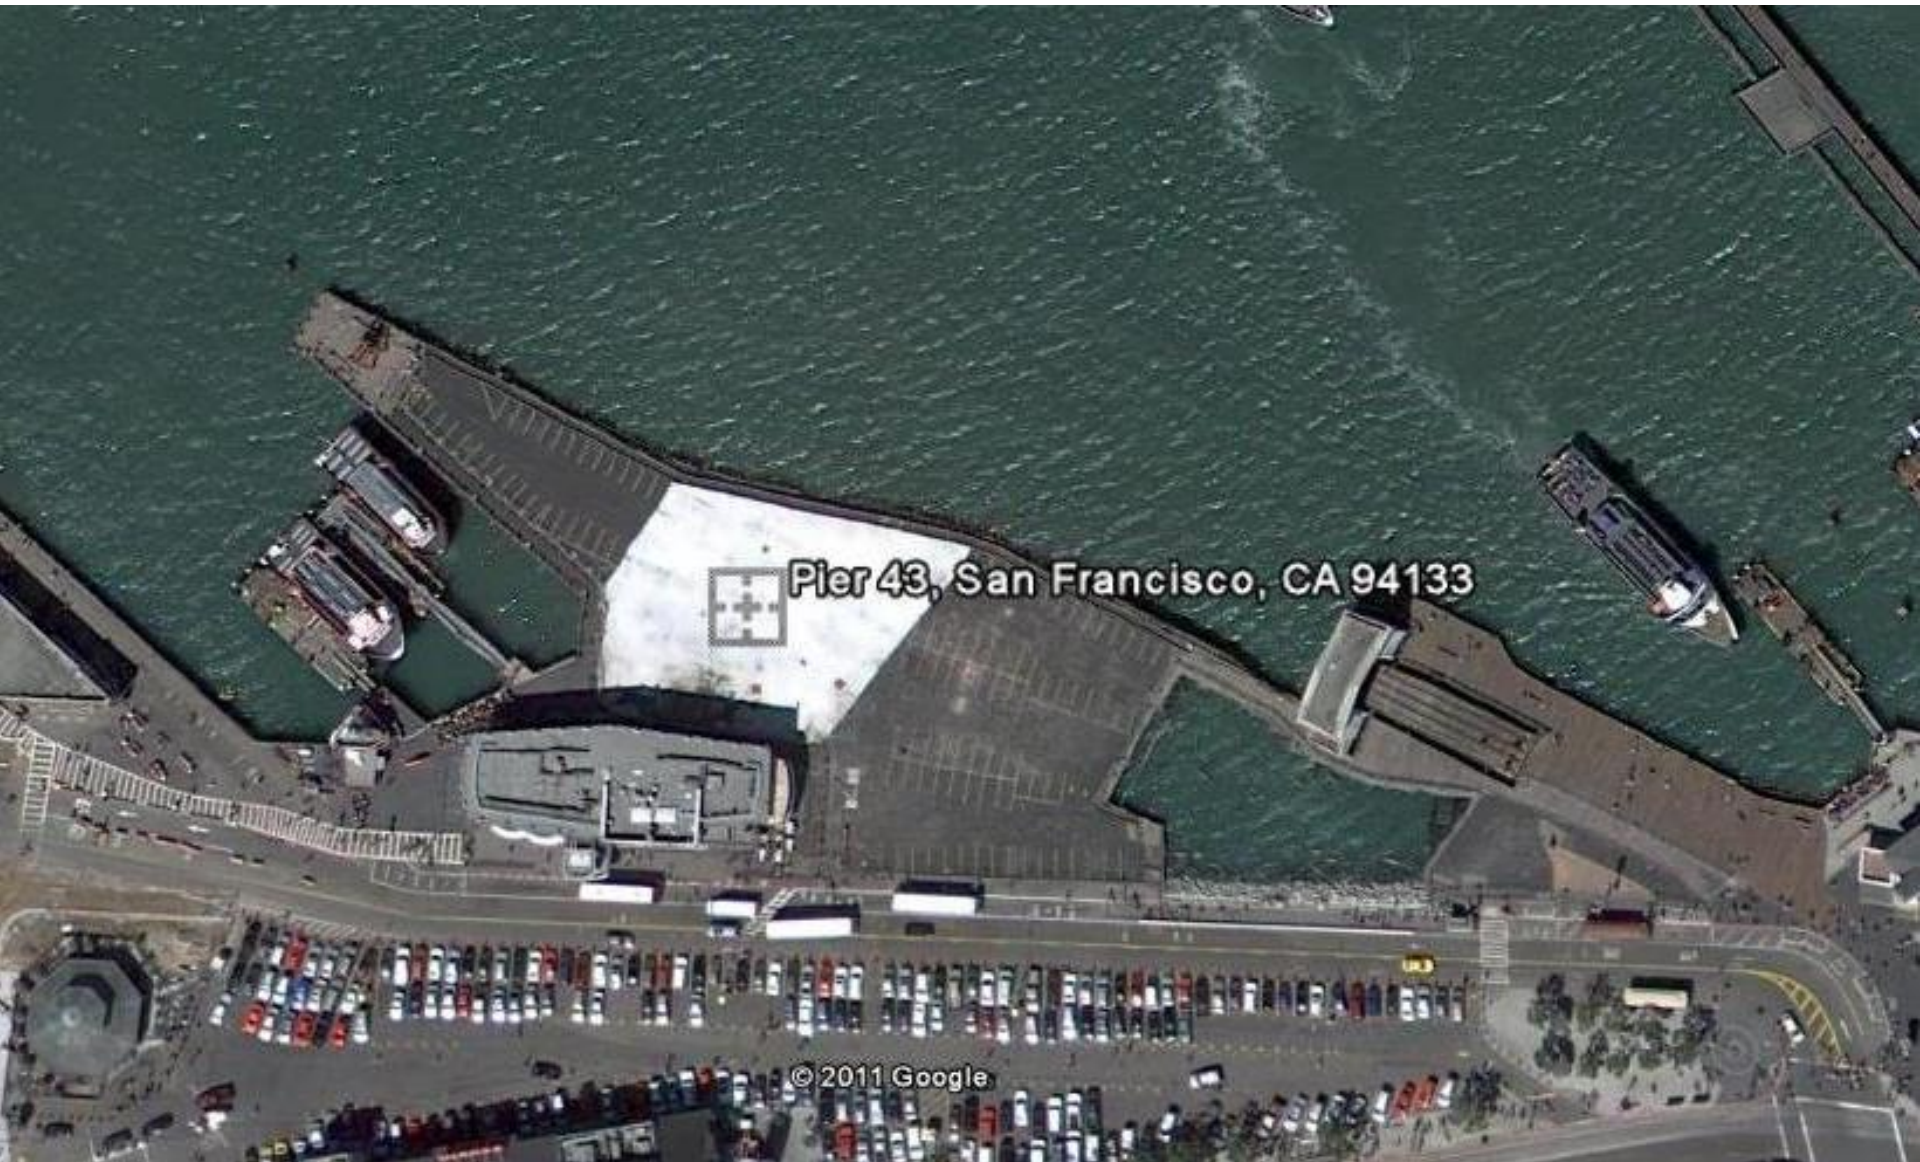
# Pier 43 Bay Trail Link (2012): Seawall Section B

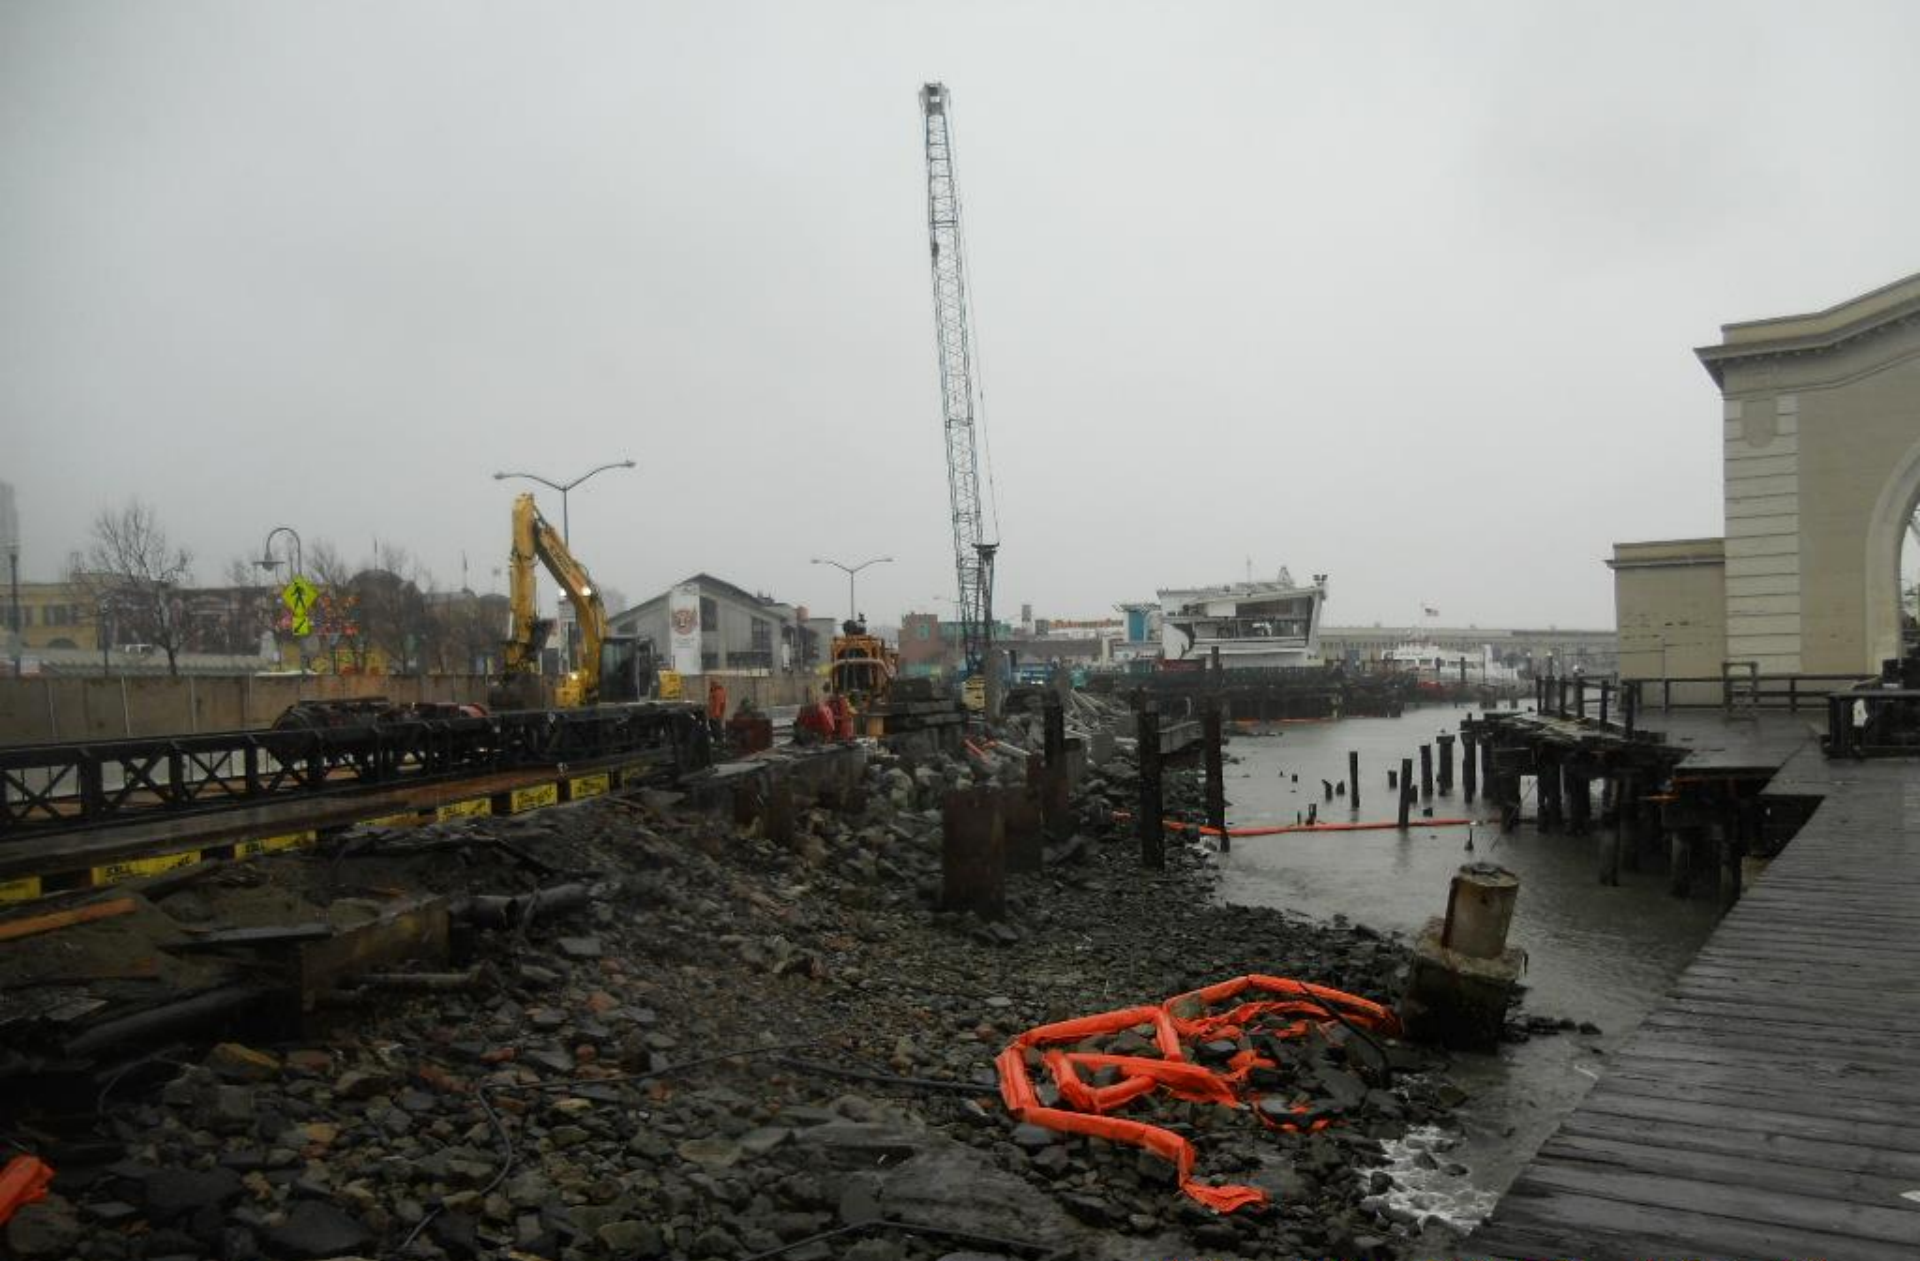
# Pier 43 Bay Trail Link (2012): Timber Bulkhead Wall and Wharf in Poor Condition, removed
