# The Northern Waterfront Seawall History and Earthquake Performance

**Waterfront Plan Working Group Meeting  
April 13, 2016**

**Steven Reel, PE - Project Manager, Engineering Division, Port**

**The Seawall is a complex and Historic Resource that  
is the foundation of the Northern Waterfront  
22 Original Seawall Sections  
55+ Combinations of Bulkheads and Wharves  
Modifications & Repairs throughout 100 years**

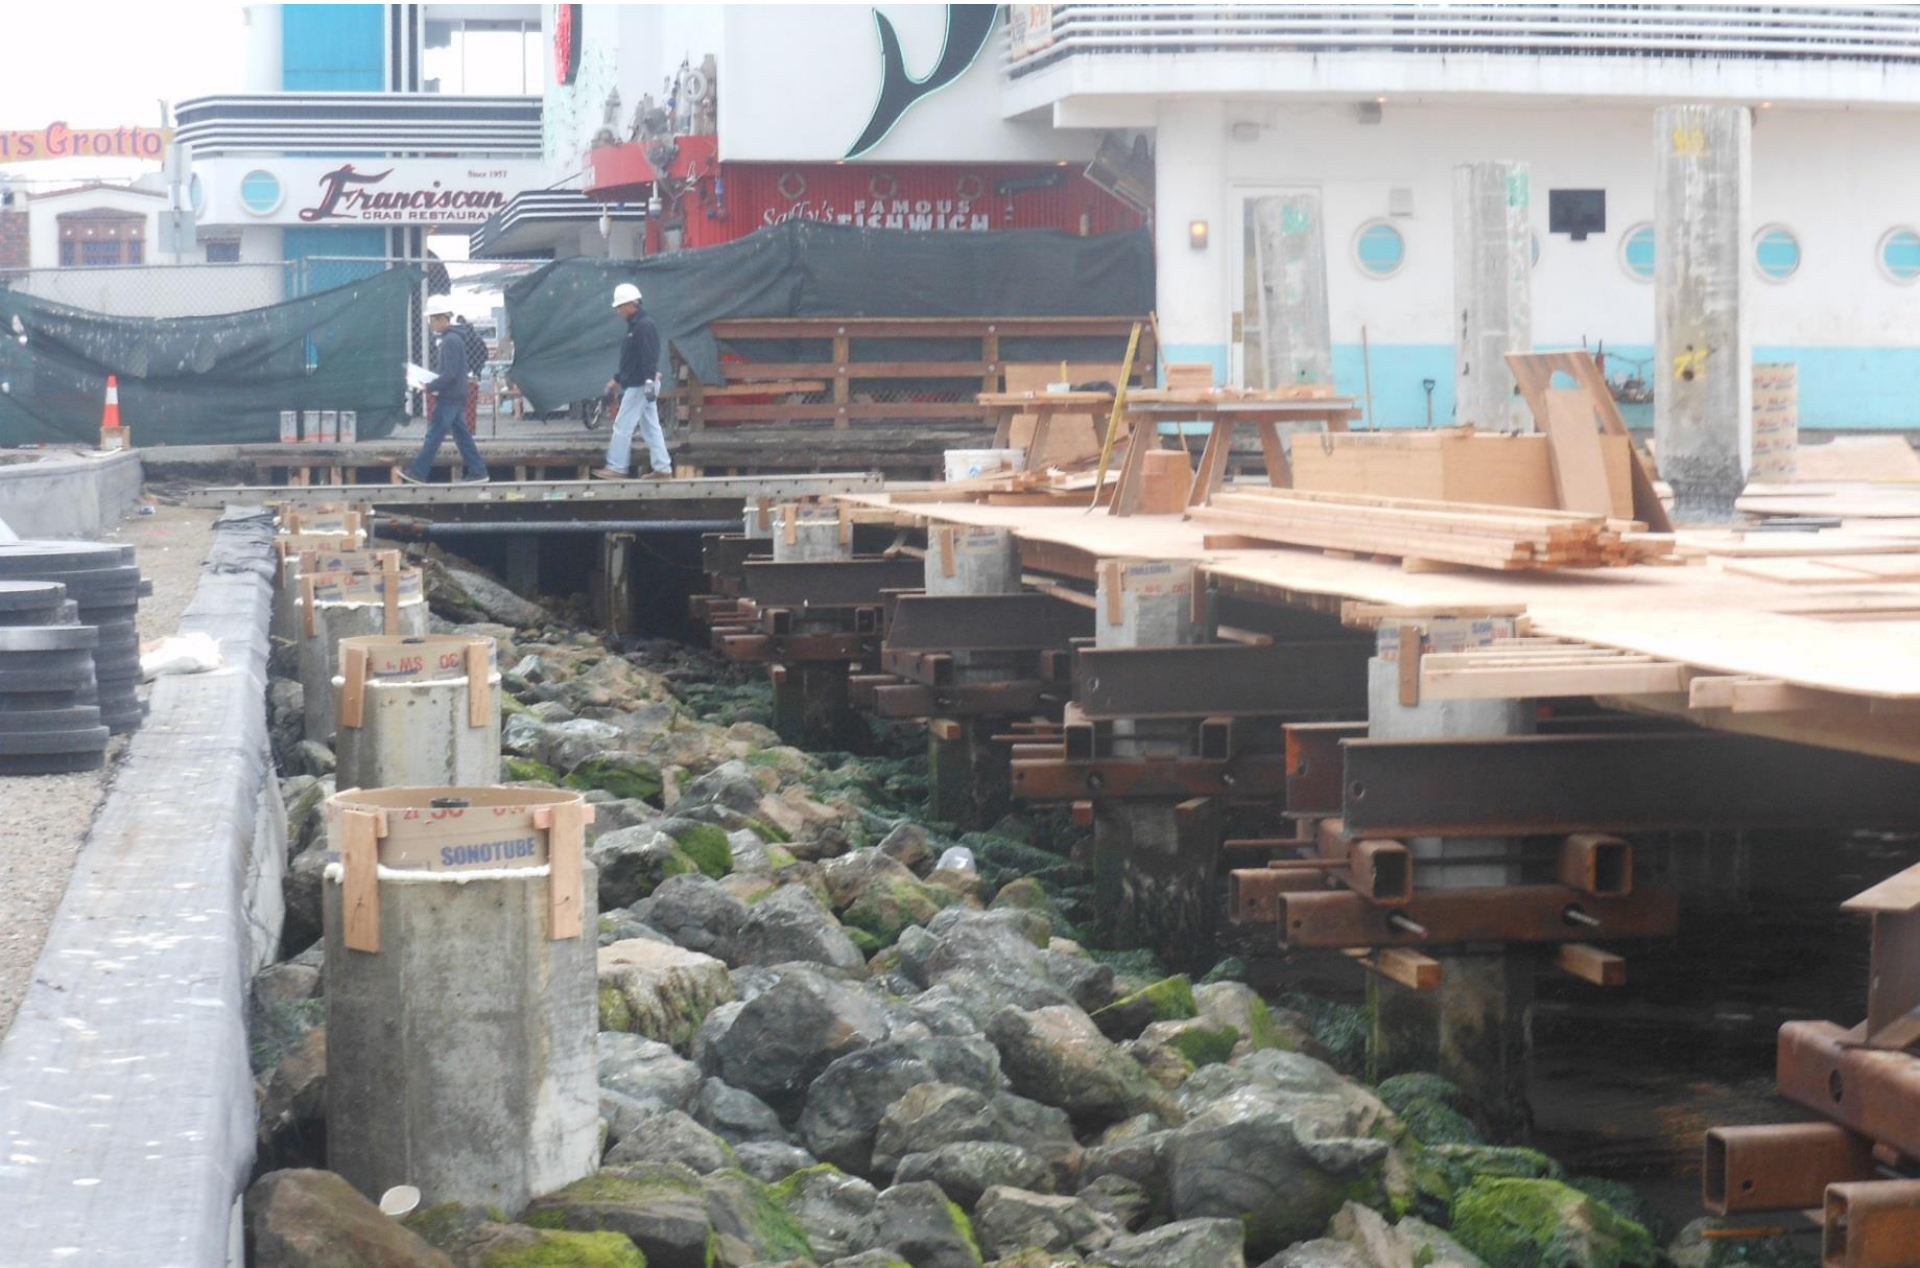
# Pier 43 Bay Trail Link(2012): New Bulkhead

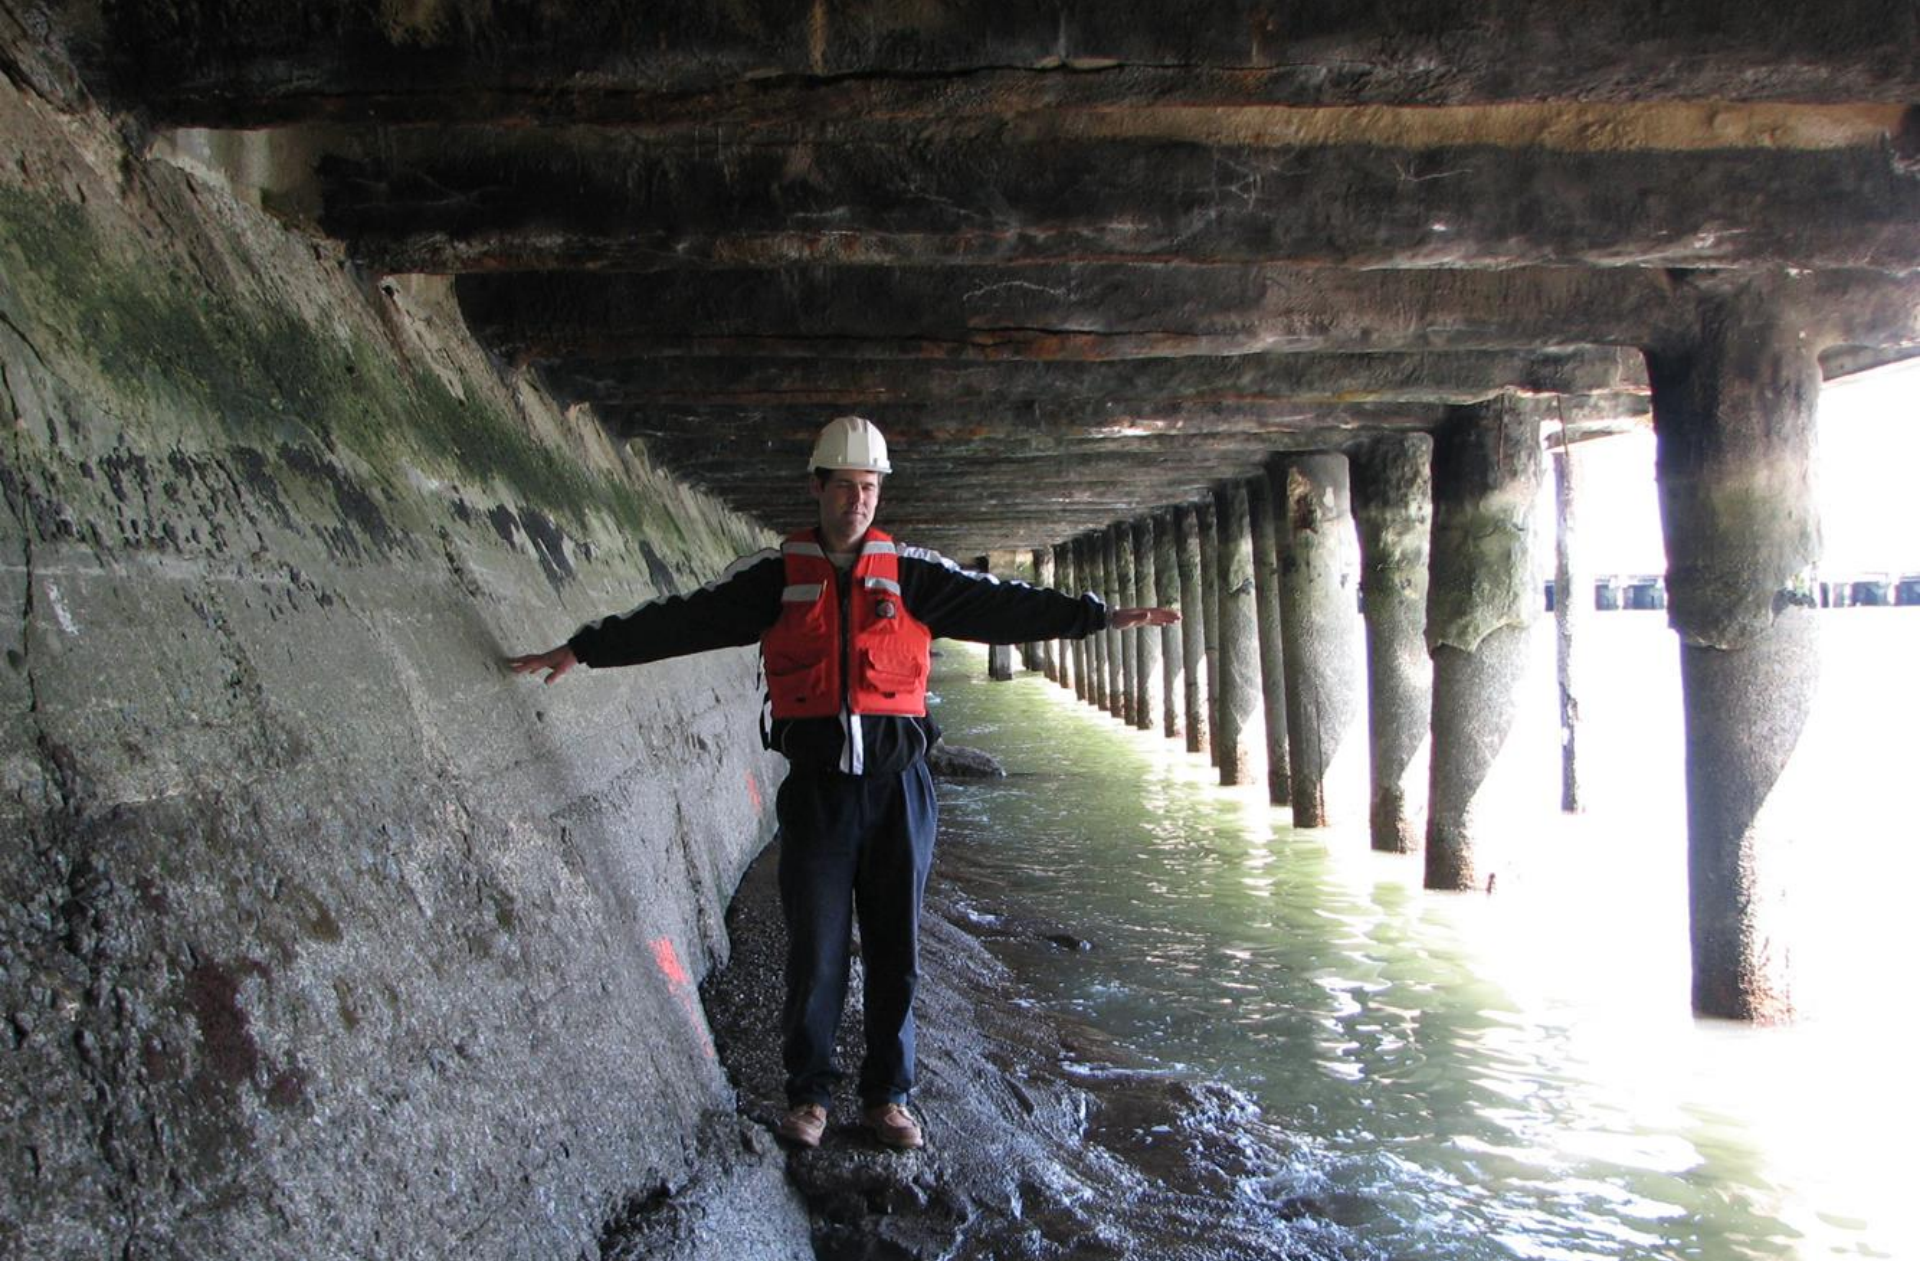
# Brannan Street Wharf (2013): Bulkhead Wall, Section 11 – To Remain

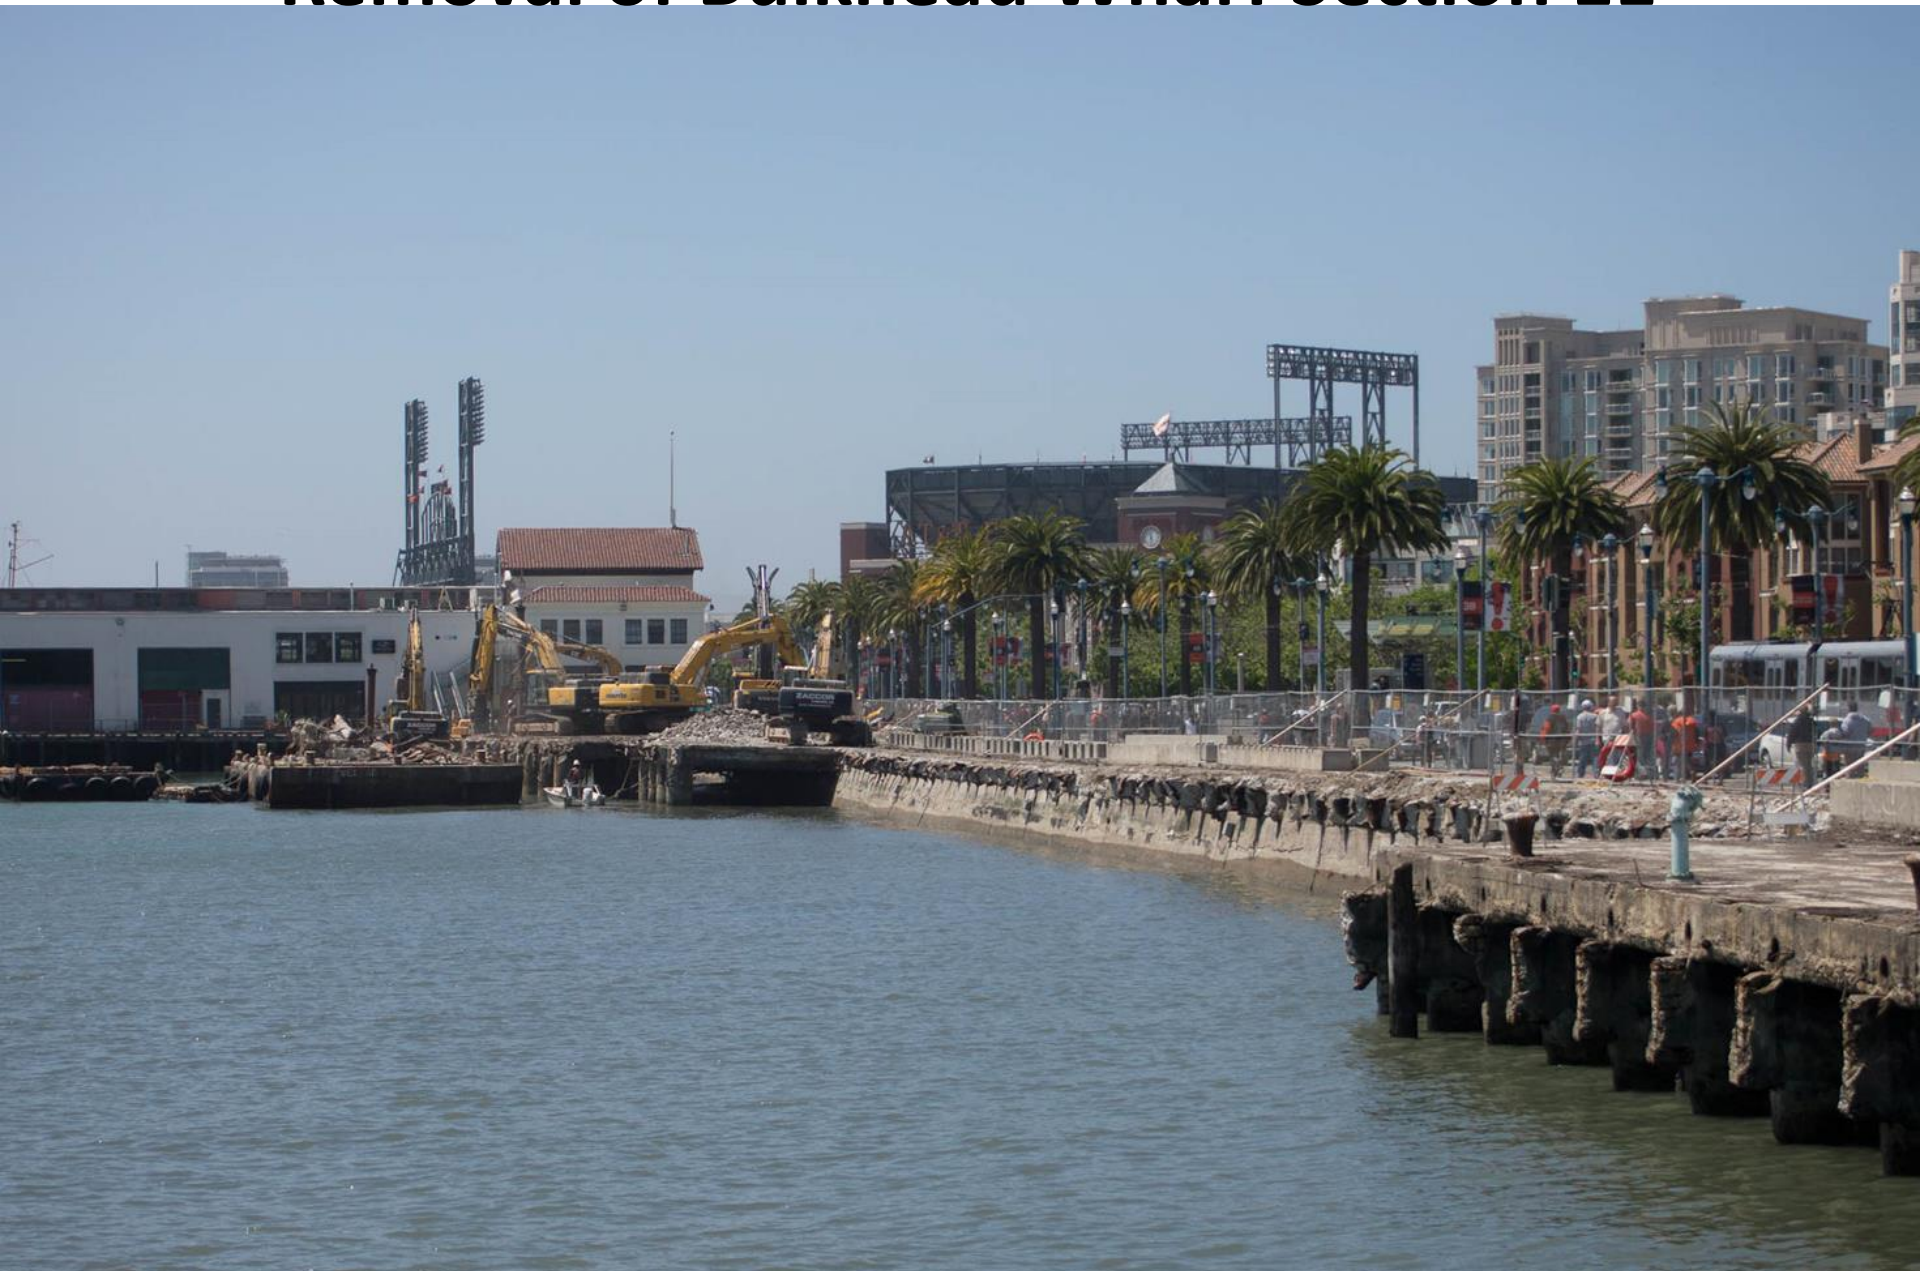
# Brannan Street Wharf (2013): Removal of Bulkhead Wharf Section 11

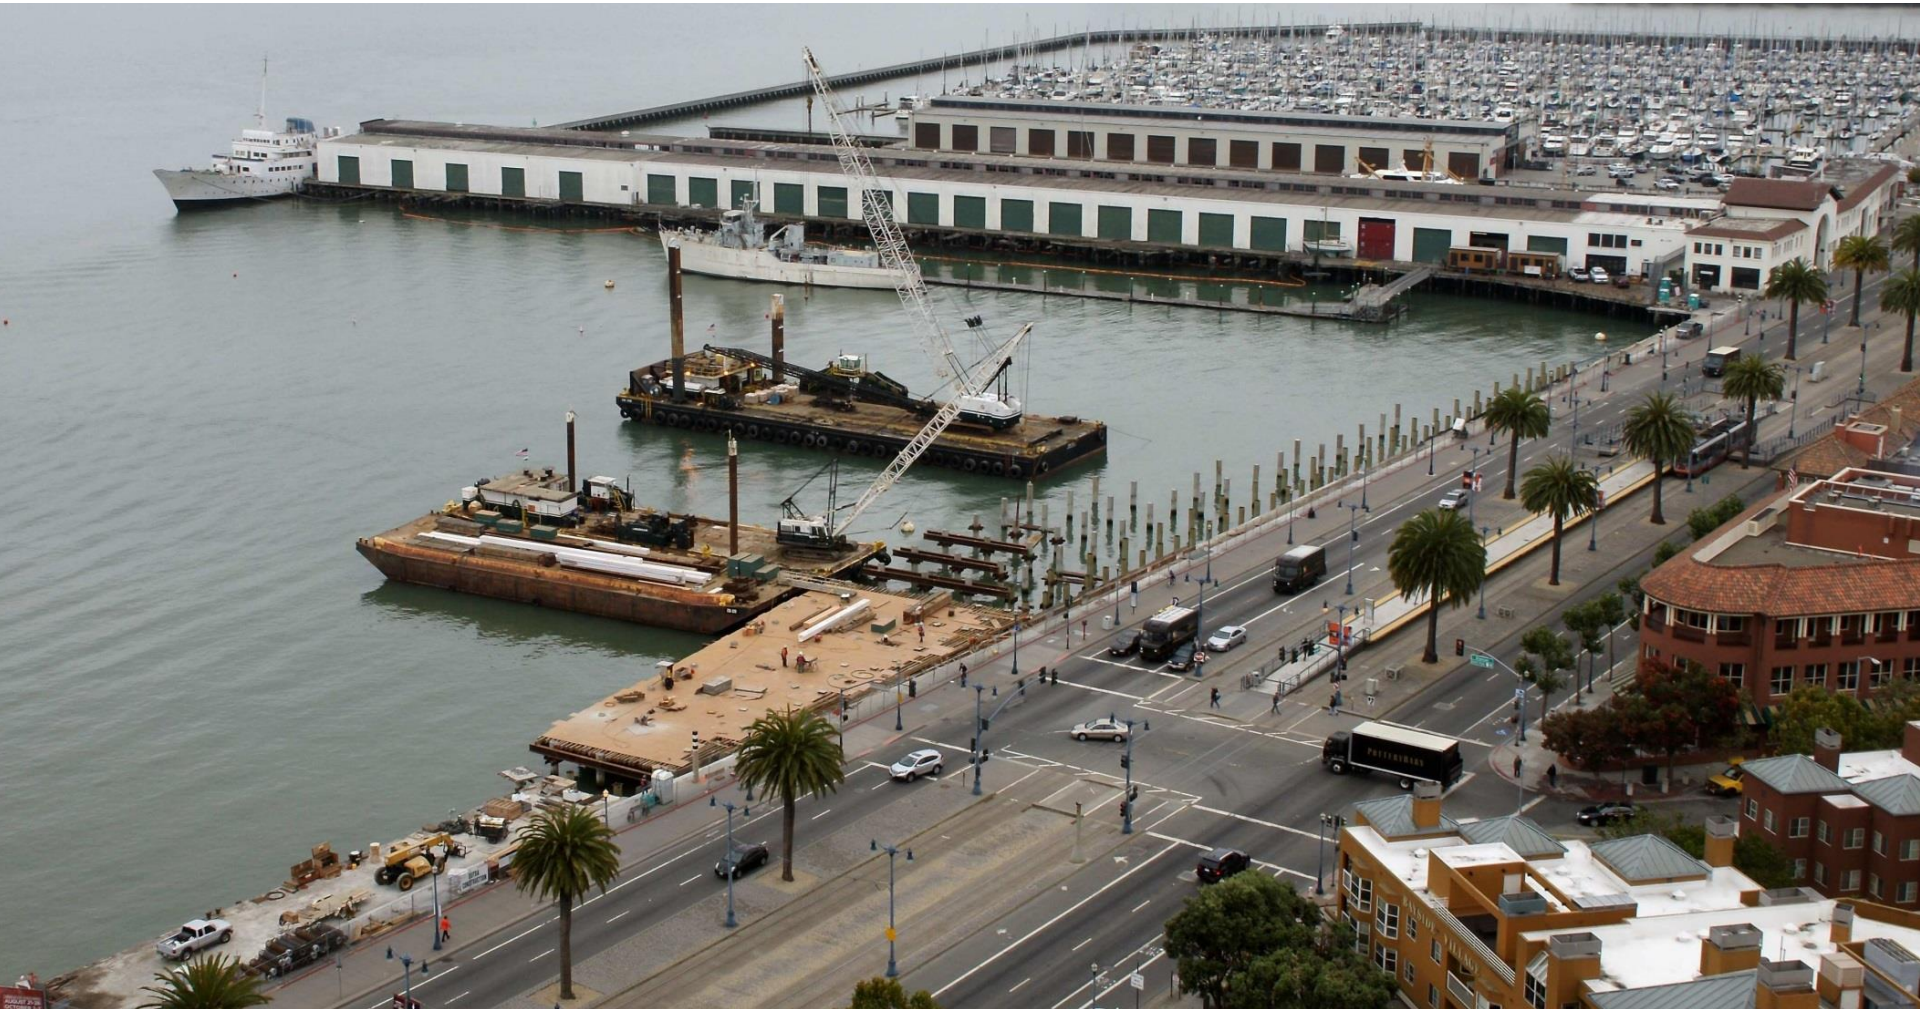
# Brannan Street Wharf (2013): New Wharf, Ductile Piles accommodate movement Construction from Water

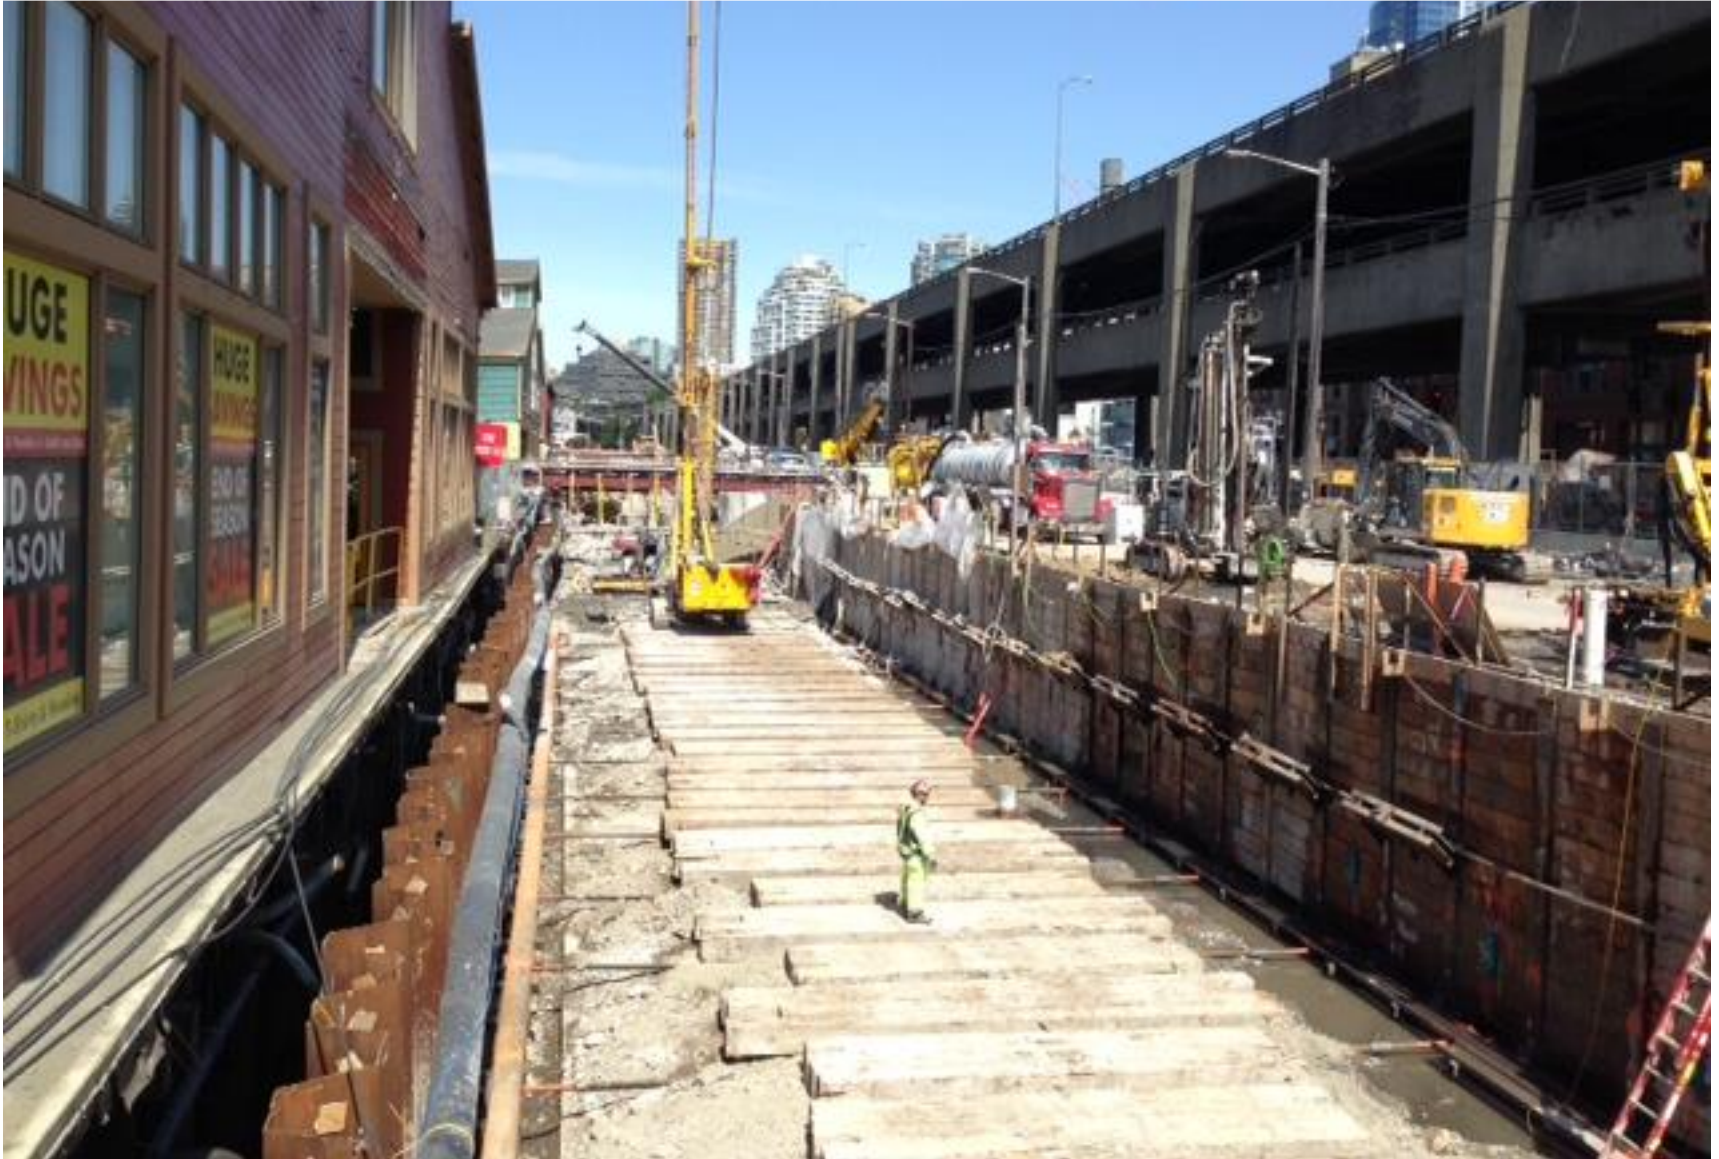
# Seattle Seawall Replacement

0.8 Mile \$400M Cost

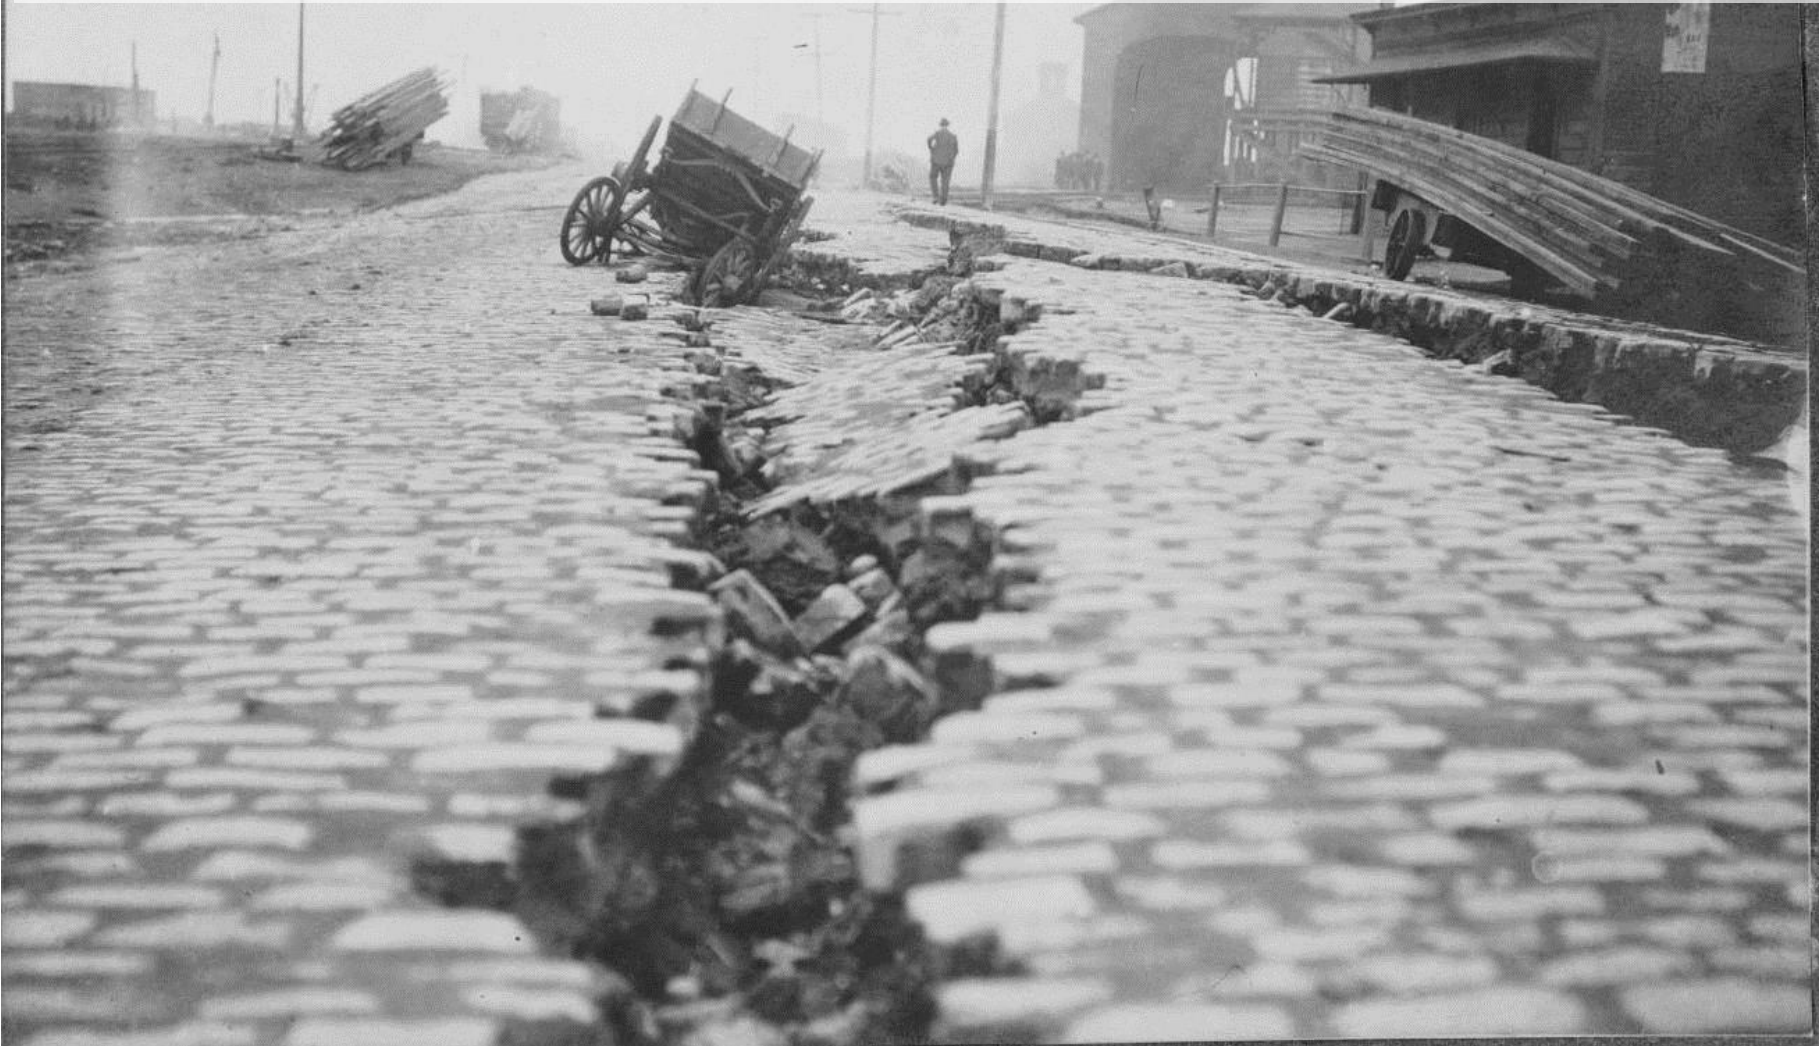
*Result of Earth-quake on East St. near the Ferry.*

**1906 EQ – Embarcadero near Lombard**
