Heron's Head

Subarea 4-5

Subarea Description

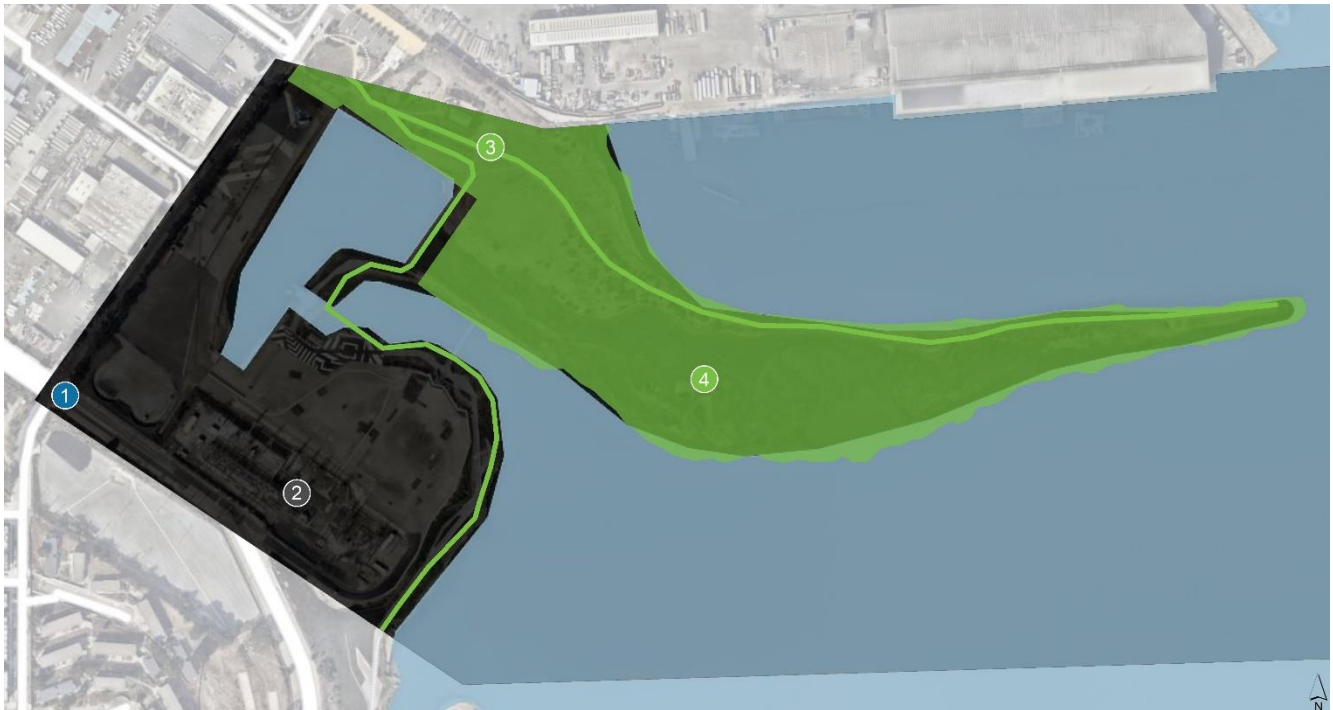
This shoreline within this subarea is primarily an embankment that is fronted by marsh or varying degrees of rock protection.

The primary pathways of flooding are from overtopping over broad stretches of mostly natural shoreline along the northern edge of Heron's Head Park and along the India Basin Shoreline to the south of this subarea. The wetland area at Heron's Head Park and the India Basin Shoreline already experience regular inundation during high tides today.

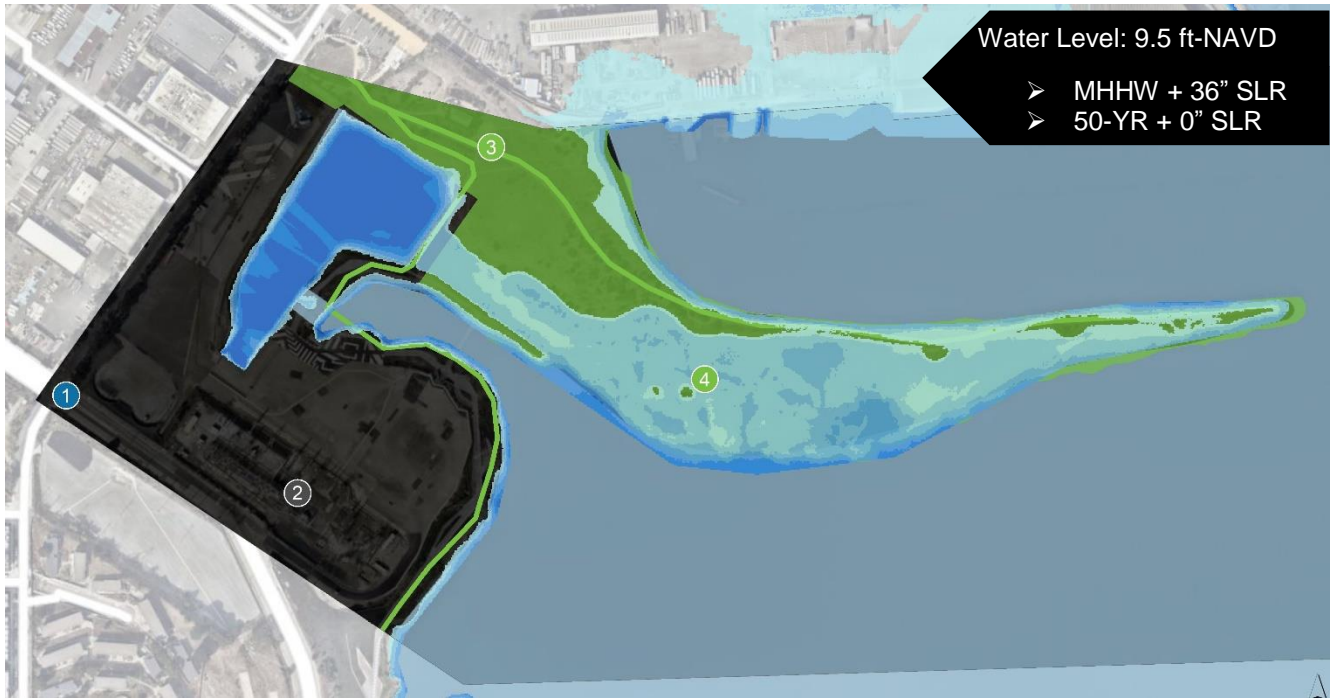
Substantial Flood Risk (Tipping Point)

Flood Progression

The following describes the progression of potential extreme tide and sea level rise flooding, along with a brief discussion of the assets that will be impacted within Subarea 4-5.

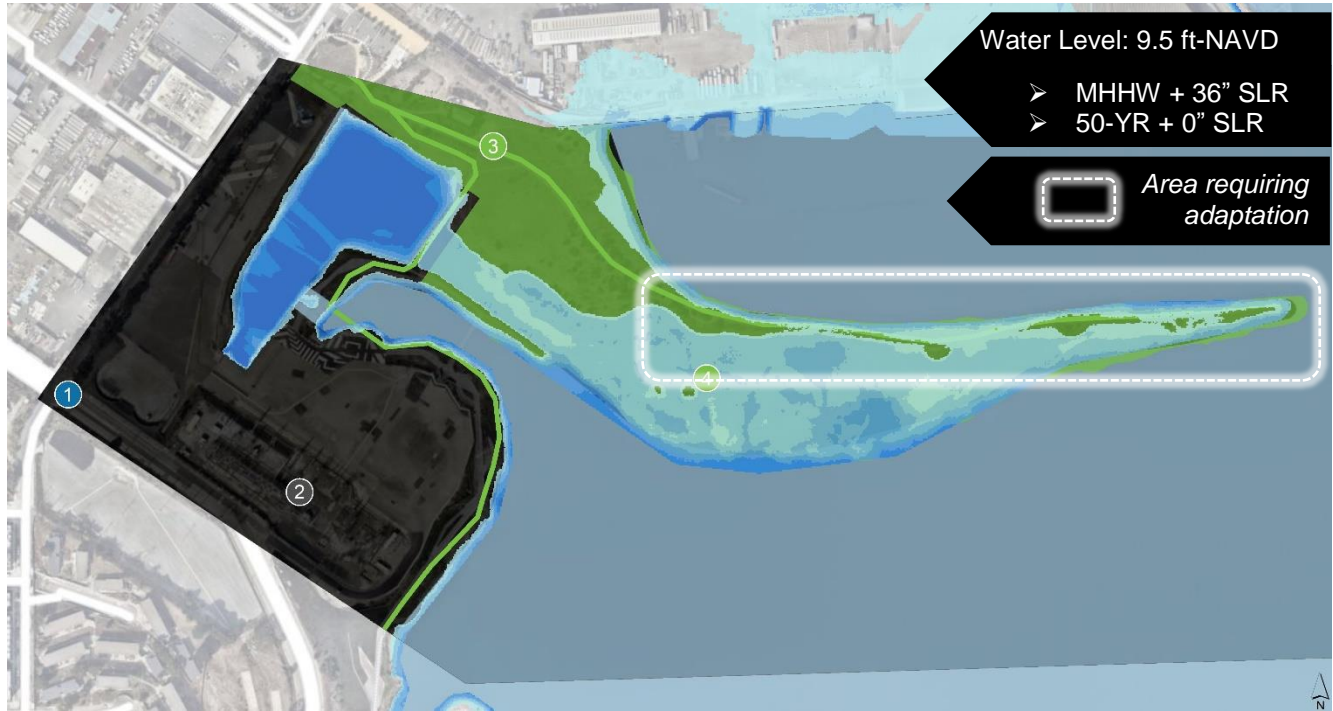
Adaptation Focus: Tipping Point

Shoreline Characteristics	Shoreline Overtopping					Timing of Impact (100-YR)				
	Classification	Avg. Elev.	Avg. Depth (ft)	Max Depth (ft)	Length (ft)	%	USACE Low	USACE Inter.	OPC Most Likely	USACE High
Berm / Embankment	9.3 ft. NAVD	0.2	0.3	1,000	14.9%	Today	Today	Today	Today	Today

- Overtopping occurs at the trail near the tip of Heron's Head Park, resulting in inundation of the Bay Trail / Blue Greenway.

- Initial adaptation measures could focus on this portion of the Bay Trail to allow for continue use of the trail.

- Adaption measures should allow the shoreline protection to be increased over time for higher sea level rise scenarios.

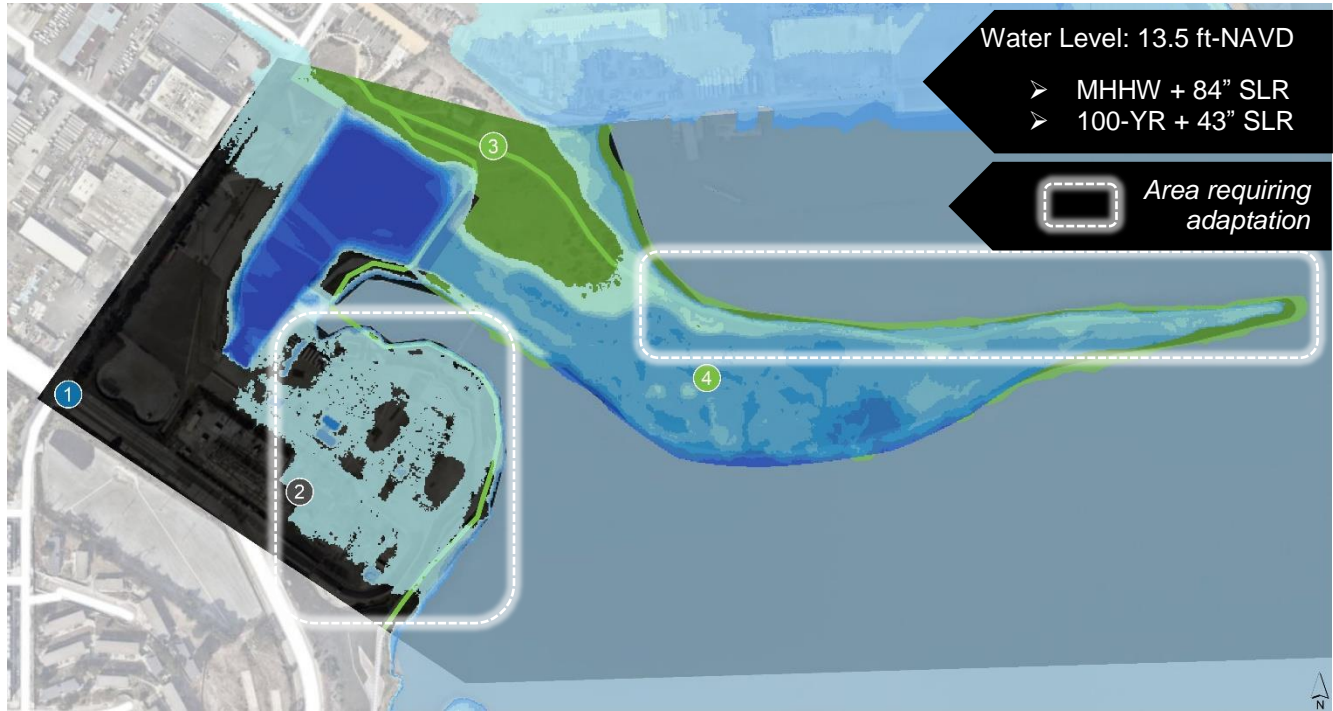
Adaptation Focus: Long-Term >2050

Shoreline Characteristics	Shoreline Overtopping					Timing of Impact (100-YR)				
	Classification	Avg. Elev.	Avg. Depth (ft)	Max Depth (ft)	Length (ft)	%	USACE Low	USACE Inter.	OPC Most Likely	USACE High
Berm / Embankment; Engineered	11.4 ft. NAVD	2.0	4.5	4,995	74.4%	>2150	>2150	2104	2083	2069
