Subarea 4-1

Subarea Description

Pier 80 (Subarea 4-1) includes Pier 80, a 60-acre working cargo pier that provides important maritime, industrial, and disaster response services. Pier 80 includes two warehouses, four deepwater large vessel berths, two cranes used to offload materials from ships, and a railroad connection. Seawall Lot 356 and portions of the Potrero Hill neighborhood's southern industrial area, which contains Muni Metro East and Warm Water Cove Park, are also in this subarea.

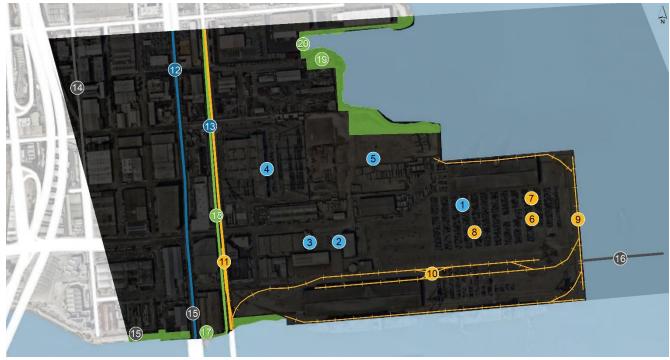
The Bay facing shoreline is comprised of an embankment fortified with revetment and an engineered pier (on piles). The Islais Creek facing shoreline has a similar shoreline type except the sections with an embankment have varying degrees of fortification.

The primary pathways of flooding are from overtopping along the northern shoreline of Islais Creek near the 3rd Street Bridge and the Illinois Street Bridge. Flooding from this subarea extends into the adjacent Subarea 4-2 (Islais Creek). Flood risk reduction strategies in this subarea will also benefit Subarea 4-2.

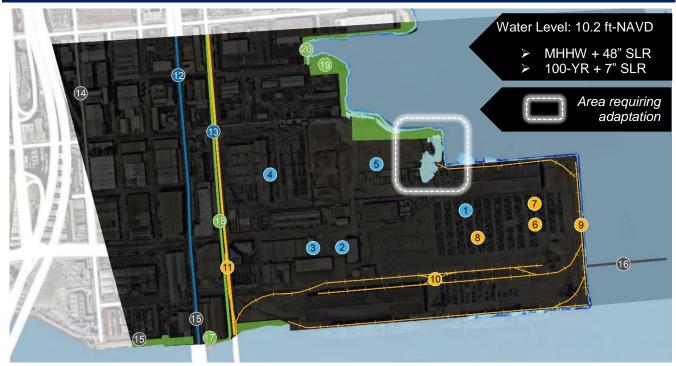
Adaptation Focus: Immediate

Shoreline Characteristics		Shorel	ine Overt	topping		Timing of Impact (100-YR)				
Classification	Avg. Elev.	Avg. Depth (ft)	Max Depth (ft)	Length (ft)	%	USACE Low	USACE Inter.	OPC Most Likely	USACE High	OPC 1-in- 200
Engineered	9.0 ft. NAVD	0.3	0.3	200	2.0%	2088	2048	2032	2025	2023

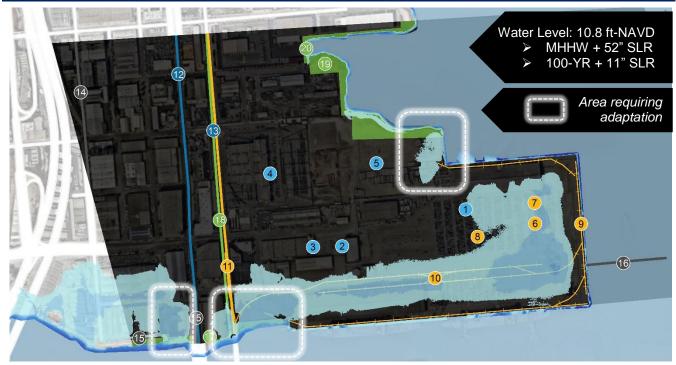
Adaptation Focus: Tipping Point

Shoreline Characteristics		Shoreli	ine Overt	topping		Timing of Impact (100-YR)				
Classification	Avg. Elev.	Avg. Depth (ft)	Max Depth (ft)	Length (ft)	%	USACE Low	USACE Inter.	OPC Most Likely	USACE High	OPC 1-in- 200
Embankment; Engineered	9.5 ft. NAVD	1.8	3.5	1,200	12.2%	2139	2066	2044	2035	2032

- Adaptation measures to reduce flood risk to this subarea will benefit the adjacent Subarea 4-2.
- Several facilities where overtopping occurs along the Islais Creek shoreline are immediately adjacent to the shoreline and may require adaptation measures within a narrow footprint at the shoreline if facilities cannot be relocated.

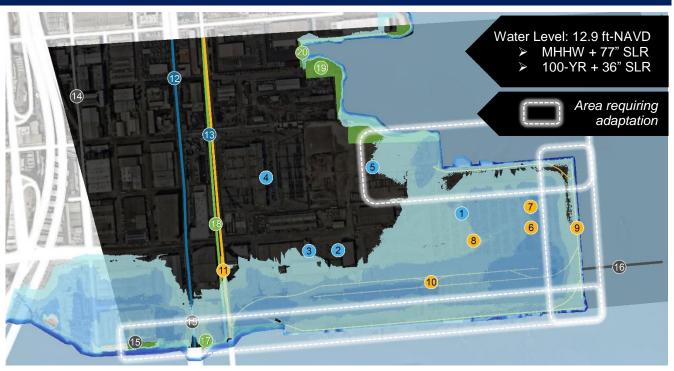
Adaptation Focus: Long-Term >2050

Shoreline Characteristics		Shoreli	ne Overt	opping		Timing of Impact (100-YR)				
Classification	Avg. Elev.	Avg. Depth (ft)	Max Depth (ft)	Length (ft)	%	USACE Low	USACE Inter.	OPC Most Likely	USACE High	OPC 1-in- 200
Embankment; Engineered	11.3 ft. NAVD	1.5	5.6	8,000	81.4%	>2150	2144	2091	2074	2063
