Aquatic Park

Subarea 1-1

Subarea Description

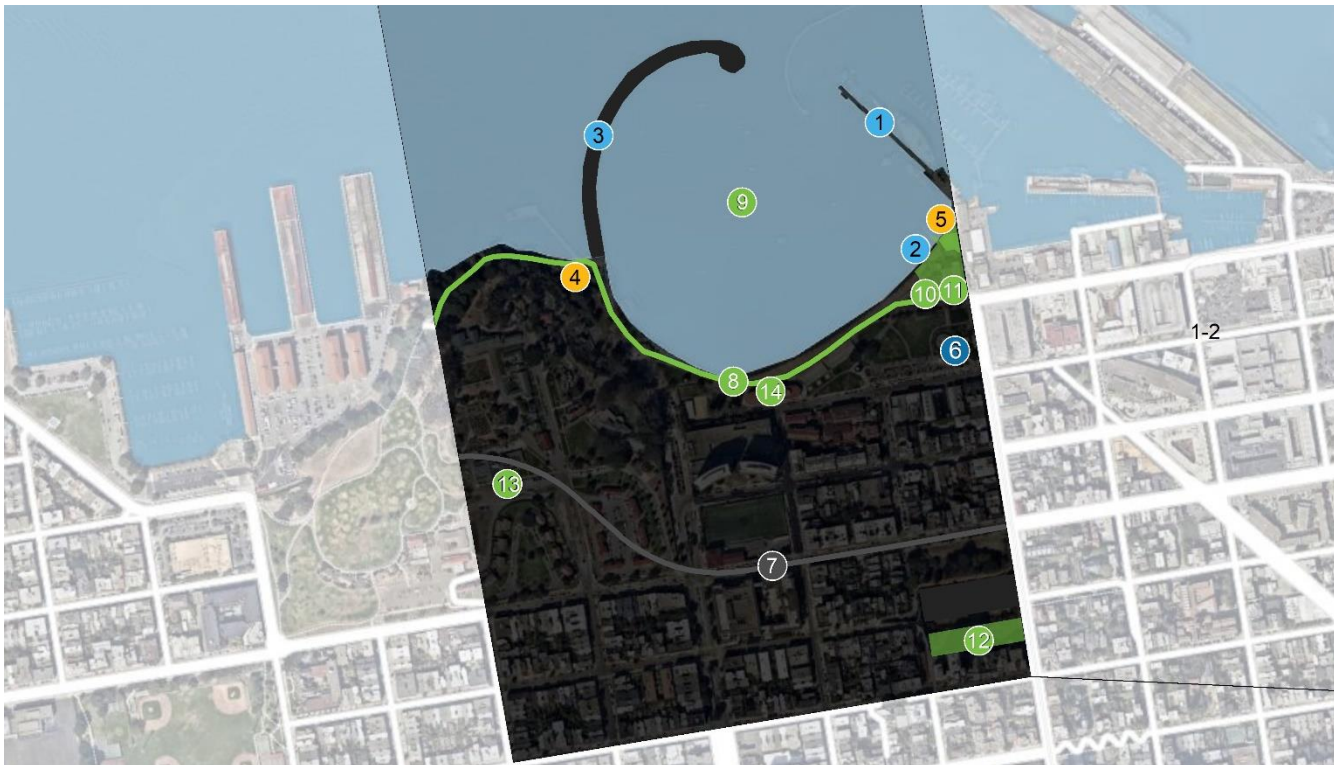
Assets and Landmarks

1. Hyde Street Pier
2. Small Boat Launch (Aquatic Park Cove)
3. Municipal Fishing Pier

4. EFWS Pump #2
5. EFWS Suction Connections (1)

6. Hyde Street Cable Car Turnaround

7. North Beach Tunnel

8. Bay Trail
9. Aquatic Park Cove
10. Dolphin Rowing Club
11. South End Rowing Club
12. Russian Hill Open Space
13. Fort Mason National Recreation Area
14. San Francisco Maritime National Historic Park

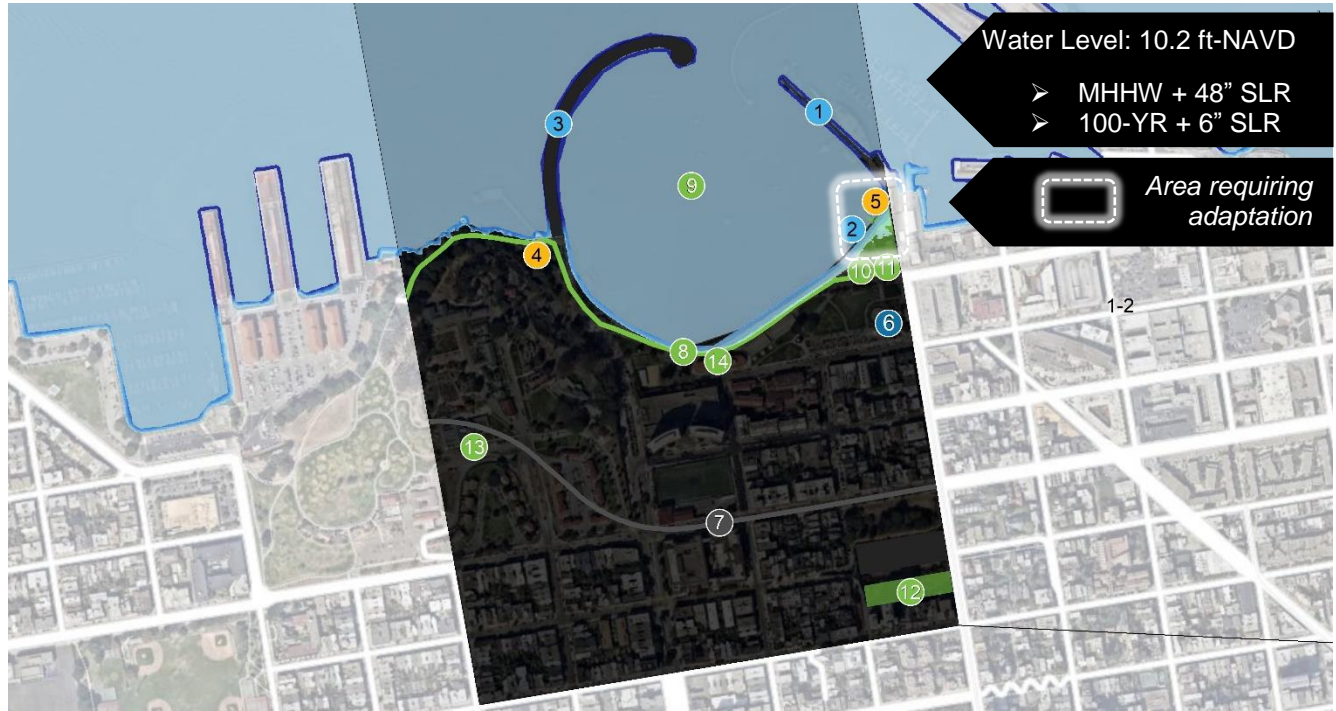
Adaptation Focus: Immediate

Shoreline Characteristics	Shoreline Overtopping					Timing of Impact (100-YR)				
	Avg. Elev.	Avg. Depth (ft)	Max Depth (ft)	Length (ft)	%	USACE Low	USACE Inter.	OPC Most Likely	USACE High	OPC 1-in-200
Engineered	9.6 ft. NAVD	0.4	1.5	1,800	30.5%	2080	2044	2030	2023	2022

- Flooding during this scenario occurs when water levels exceed the lower-lying shoreline within this subarea adjacent to the Hyde Street Pier, and in front of the Dolphin Club and South End Rowing Club.
- Inundation will occur along the front edges of these facilities, but flooding will be localized near the existing shoreline.

- Isolated adaptation measures within this subarea would address flooding at the MHHW + 48” scenario.

- Higher water levels will eventually overtop most of the Embarcadero shoreline. Adaptation measures should consider embedding capacity to adapt to higher water levels over time.

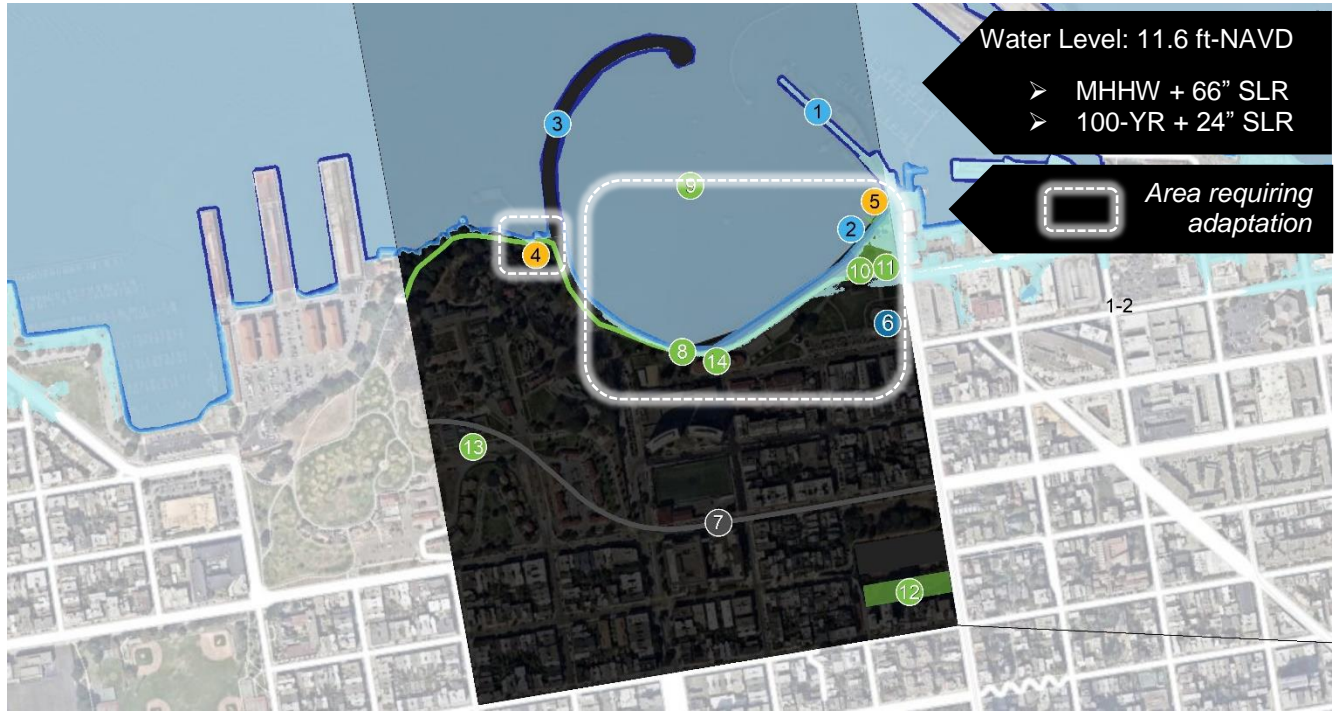
Adaptation Focus: Tipping Point

Shoreline Characteristics	Shoreline Overtopping					Timing of Impact (100-YR)				
	Classification	Avg. Elev.	Avg. Depth (ft)	Max Depth (ft)	Length (ft)	%	USACE Low	USACE Inter.	OPC Most Likely	USACE High
Engineered	11.2 ft. NAVD	0.4	1.5	1,800	30.5%	>2150	2113	2071	2059	2052

- Overtopping occurs over a broad stretch of subarea shoreline, including a portion of the seawall along the Aquatic Park Cove shoreline resulting in inundation of the Bay Trail / Aquatic Park promenade. Flooding remains largely localized within the Bay Trail.
- Overtopping also occurs near Black Point resulting in inundation of the Bay Trail.
- Inundation of Jefferson Street occurs from the comingling of flood pathways between this subarea and the adjacent Subarea 1-2.

- Subarea wide shoreline adaptation measures are required.

- Comingling of flooding with the adjacent Subarea 1-2 requires adaptation measures to be coordinated across these subareas and implemented in tandem.
- Adaptation measures should consider embedding capacity to adapt to higher water levels over time.

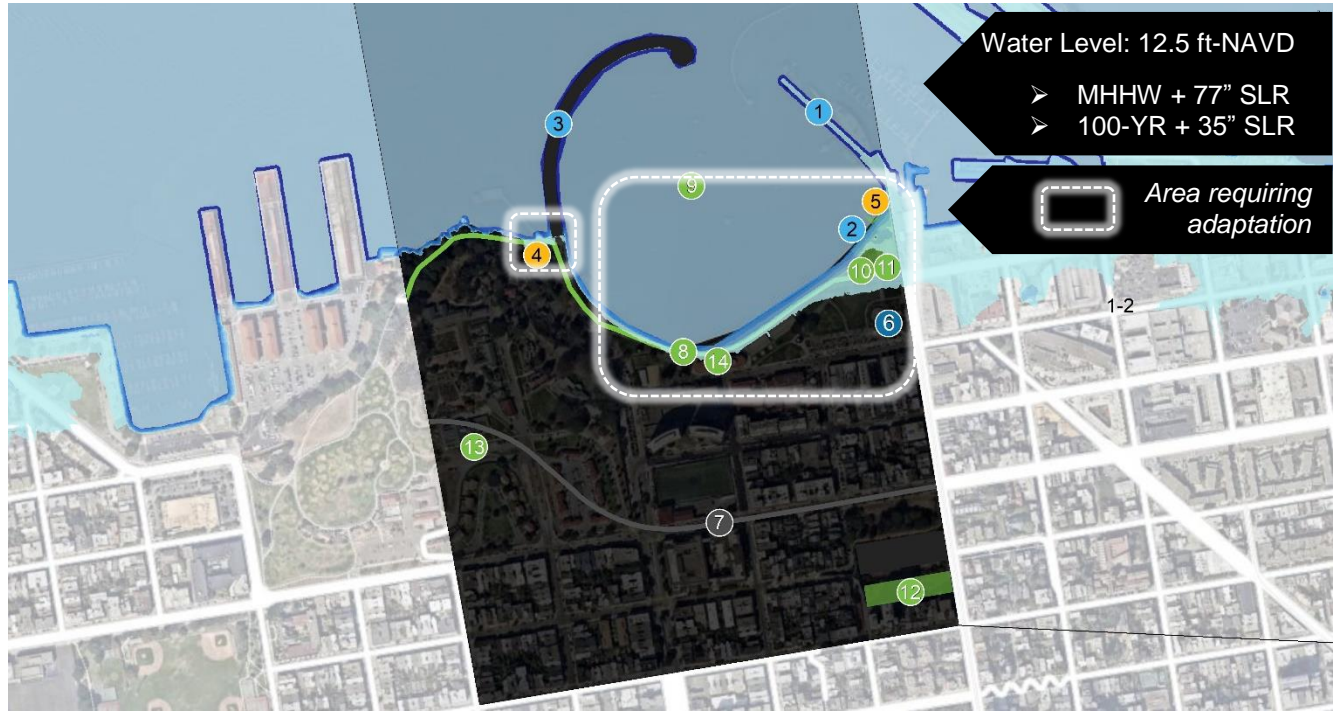
Adaptation Focus: Long-Term >2050

Shoreline Characteristics	Shoreline Overtopping					Timing of Impact (100-YR)				
	Classification	Avg. Elev.	Avg. Depth (ft)	Max Depth (ft)	Length (ft)	%	USACE Low	USACE Inter.	OPC Most Likely	USACE High
Engineered	11.3 ft. NAVD	1.2	2.3	2,118	35.9%	>2150	2142	2090	2074	2063

- Overtopping occurs over a broad stretch of Subarea 1-2 shoreline, including a portion of the seawall along the Aquatic Park Cove shoreline resulting in inundation of the Bay Trail / Aquatic Park promenade. Flooding remains largely localized within the landward edge of the Bay Trail.
- Flooding begins to encroach on the landward areas adjacent to the Bay Trail along Aquatic Park Cove.
- Overtopping also occurs near Black Point resulting in inundation of the Bay Trail.
- Inundation of Jefferson Street occurs from the comingling of flood pathways with the adjacent Subarea 1-2.

- Subarea wide shoreline adaptation measures are required.

- Comingling of flooding with the adjacent Subarea 1-2 requires adaptation measures to be coordinated across these subareas and implemented in tandem.
- Adaptation measures should consider embedding capacity to adapt to higher water levels over time.
