Port of San Francisco Dry Dock EUREKA Structural Assessment Report

June 2017

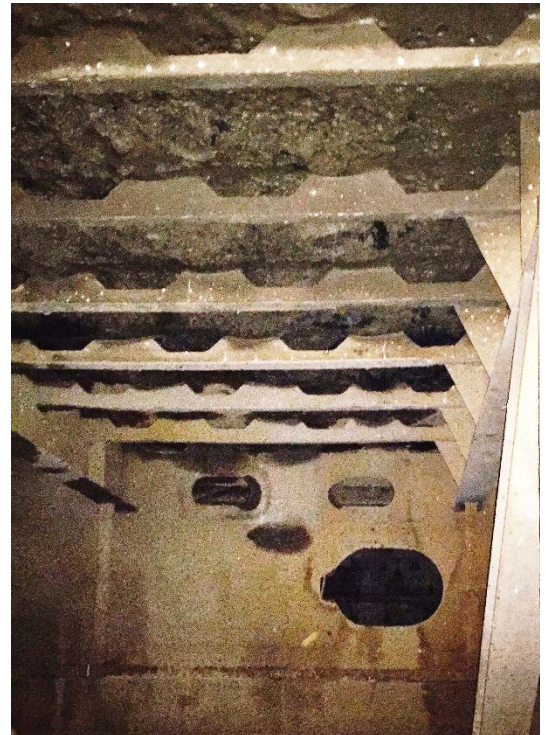
Figure 6: Undamaged Serrated Stiffener Example

An example of heavy corrosion damage to the channel stiffeners is shown in Figure 5 below, compared against an undamaged stiffener shown in Figure 6.

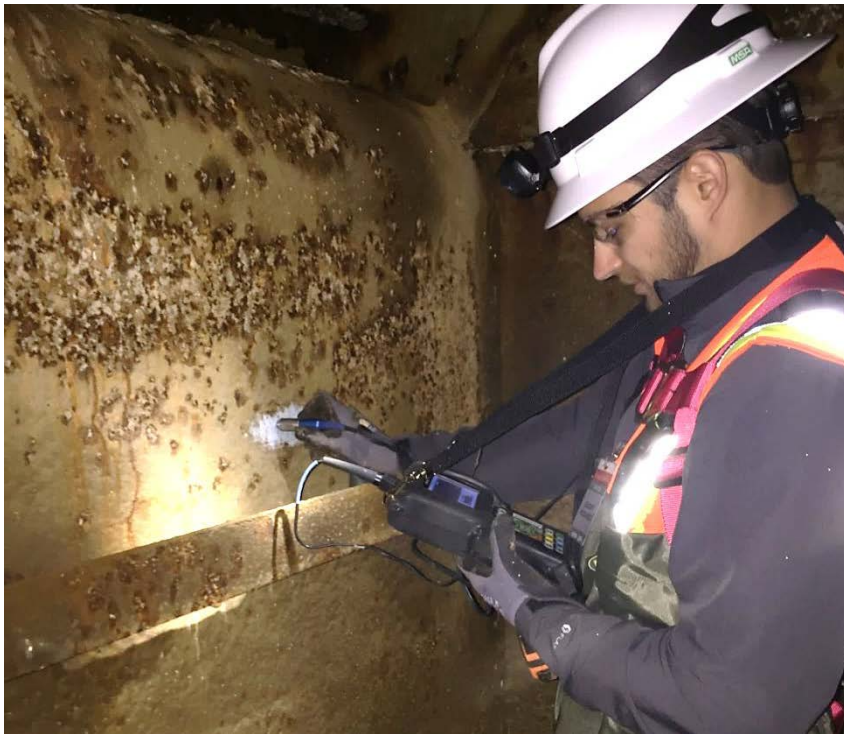
Figure 16: Process for Typical UT Measurement

Wall thickness measurements were obtained using an Olympus 38 DL Plus Ultrasonic Thickness Gage Dual Transducer (THRU-COAT Transducer # D7906-SM) and glycerin couplant. Eight (8) thickness measurements were recorded at each of the locations measured which was used to determine average wall thickness at each location tested. Figure 16 depicts typical process to take UT measurement of wall thickness. Selected beam web thicknesses were measured using a General UltraTECH digital micrometer. The webs were cleaned and prepared for assessment using a wire brush with a scraping tool to remove residual contaminants and corrosion product, where applicable.

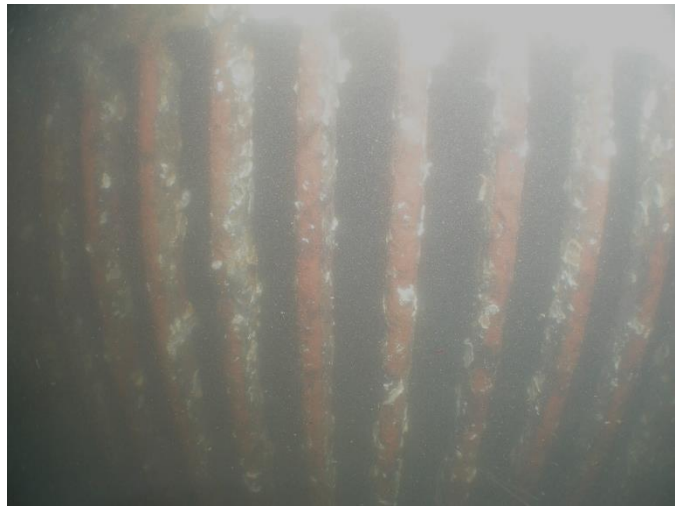
Diver checked each screen again after cleaning and found one screen that has a bent bar which is identified in ***Drawing B***. All other screens are securely fastened to dry dock and in good condition. Below are pictures of a few screens which are typical of all screens after cleaning.

Two intake screen pictures below are “typical” of all intake screens

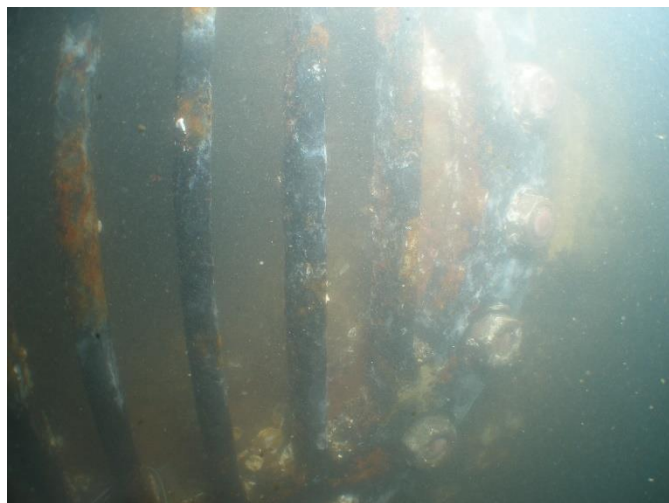
Two discharge screen pictures below are “typical” of all discharge screens
