Pier 68-70 Shipyard Facility Condition Survey Marine Structures

Pier 68-70 Shipyard Facility Condition Survey
 Marine Structures - July 2017
 (This drawing is a reproduction of available
 record drawing marked up to indicate the
 findings of the 2017 survey)

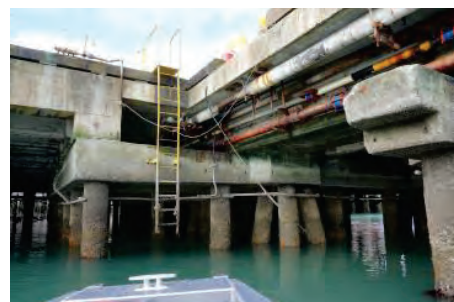
Typical Condition

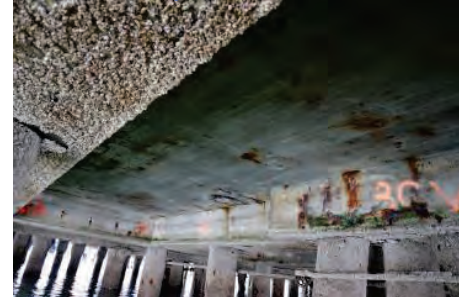
Deck Condition
