FINAL REPORT
JUN 5, 2017

Port of San Francisco
Dry Dock EUREKA
Structural Assessment Report

June 2017

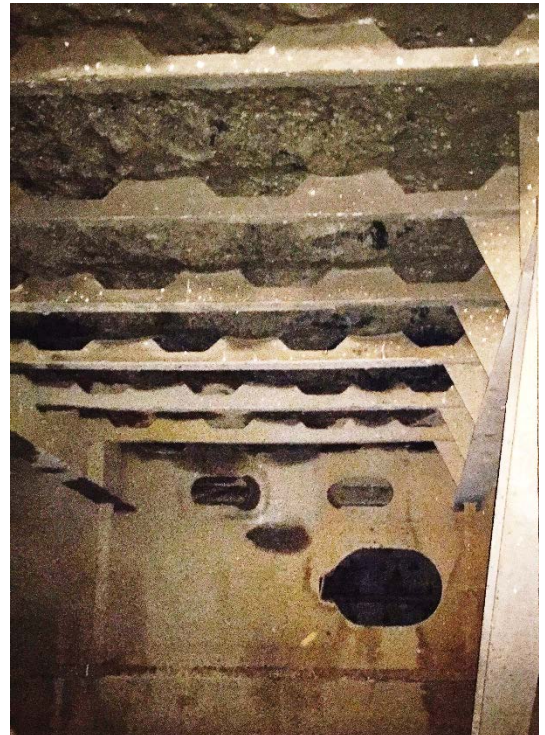
Figure 6: Undamaged Serrated Stiffener Example

An example of heavy corrosion damage to the channel stiffeners is shown in Figure 5 below, compared against an undamaged stiffener shown in Figure 6.

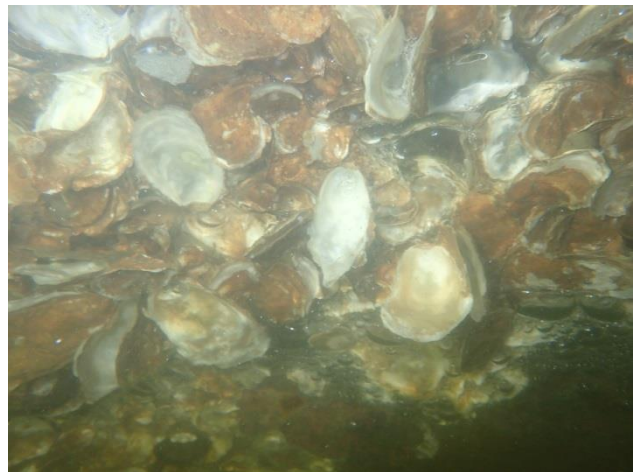
21. Wall stiffeners at Tank 6

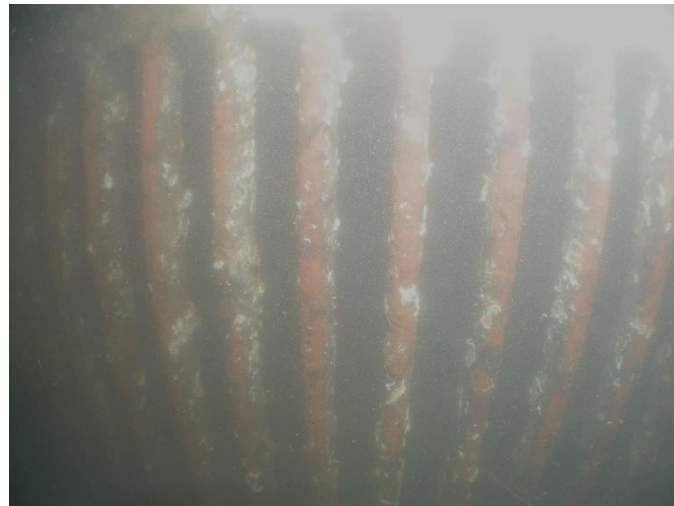
Diver checked each screen again after cleaning and found one screen that has a bent bar which is identified in ***Drawing B***. All other screens are securely fastened to dry dock and in good condition. Below are pictures of a few screens which are typical of all screens after cleaning.

Two intake screen pictures below are “typical” of all intake screens
